NMFS No: E04-23	Date First Observed Entangled: 2/09/2023	
Location First Observed Entangled:	Latitude/Longitude First Observed	
33.2 NM southeast of Nantucket Island, MA	Entangled:	
	40° 42' N, 69° 51' W	
Initial Movement (Anchored/Free): Free-	Status: Partial disentanglement	
swimming		
Sighting prior to entanglement: 7/28/2022	Re-sightings Post-entanglement: None	
Whale Biology: Live right whale #4545, adult female		
NMFS Serious Injury/Mortality Determination: TBD

FISHERY INTERACTION GEAR ANALYSIS					
NMFS No.	E04-23	Gear Recovered (y/n)	Yes		
Date Set	Unknown	Date Lost	Unknown		
Line Diameter	5/8"	Gear Part	Buoy line and		
			buoy.		
Fishery Mark	Yes	Fishery Mark Origin and	Canadian		
Recovered/Documented		Color	orange and		
			yellow		
Target Species	Snow Crab	Location of set	Unknown		
Gear Type	Canadian snow crab – Area 12				
Gear Description:	53 fathoms of 5/8" line was recovered with 33 fathoms being green				
	float line with yellow tracer and the remaining 20 fathoms being				
	green beaded leaded sink line with black tracer. The transition from				
	float line to sink line is seamless with no knots or splice. The line				
	overall was twisted upon itself (mainly near

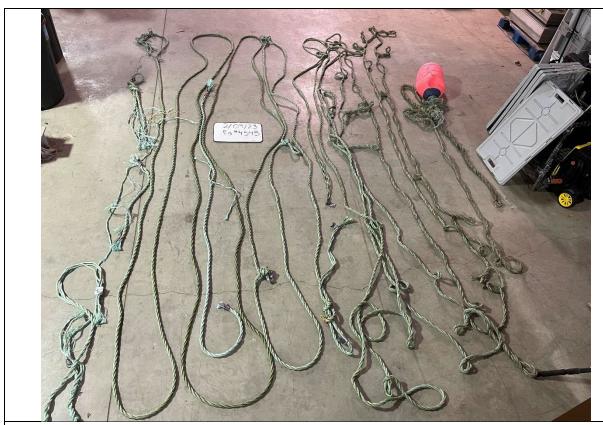
E04-23 image – Recovered gear separated for measurement.

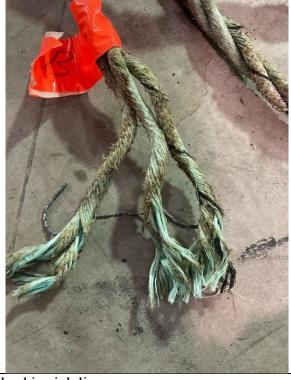
E04-23 image – Beaded lead in sink line.

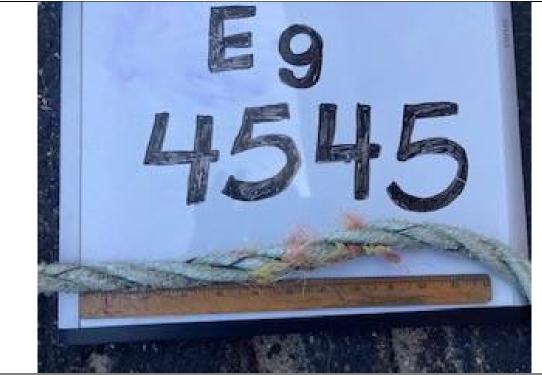
present in the line with the length of the recovered marks being 3.5,				
	5, and 5.5 inches respectively.				
	A deflated LD 2 polyball was recovered with the numbers 145				
	painted on it.				
<u>Comments</u> :	Canadian DFO was consulted with this analysis and the marks are				
	consistent with Canadian Snow Crab – Area 12 in the Gulf of St.				
	Lawrence. No known U.S. fishery has a similar color schemed				
	fishery identification mark. The legal season for Canadian snow				
	crab in 2022 was from April 13 to June 30.				
	Canadian DFO analysis can be found <u>here</u> .				
<u>Conclusions</u> :	Whale was entangled in the buoy line of a Canadian snow crab trap				
	from Area 12 of the G	fulf of St. Lawrence.

E04-23 image – Fishery identification mark.

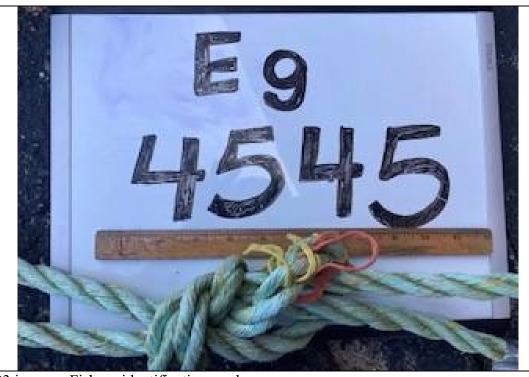
E04-23 image – Fishery identification mark.
