Naval Base Kitsap-Bangor Explosives Handling Wharf 2 Year 1 Marine Mammal Monitoring Report (2012–2013)

BANGOR, WASHINGTON

April 2013

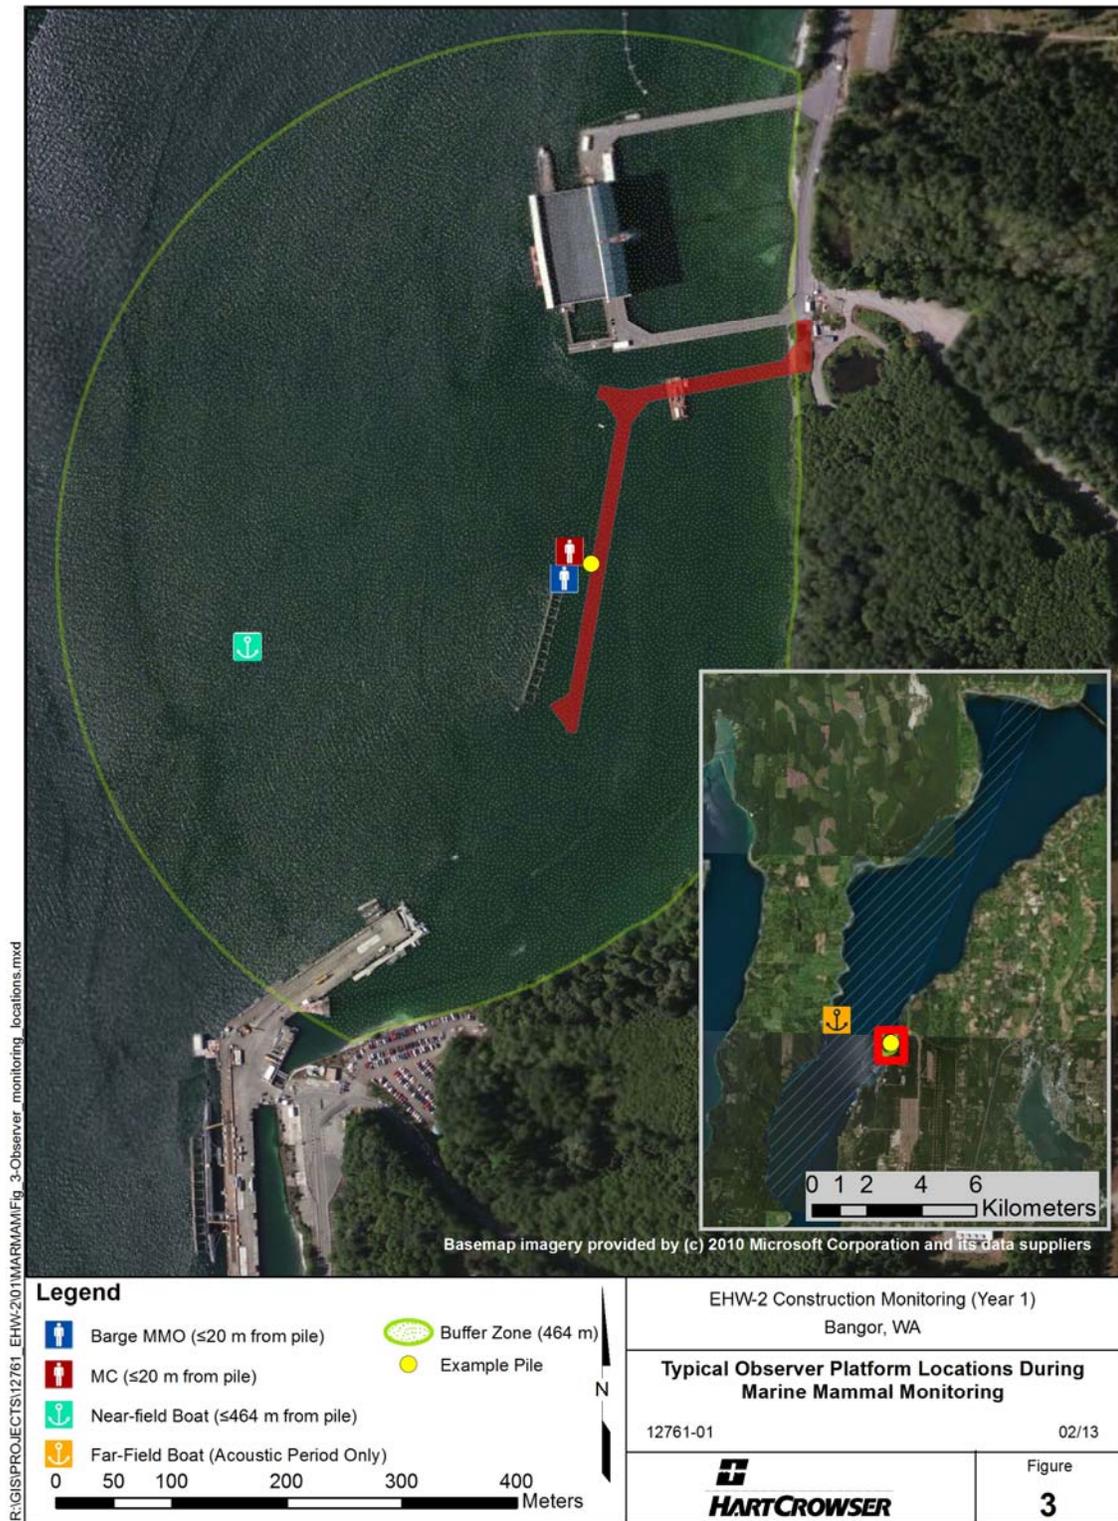
Figure 3. Typical Observer Monitoring Platforms During Marine Mammal Monitoring

Pier- and Barge-based Monitoring. The MC was typically located on the construction barge or the construction pier, and also served as an additional MMO as needed from that relatively stationary location. Occasionally, when pile driving occurred off the construction pier, the best

safe monitoring platform for the MC was atop the bank on the shore. The MC was typically 5–20 m (16–66 ft) from the pile, and at all times had a full view of the shutdown zone. The MC was positioned in close proximity to the construction foreman or in the foreman’s line-of-sight, and each pile driving event was communicated between the foreman and MC. The MC would transmit the pile specifications and other details to the observers, vessel captains, and acoustic personnel, all of whom monitored the same radio channel. The MC logged pile driving times and related construction activities for each pile. This served as the basis for marine mammal sightings data quality control.

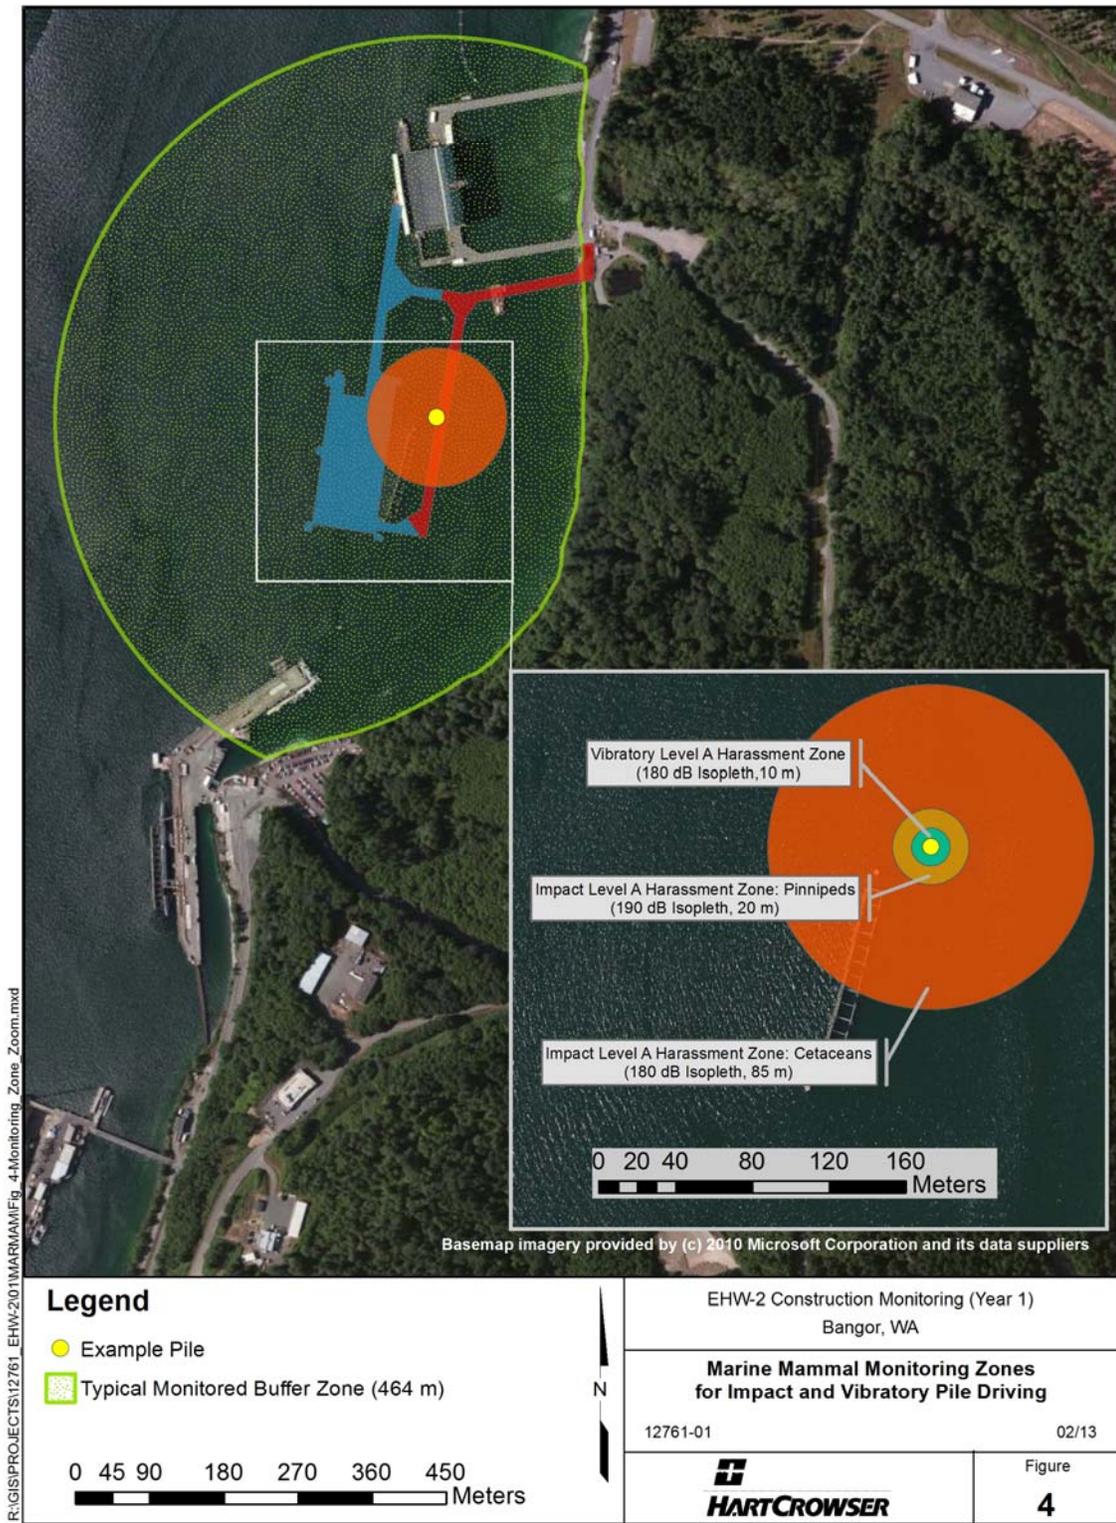
Figure 4. Marine Mammal Monitoring Zones for Impact and Vibratory Pile Driving

Shutdown Zone. The shutdown zone included all areas where the underwater sound pressure levels (SPLs) were anticipated to equal or exceed the Level A (injury) Harassment criteria for marine mammals (180 decibels referenced to 1 micropascal [dB re 1 μ Pa] isopleths for cetaceans; 190 dB re 1 μ Pa isopleths for pinnipeds; Figure 4). For vibratory pile installation and removal, monitoring was conducted for a 10-m (32.8-ft) shutdown zone (Level A Harassment) surrounding each pile for the presence of marine mammals before, during, and after pile operations. For impact pile installation, monitoring was conducted for a 20-m (65.6-ft) shutdown zone for pinnipeds and an 85-m (278.9-ft) shutdown zone for cetaceans. The 10-m shutdown zone was also monitored during other activities with the potential to affect marine mammals, including movement of a barge to the pile location and the removal or insertion of a pile from the water column via a crane (“dead pull” and “stabbing,” respectively).

Buffer Zone. Although a buffer zone (Level B harassment, 120 dB isopleth) for vibratory pile removal was predicted to have an area of 41.4 square kilometers (km²; 16.0 square miles), monitoring an area of that size would have been impractical (Figure 5). Instead, MMOs used the NMFS-approved 464-m (1522-ft) radius buffer zone (160 dB isopleths) as a guideline for placement of marine mammal monitoring platforms during vibratory pile driver activity (Figure 4; DoN 2012). However, all identifiable marine mammals, regardless of whether inside or outside the 464-m zone, were recorded.

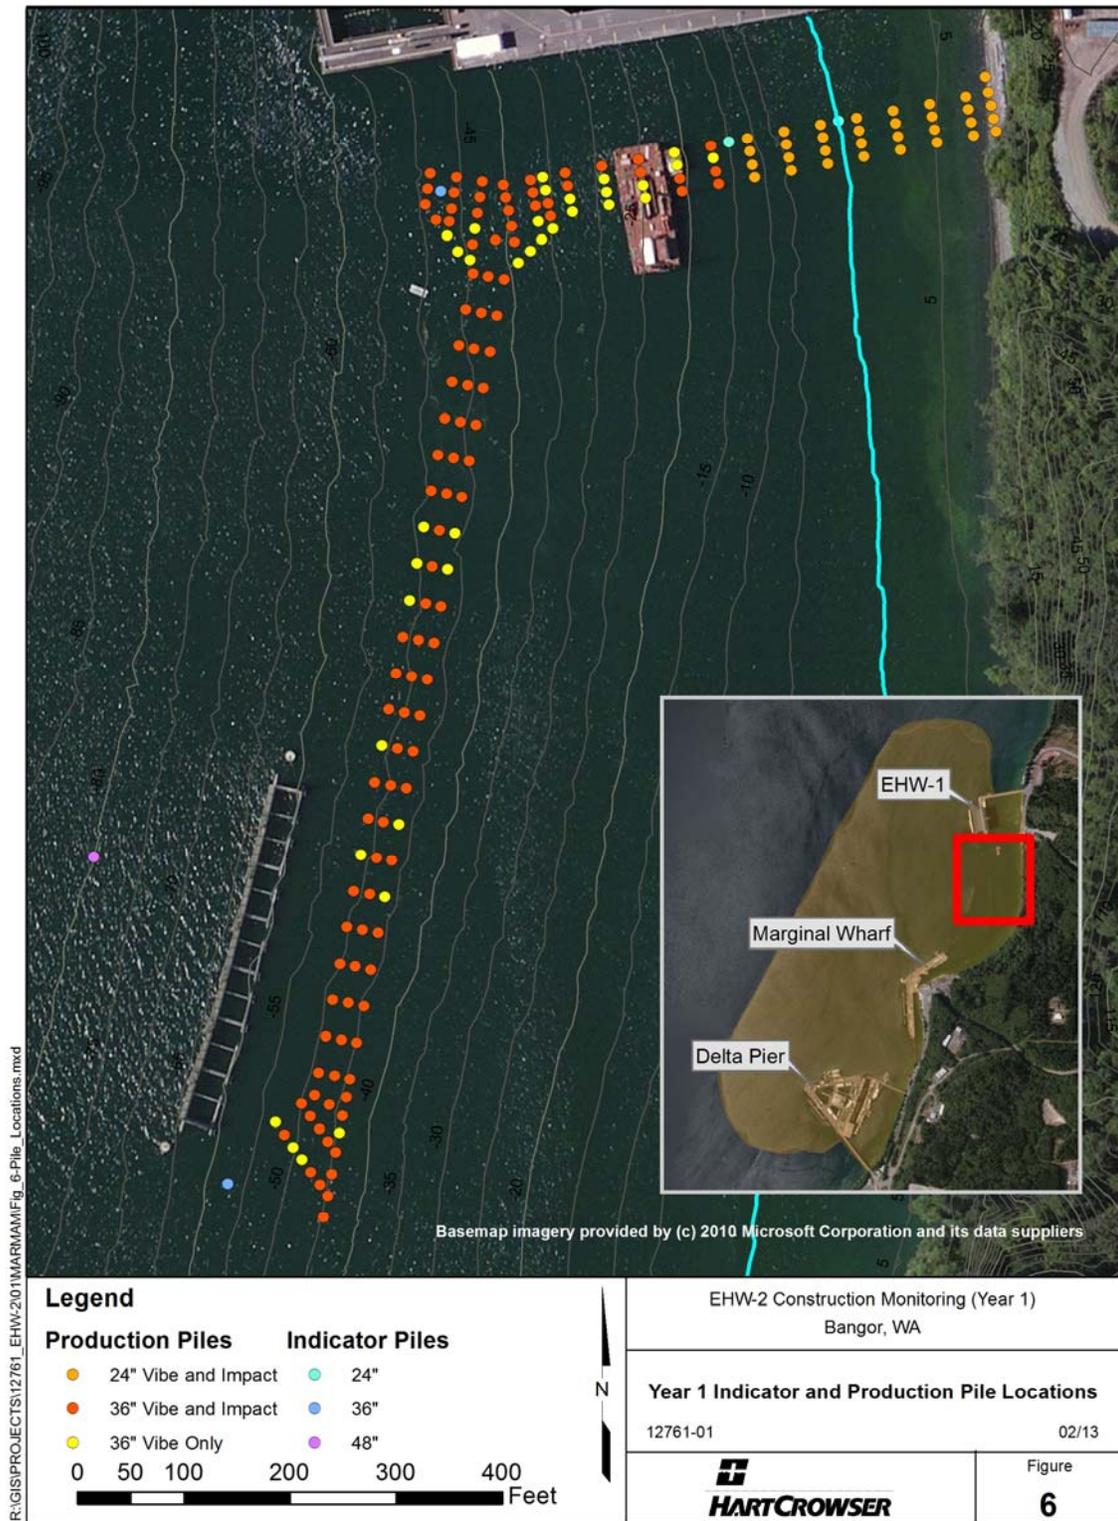
Figure 6. Year 1 Indicator and Production Pile Location

Pile Driving Equipment. Pile driving equipment was provided and operated by EHW Constructors pile driving crews. Two vibratory (American Piledriving Equipment [APE] 400 and APE 600) and two impact hammers (APE D80 and APE D100) were used during the project, though only one impact hammer was in operation at any time.

The APE 400 and APE 600 have drive forces of 361 tons and 556 tons, respectively. Impact hammers APE D80 and APE D100 were rated for 198,450 ft-pounds (lbs) and 248,063 ft-lbs, respectively. The APE 400 was used on 24-inch piles, while APE 600 was used for 36- and 48-inch piles, as well as a few 24-inch piles. Similarly, APE D80 was used to impact 24-inch piles. The APE D100 was used to impact 36- and 48-inch piles (**Figure 6, Appendix C**). In total, there were 160 instances where piles were driven with an impact hammer, and therefore required formal monitoring for marbled murrelets. Marbled murrelet monitoring methods and findings are presented in a separate report (Hart Crowser 2013).

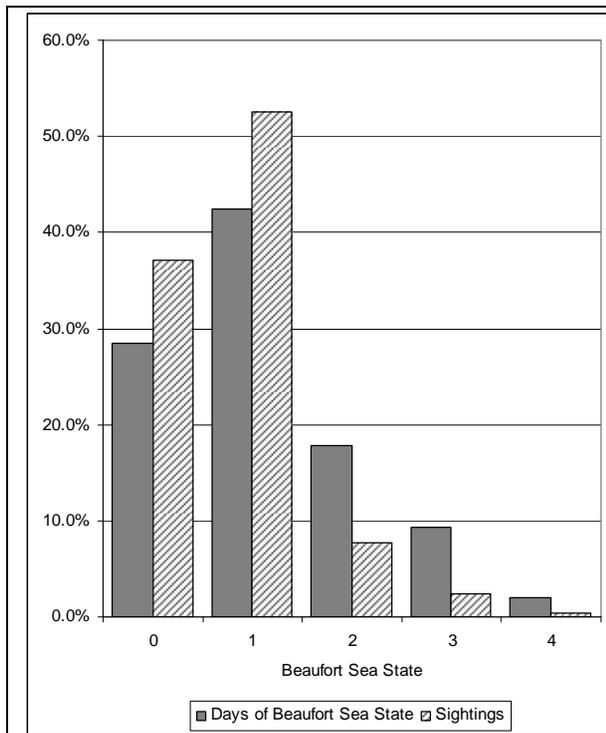
Figure 11a. Sightings by Sea State

Favorable weather persisted throughout construction, and shutdowns due to reduced visibility were not required at any time. Most marine mammal sightings were made in calm conditions with low wave height (**Figures 11a** and **11b**). Just over 97% (1079 of a total 1109) of marine mammal sightings were made during Beaufort sea state (BSS) conditions of 0–2 (winds at or below 6 knots; see **Appendix B** for the Beaufort scale). Sightings declined significantly at BSS 2 and above, with

2.1 sightings per day compared to 9.3 sightings per day during BSS 1 or less. All construction and marine mammal surveys occurred during sea states of BSS 4 (winds at or below 16 knots) or below. Favorable weather conditions (cloudy and sunny) occurred on 76% of construction days; 83% of all sightings occurred under those conditions. Glare on sunny days did not apparently limit sightings, as the proportion of sightings occurring on sunny days (17.9%) was higher than the proportion of sunny days (14%). Weather that produced reduced visibility (fog and rain) occurred on 24% of construction days; 17% of all sightings occurred under those conditions.

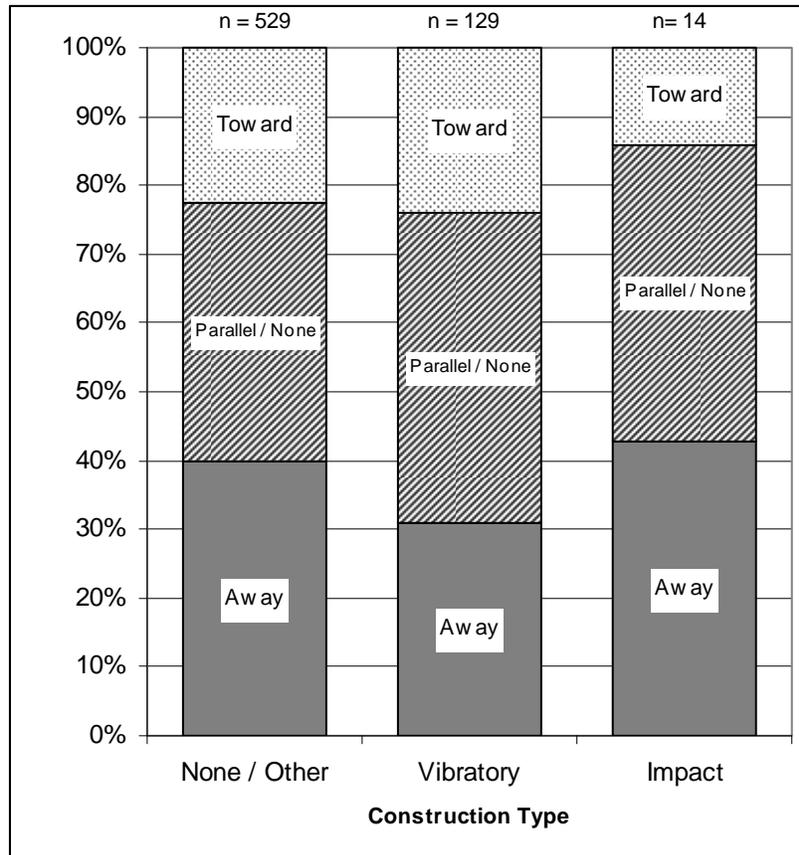
Figure 18. Relative Motion of Marine Mammals by Construction Event

Summary of Quantitative Analysis. During periods of construction other than pile driving events, marine mammals were most frequently observed swimming away from the pile (40%, n=209; Figure 18). During vibratory pile driving, marine mammals were most frequently observed moving parallel or having no relative motion to the pile (45%, n=139). There was also a slight increase in the percentage of animals that moved toward the pile during vibratory pile

driving (24%, n=31) compared to non-pile driving periods (22%, n=118; **Figure 18**). During impact driving events, animals were most frequently observed moving away and/or moving parallel to or having no relative motion to the pile (each 43%, n =6). Marine mammals did not move toward the pile as frequently during impact pile driving (14%, n=2), as during vibratory driving (24%, n=31) or during periods of no pile driving (22%, n=118).

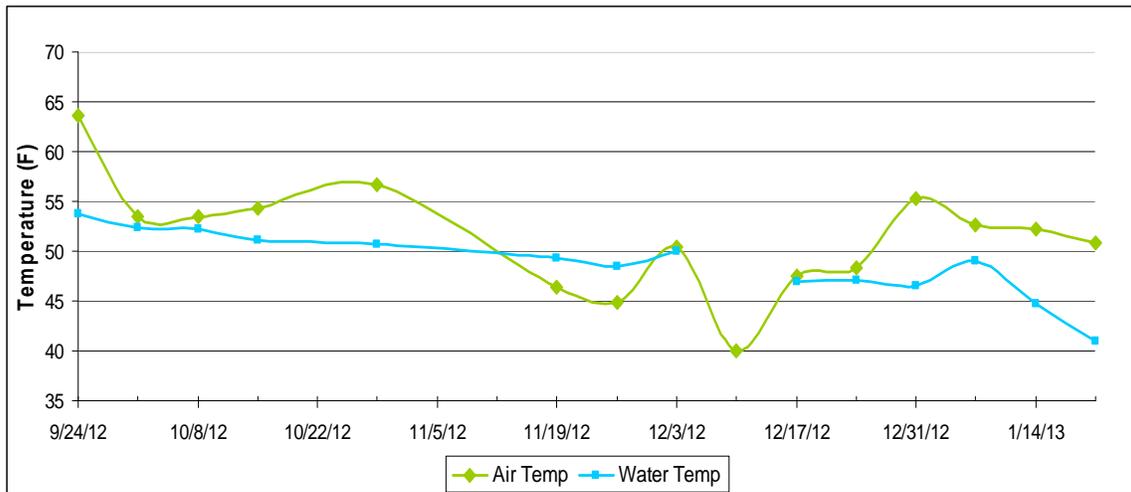
Figure 19. Air and Water Temperature for duration of the EHW-2 CMP

Environmental data are summarized in **Appendix E**. Average daily air temperatures ranged from 40 degrees Fahrenheit (° F) to 61° F for the duration of EHW-2 CMP (**Table 19**). Average weekly air temperatures fluctuated from 64° F in September to 51° F in January. Water temperatures fell from 54° F at the beginning of the project to 43° F over the course of the monitoring period. The lowest recorded weekly average water temperature was 40° F in the second week of December 2012. No correlation was found between air or water temperatures and frequency of marine mammal sightings.

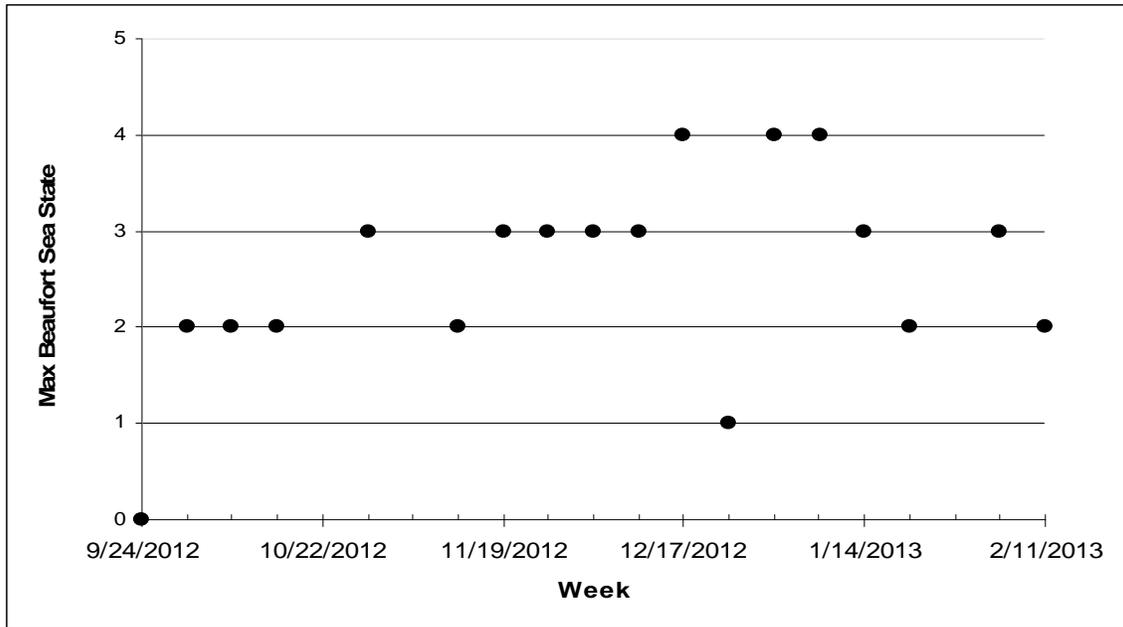
Figure 20. Maximum Beaufort Sea State for the duration of the EHW-2 CMP.

The Beaufort sea state reached a maximum weekly average of BSS 4 in December and January (**Figure 20**). However, 97% of sightings occurred during a BSS 0–2, while the smallest percentage of sightings occurred during a BSS 4 (**Figure 11a**). Due to the wind and wave stilling effects of the construction barges that were clustered around the pile being driven, the

marine mammal observers consistently reported having clear view of the shutdown zone and nearer portions of the buffer zone during pile driving activities.

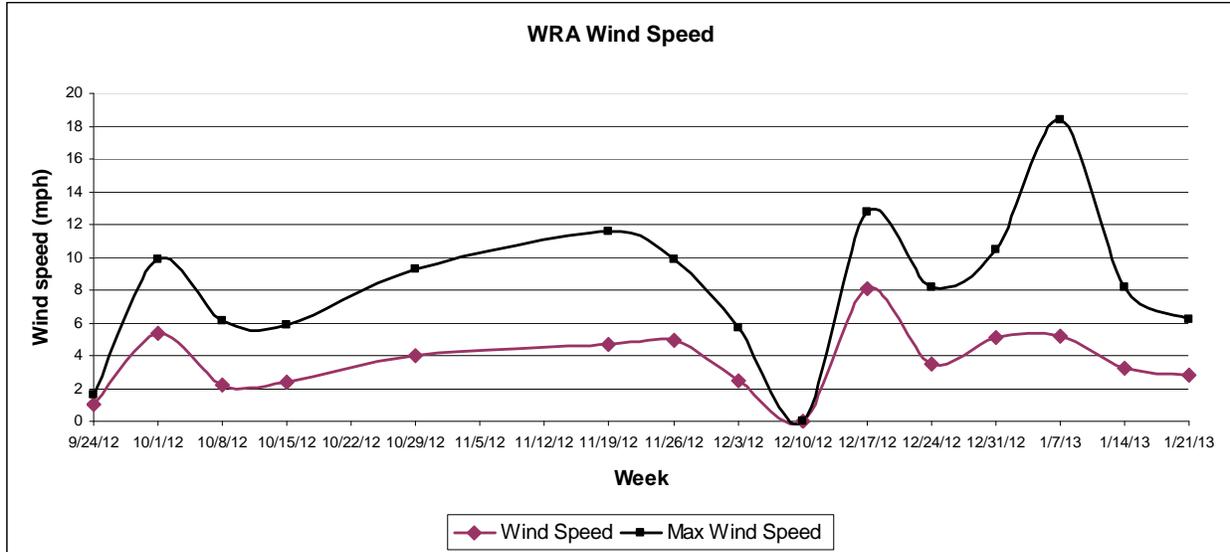
Figure 21. Wind Speed for the duration of EHW-2 CMP

Wind speeds ranged between 0 miles per hour (mph) to 18.4 mph, but were in the range of 0 mph to 8 mph most days (Figure 21). There was no clear link between recorded wind speed and BSS ($R^2=0.03073$). For example, the highest wind speeds on 10 January were associated with a BSS range from 0–1. Observers found that localized wind “chop” rather than more regular waves were the primary determinant of the quality of viewing conditions. Similarly, wind direction was also important: winds from the east, southeast, and northeast could be strong but lacked the fetch to significantly affect the BSS in the WRA. This benefited observers in the WRA as conditions in this area were generally calmer than in adjacent areas of Hood Canal due, in part, to the location of the project area between EHW-1 and Marginal Wharf and in part, to the security fence, which provided a degree of shelter and dissipated wind and wave energy from the open waters of Hood Canal.
