Naval Base Kitsap-Bangor Explosives Handling Wharf 2

Year 3 Marine Mammal Monitoring Report (2014-2015)

BANGOR, WASHINGTON

March 2015

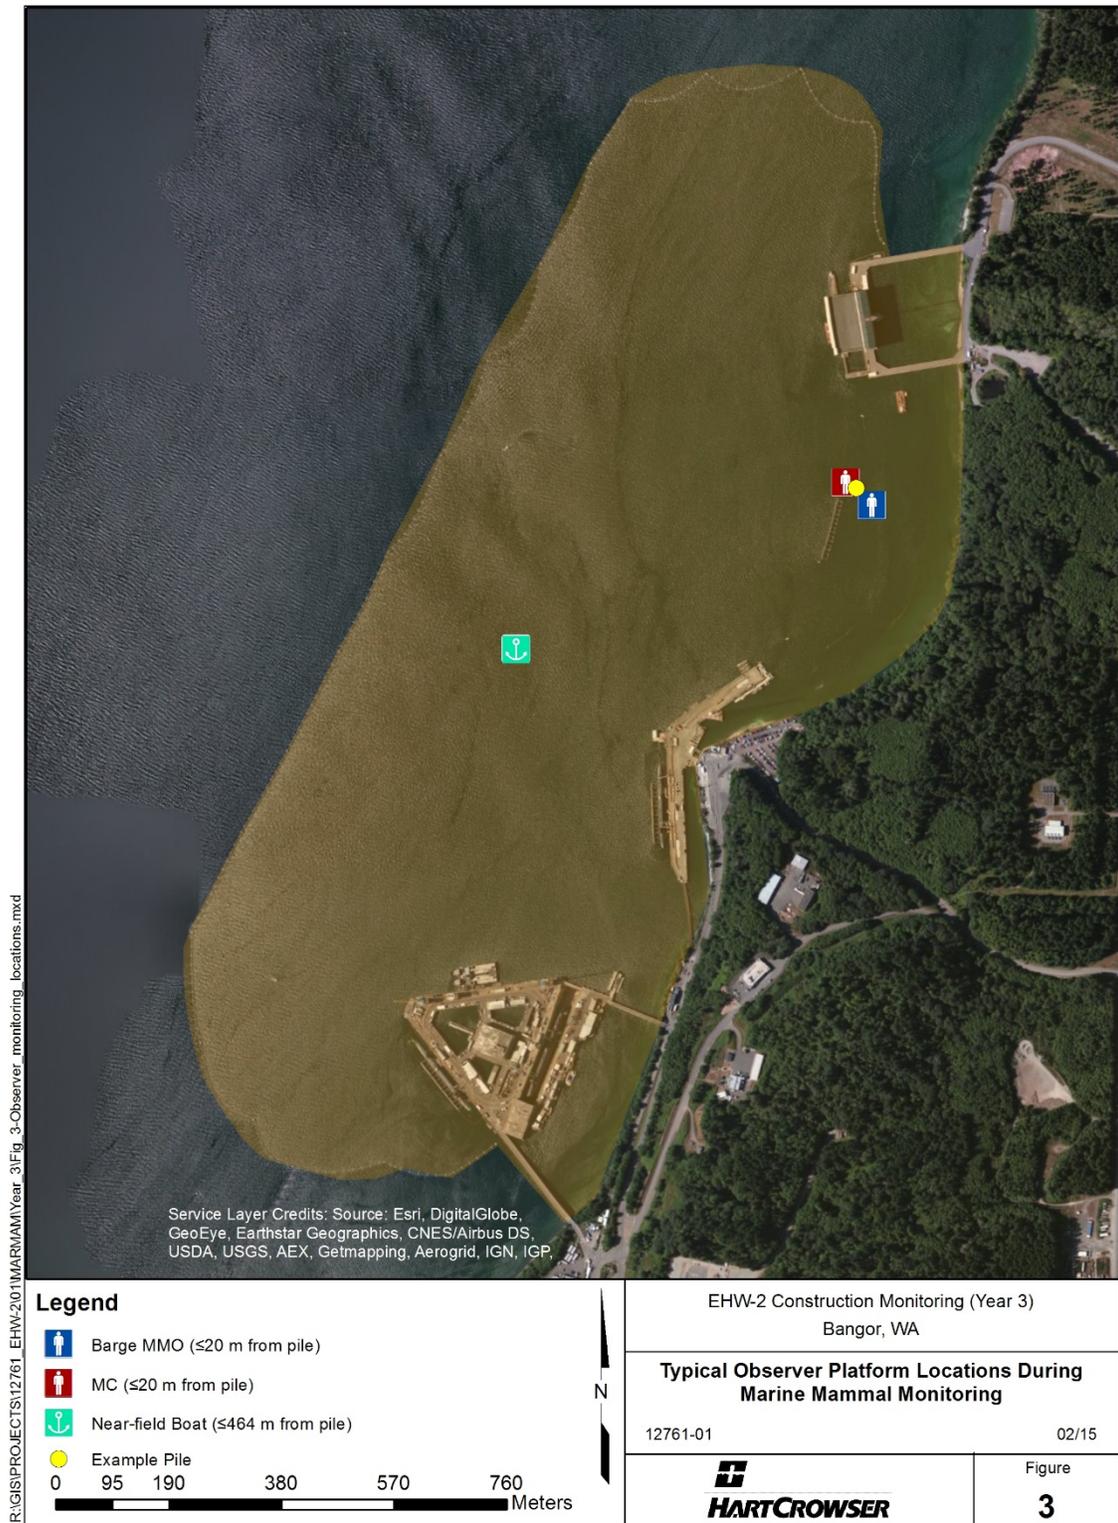
Figure 3. Typical Observer Monitoring Platform during Marine Mammal Monitoring

Vessel-based Monitoring. Vessels were used as observation platforms and for transportation to pile driving barges. The Year 3 EHW-2 CMP included one 32-foot (9.8-meter [m]) fiberglass-hulled Bayliner, which was used daily as the primary monitoring platform for the MMO conducting surveys of the buffer zone. Tugboats and several other smaller vessels were used for transportation of personnel and equipment when navigation or barge access was difficult, but were not used as monitoring platforms. Vessels were equipped with VHF radios and depth sounders. All captains were United States Coast Guard-certified and were familiar with the Puget Sound waterways and the unique characteristics of the region. MMO monitoring vessels were equipped with elevated observation platforms, which provided maximum viewing capability. The MMO monitoring vessel's observation platform was approximately 3 to 4 m (9.8 to 13.1 feet [ft]) above the water line.

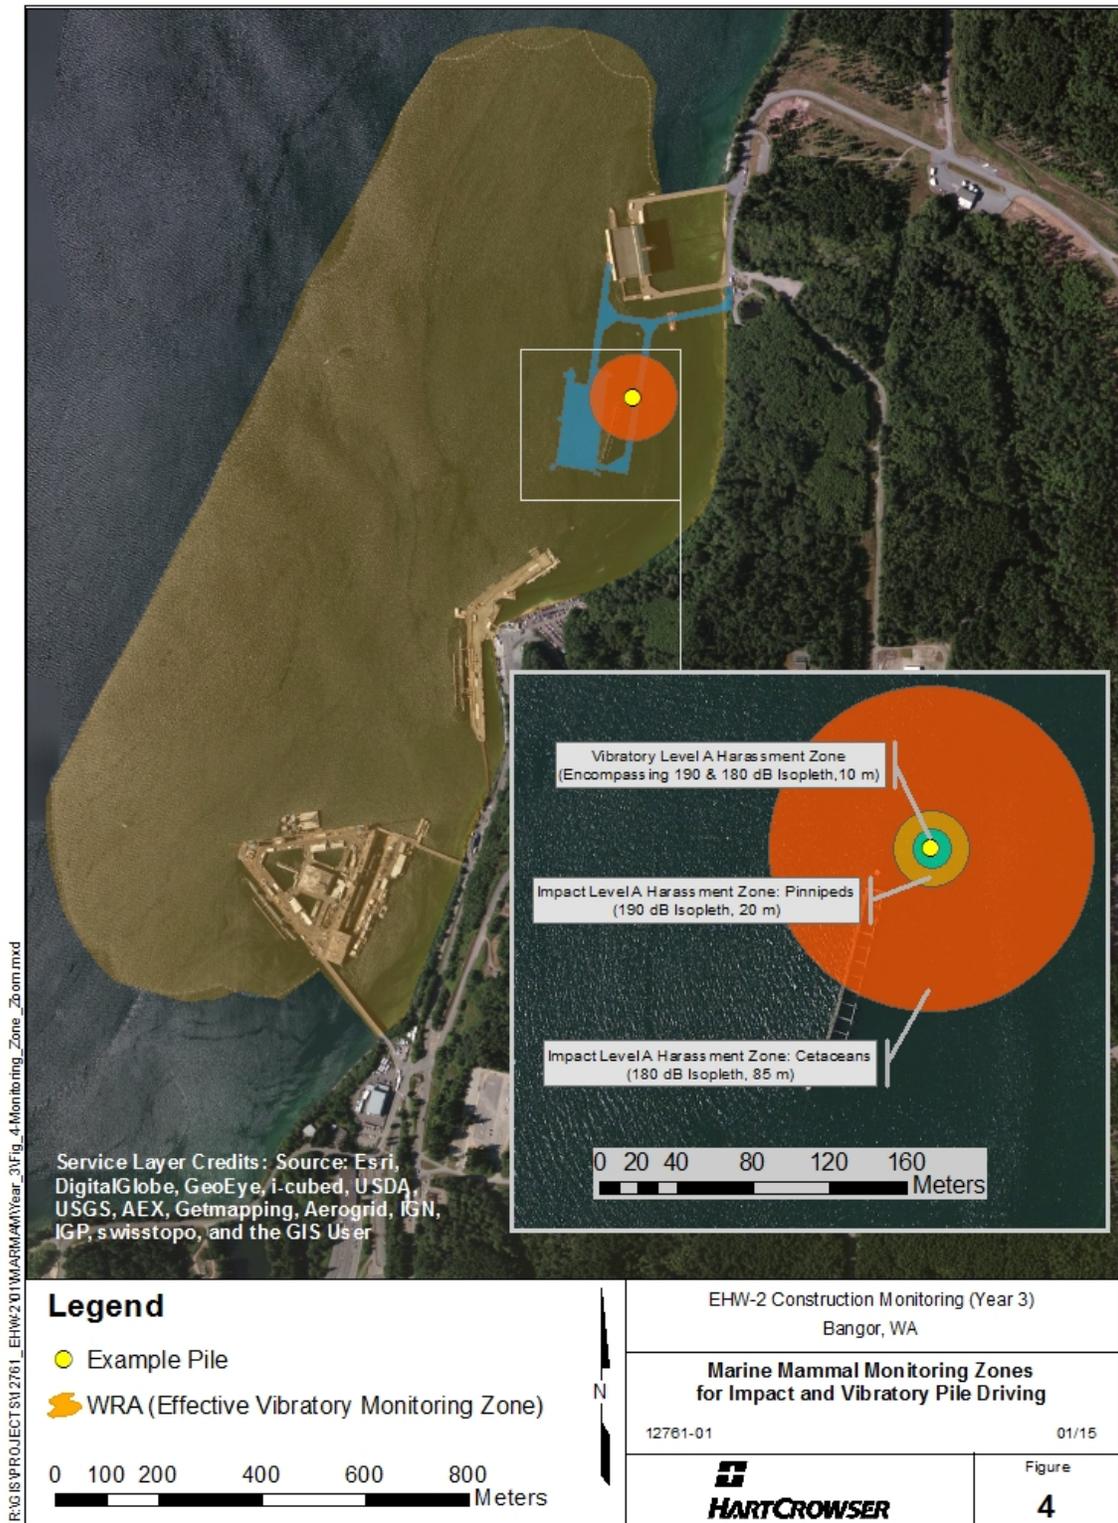
Figure 4. Marine Mammal Monitoring Zones for Impact and Vibratory Pile Driving

Shutdown Zone. The shutdown zone included all areas where the underwater sound pressure levels were anticipated to equal or exceed the Level A (injury) Harassment criteria for marine mammals (180 decibels referenced to 1 micropascal [dB re 1 μ Pa] isopleths for cetaceans; 190 dB re 1 μ Pa isopleths for pinnipeds). For vibratory pile installation and removal, monitors enforced a 10-m (32.8-ft) shutdown zone, which encompassed the Level A Harassment zones for cetaceans and pinnipeds (**Figure 4**). For impact pile installation, monitors enforced a 20-m (65.6-ft) shutdown zone for pinnipeds and an 85-m (278.9-ft) shutdown zone for cetaceans (**Figure 4**). The 10-m shutdown zone was also monitored during other activities with the potential to affect marine mammals, including movement of a barge to the pile location, and the removal or insertion of a pile from the water column via a crane (“dead pull” and “stabbing,” respectively).

Buffer Zone. Although a buffer zone (Level B harassment, 120 dB isopleth) for vibratory pile removal was predicted to have an area of 41.4 square kilometers ([km²]; 16.0 square miles), monitoring an area of that size would have been impractical (**Figure 5**). Instead, MMOs monitored from locations throughout the WRA during vibratory pile driver activity (approximately 1.4 km² **Figure 4**). However, since all MMOs were aware that the disturbance zone extended beyond the WRA, all identifiable marine mammals, regardless of whether inside or outside the WRA, were recorded.

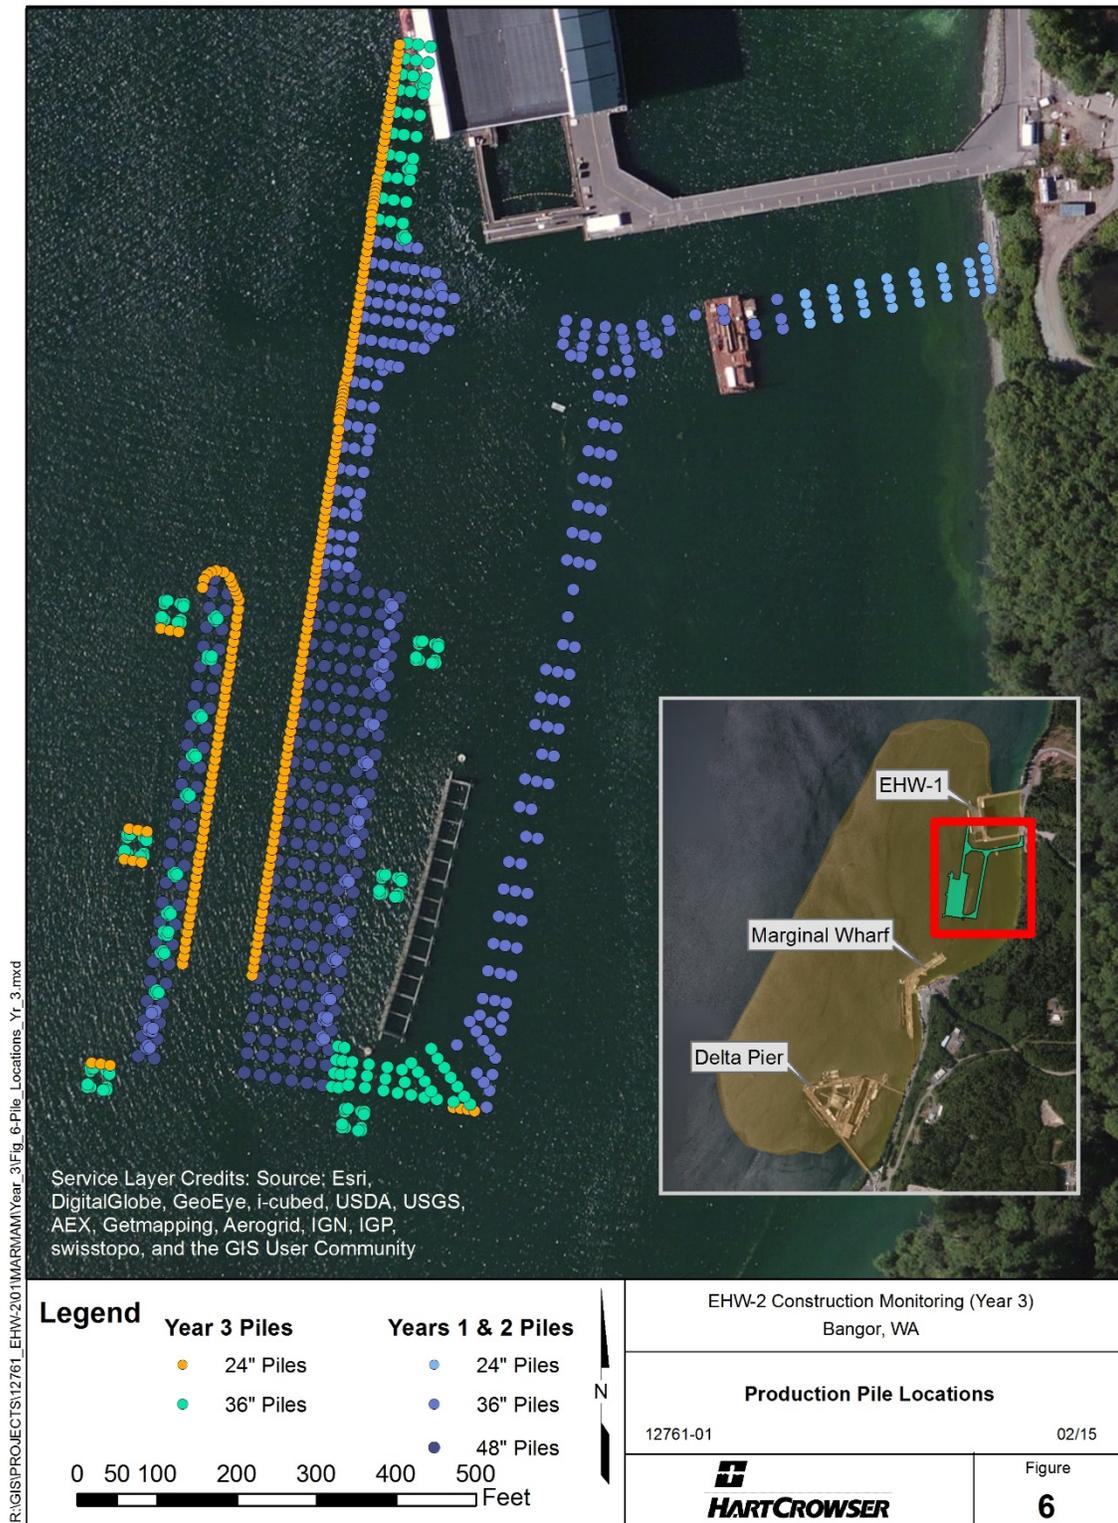
Figure 6. Production Pile Locations

Pile Descriptions. During the Year 3 EHW-2 CMP, 397 production steel piles (piles that will remain as part of the EHW-2 structure) were driven by vibratory and impact hammers. All 397 piles were driven by a vibratory hammer, and 121 of those piles were subsequently proofed by an impact hammer. Piles impacted consisted of 63 plumb piles and 58 batter piles (additional

“temp” piles were installed as discussed below). Production piles ranged in diameter from 24- to 36-inches (0.61 to 0.92 m) (**Figure 6; Appendix D**).

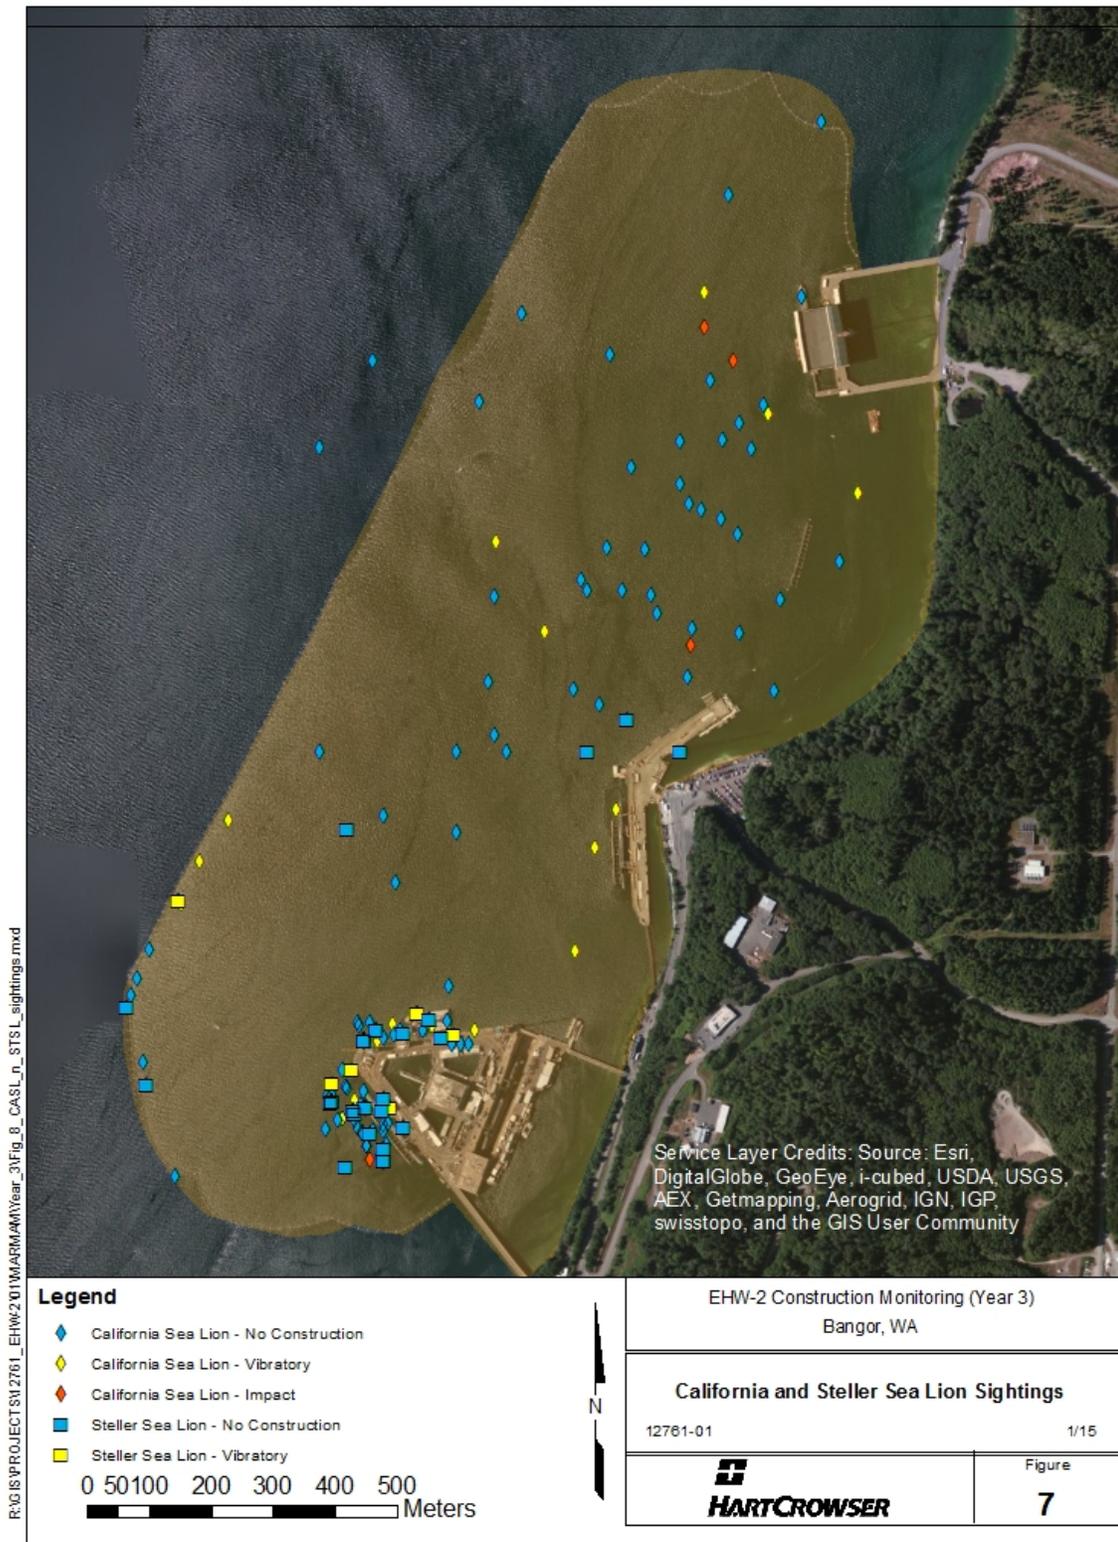
Figure 7. California and Steller Sea Lion Sightings

A total of 641 sightings of 1,096 marine mammals were observed during surveys of pile installation and removal activities (impact and vibratory pile driving; **Table 4**; **Figures 7** and **8**). Harbor seals were the most frequently sighted species during impact and vibratory pile driving, accounting for 93% of all sightings. California sea lions were also observed during vibratory pile driving and impact pile driving. California sea lions were observed hauled out in groups during vibratory pile driving (average $n=7$). MMOs observed California sea lions singularly during impact pile driving, but these sightings only accounted for 1.5% of all impact sightings. Steller sea lions were observed hauled out in groups and only during vibratory pile driving (average $n=3$).

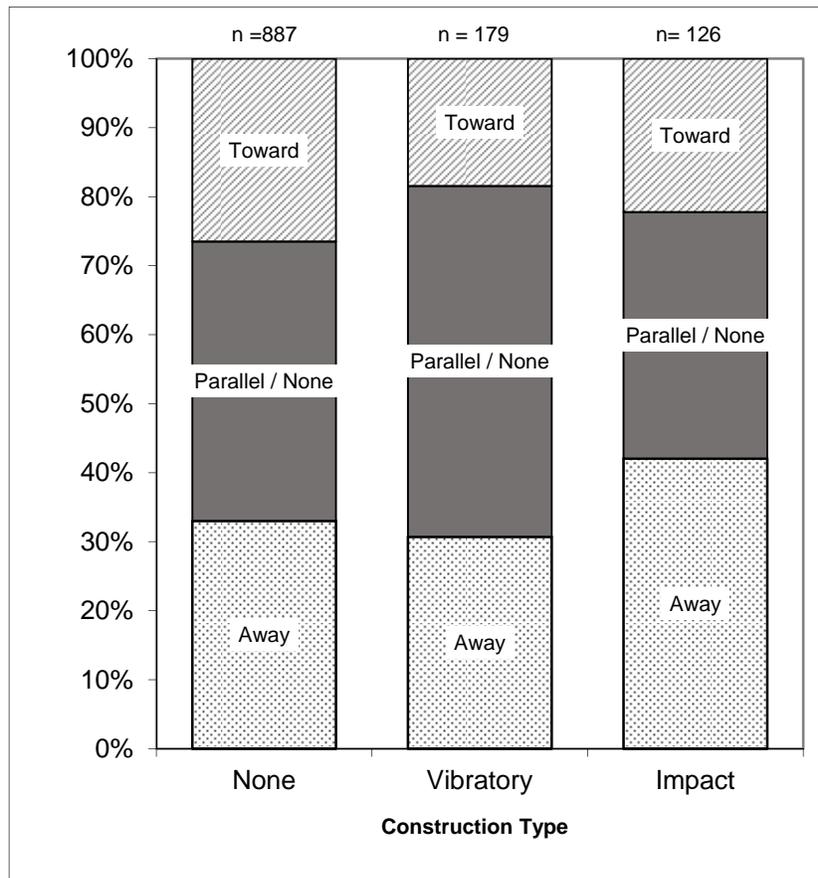
Figure 13. Relative Motion of Marine Mammals by Construction Event

Summary of Quantitative Analysis. During periods of construction other than pile driving events, marine mammals were most frequently observed swimming parallel or having no relative

motion to the construction area (40%, n=359; **Figure 13**). During vibratory pile driving, marine mammals were most frequently observed having no relative motion (51%, n=91). There was also a decrease in the percentage of animals that moved toward the pile during vibratory pile driving (18%, n=33) compared to non-pile driving periods (26%, n=235; **Figure 13**). During impact driving events, animals were most frequently observed moving away from the pile (42%, n=53). Marine mammals moved toward the pile less frequently during impact pile driving (22%, n=28) than during periods of no construction (26%, n=235).

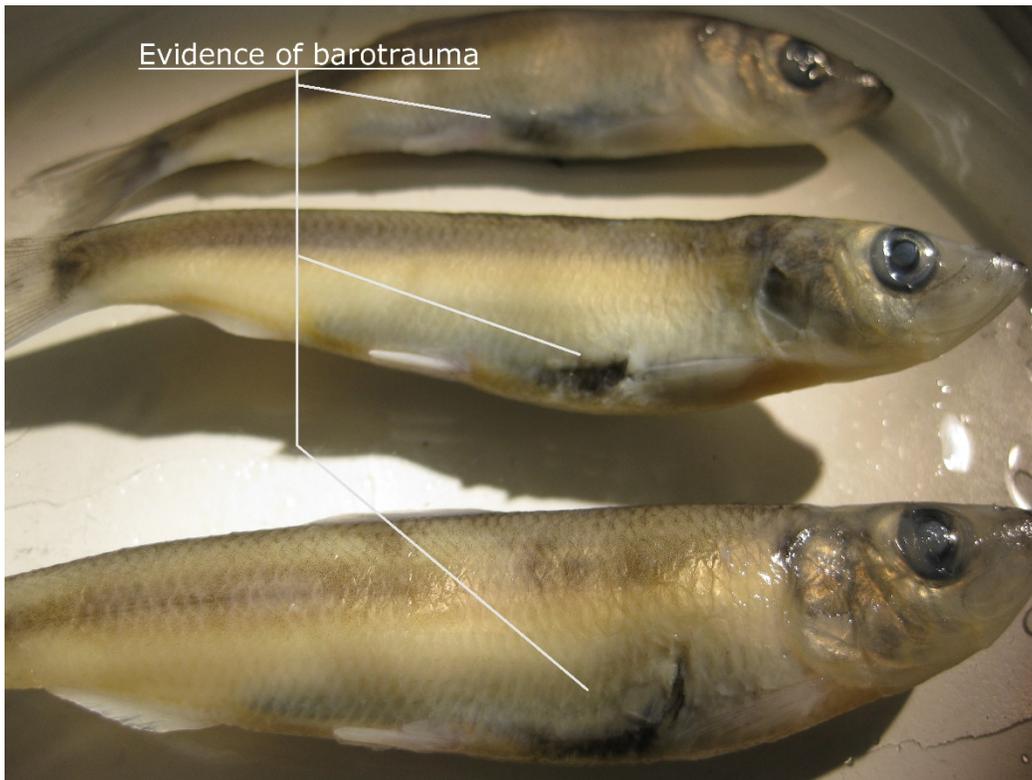
Photograph 1. External signs of barotrauma on herring retrieved during impact pile driving 21 August 2014.

Although the focus of monitoring was on marine mammals, observers also looked for other environmental indicators of potential impacts from pile driving. Pacific herring (*Clupea pallasii*), a non-ESA-listed species, appeared in massive schools in August and September 2014. Marine mammal monitors observed large herring schools on numerous days during this period, which may also help explain the greater number of harbor seal sightings per monitoring hour during that period (**Figure 14**). These large schools of herring coincided with observed fish mortalities and stuns on five days between August and September, 2014 (**Table 10**). Observed herring impacts only occurred when large schools were present and adjacent to the piles, and were observed for a very limited number of work days (1% of all work days). Herring impacts occurred during both vibratory and impact pile driving events (all piles 36-inch diameter), with the number of herring impacted ranging from one to approximately 100 fish per incident. Herring recovered on 21 August 2014 after impact pile driving showed evidence of hemorrhaging in the abdominal walls (based on external observations and dissection) consistent with effects of barotrauma (**Photographs 1 and 2**). Fish were not collected and analyzed for other dates. Mitigation delays or shutdowns occurred during both instances when herring impacts were observed during impact pile driving due to harbor seals foraging near the pile (**Tables 9 and 10**).

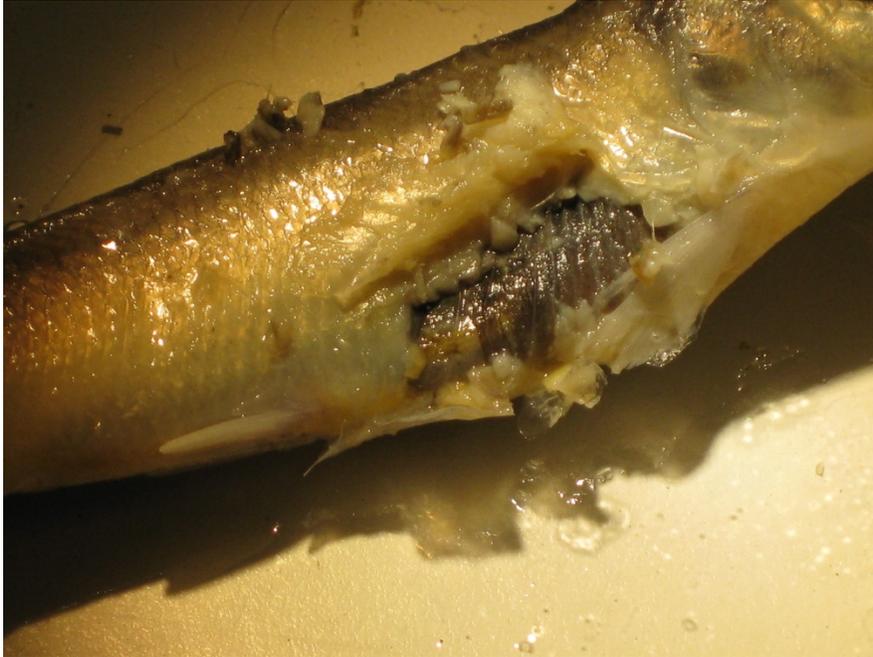
Photograph 2. Hemorrhaging in the abdominal wall of herring.

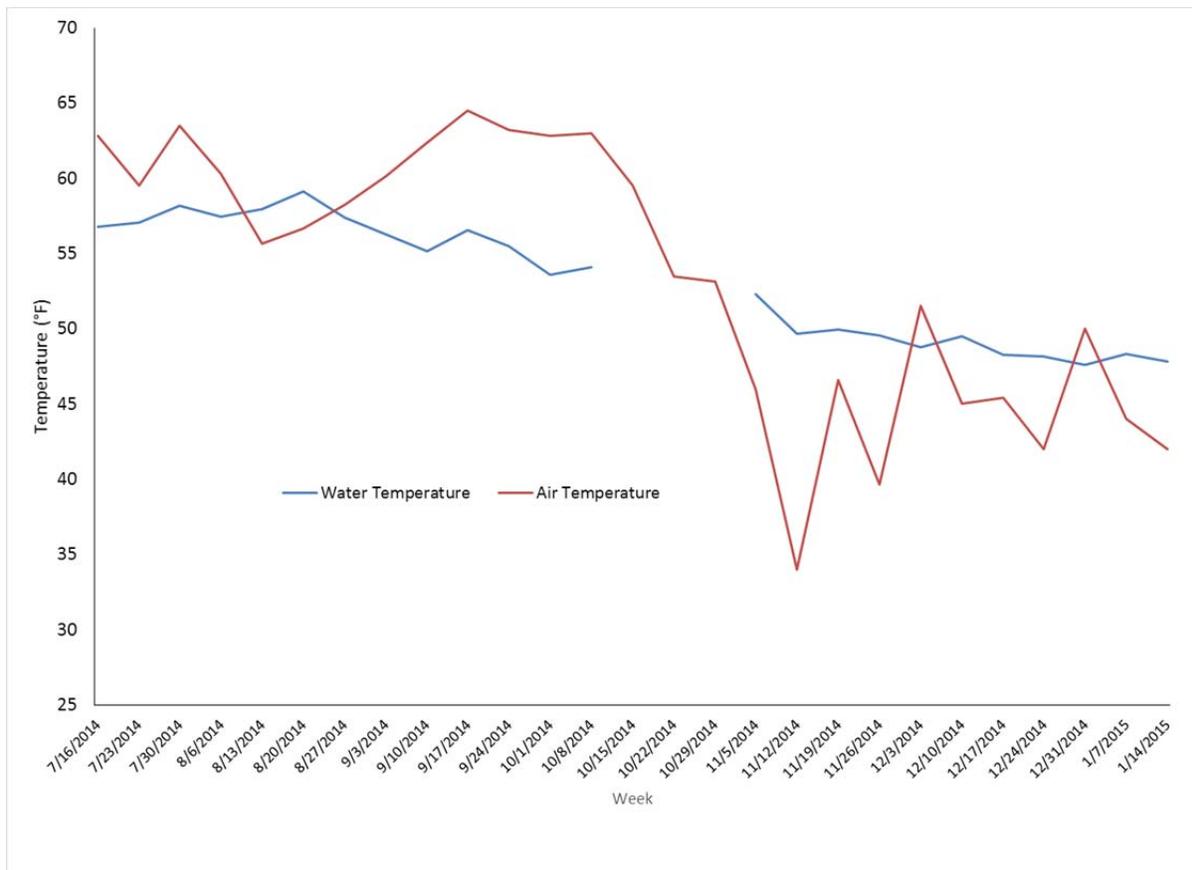
Figure 15. Average Air and Water Temperatures in the WRA

Environmental data can be found in **Appendix G** and are summarized by week in **Figures 15** and **16**. Average weekly air temperatures fluctuated from 65 degrees Fahrenheit (° F) in mid-September 2014 to the lowest recorded average temperature of 34° F in mid-November 2014. Water temperatures were steady between 57° F and 59° F from July through August 2014, then steadily decreased to 48° F by mid-January when monitoring ended. Neither air nor water temperatures had any effect on the observers’ ability to identify marine mammals within the

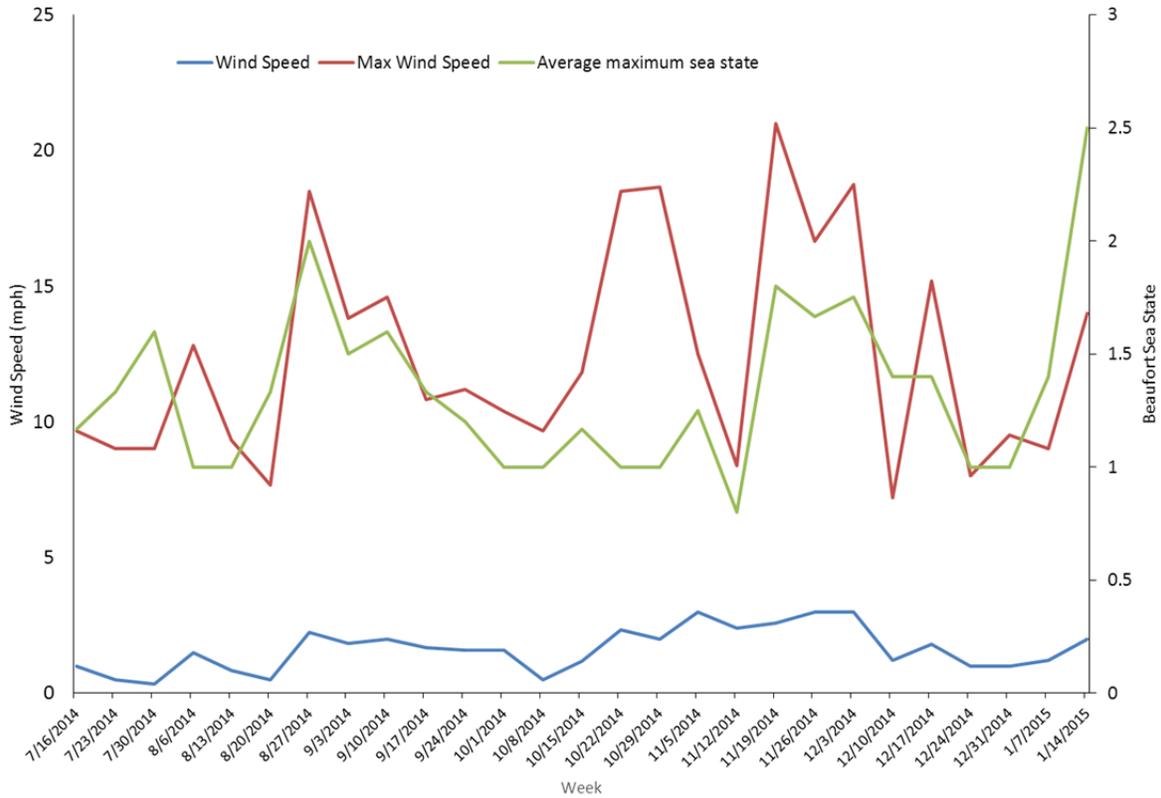
Figure 16. Wind Speed in the WRA

Average weekly wind speeds ranged from 0.3 to 3.0 miles per hour (mph), with the maximum wind speed of 32 mph on 24 November 2014 (**Figure 16**). No impact pile driving occurred during high wind periods due to the Marbled Murrelet Monitoring Plan protocol limiting sea state to less than BSS 3 during impact pile driving. Wind speeds did not result in unacceptable visibility ranges during pile driving activity, and resulted in a maximum BSS 3 during marine mammal monitoring (typically BSS 1–2). Observers found that localized wind “chop” was the primary determinant of the quality of viewing conditions. This benefited observers in the WRA as conditions in this area were generally calmer due, in part, to the location of the project area between EHW-1 and Marginal Wharf and in part, to the security fence, which provided a degree of shelter and dissipated wind and wave energy from the open waters of Hood Canal. Construction barges and boats also tended to reduce sea state in the vicinity of the construction work area.
