**San Francisco – Oakland Bay Bridge
East Span Seismic Safety Project**

**MARINE MAMMAL MONITORING ANNUAL REPORT
FOR PILE DRIVING AND MECHANICAL
DEMOLITION**

JANUARY 8, 2014 – JANUARY 7, 2015

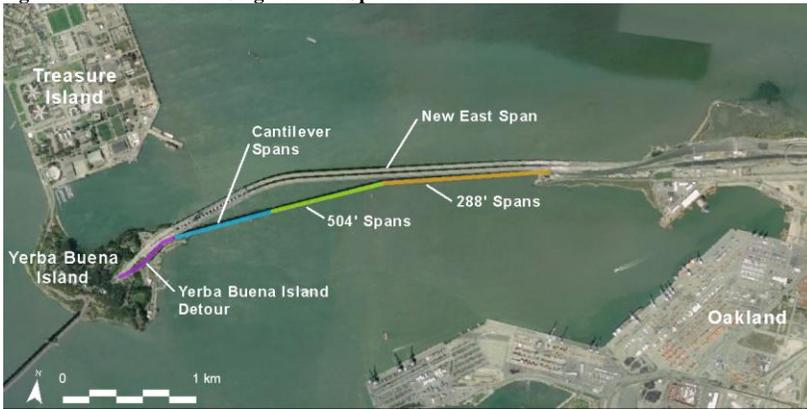
Figure 1. Sections of the Original East Span for Removal.

Dismantling of the original bridge has five components (see Figure 1):

- Yerba Buena Island (YBI) Detour
- Cantilever Truss (Pier E1-E4)
- 504-Foot Span Steel Trusses (Piers E4-E9)
- 288-Foot Span Steel Trusses (Piers E9-E23)
- Marine Foundations

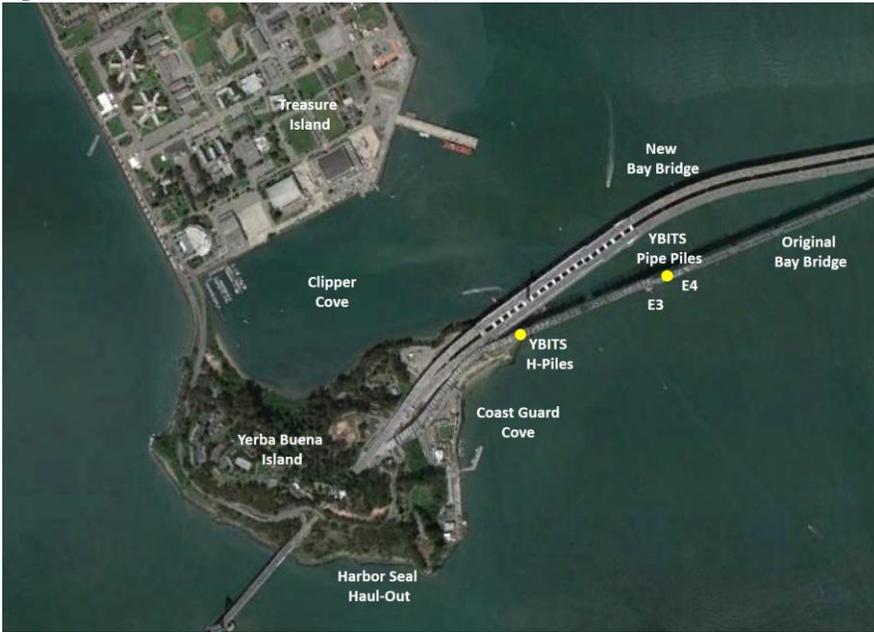
Figure 2. Aerial Photo of the Construction Area (closed circles).

Marine mammal monitoring was conducted for two construction contracts for the project at the east shoreline of YBI and in water near Piers E3/E4, totaling 42 days of pile driving, and included vibratory pile driving and un-attenuated impact pile driving (Table 1 and Figure 2). All monitoring was conducted in accordance with the requirements of the IHA (Sections 6b and 7) issued to the Department (NMFS 2014). The marine mammal exclusion zones (MMEZ) for impact pile driving, and Zone of Influence (ZOI) for Level B behavioral harassment for impact and vibratory pile driving were observed based on Table 1 of the IHA.

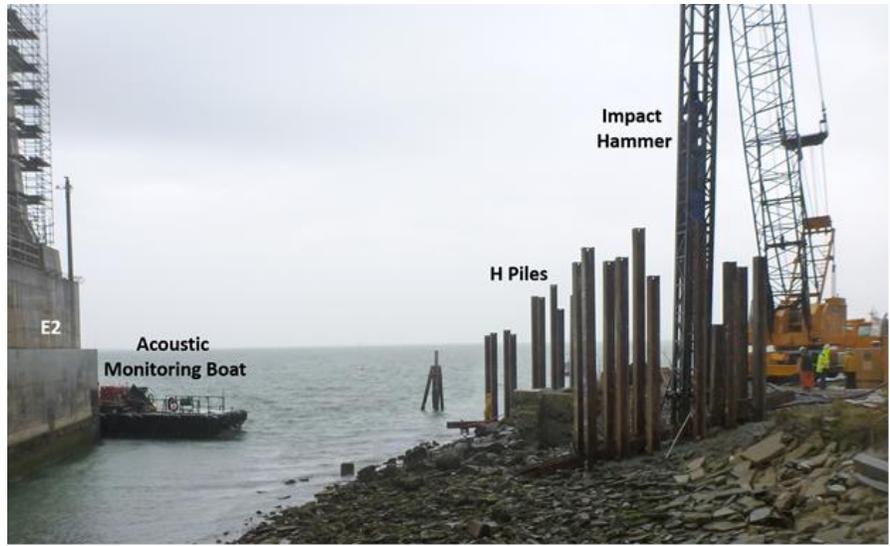
Figure 3. Photo of the YBITS2 Temporary H-Piles Site.

Monitoring was conducted during 31 days of pile driving from February 3-23, 2014 and June 2-28, 2014 (Table 3). All impact driving was monitored (70 piles including removed and re-driven piles, and piles with an extra section spliced on to the original pile). Only 88% of vibratory driving was monitored (42 piles) and is well above the IHA requirement of monitoring a minimum of 20% of piles. On most days there was a mix of impact and vibratory driving, therefore the MMOs continued to monitor during vibratory pile driving. All pile driving was conducted out of water during low tide (Figure 3).

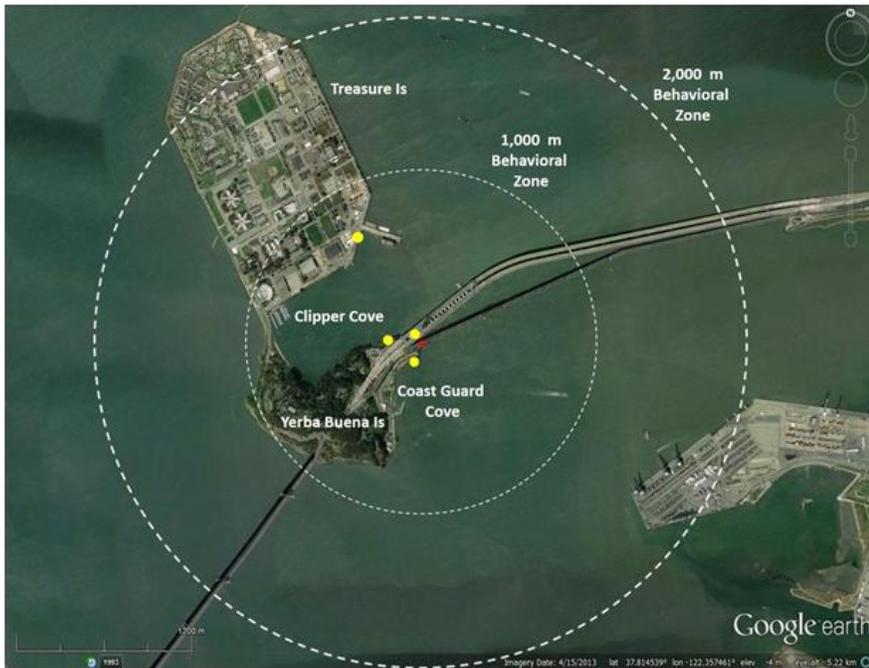
Figure 4. Zone of Influences for Behavioral Harassment and Monitoring Positions.

The position of each observer is shown in Figure 4. A ZOI of 2,000 meters (6,562 feet) for vibratory driving, a ZOI of 1,000 meters (3,281 feet) for impact pile driving, and an MMEZ of 10 meters (33 feet) for impact driving was implemented for monitoring (Figure 4).

Pile site is represented by a red circle and monitoring positions are represented by yellow circles.

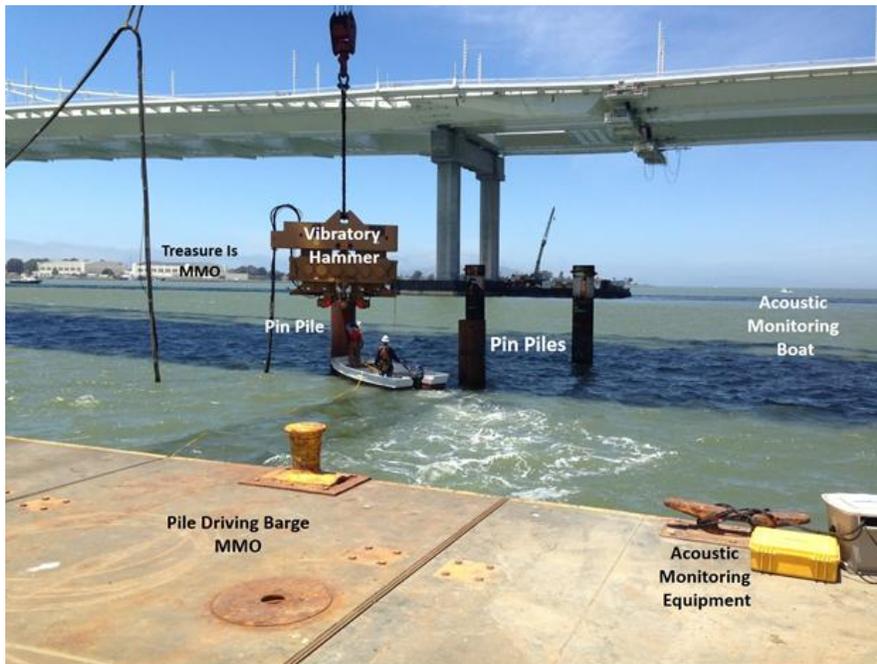
Figure 5. Photo of the Piers E3/E4 Pile Installation Site.

Installation of temporary piles were required to construct the temporary falsework needed to support the original SFOBB structure during dismantling between Piers E3 and E4. All piles were driven using a vibratory hammer although some piles were proofed (brief impact hammer; Figure 5; Table 4). Eleven days of monitoring were conducted on June 19, and from July 11 to September 11, 2014. Monitoring was conducted during installation of both the 61-centimeter (24-inch) pin piles (provided support for the pile installation template) and the 91-centimeter (36-inch) piles (main support for the falsework). Twenty-eight of the 94 temporary piles were driven by vibratory hammer providing 30% of the required monitoring for vibratory driven piles as required by the IHA issued to the Department (monitoring is required of at least 20% of vibratory piles driven; NMFS 2014).

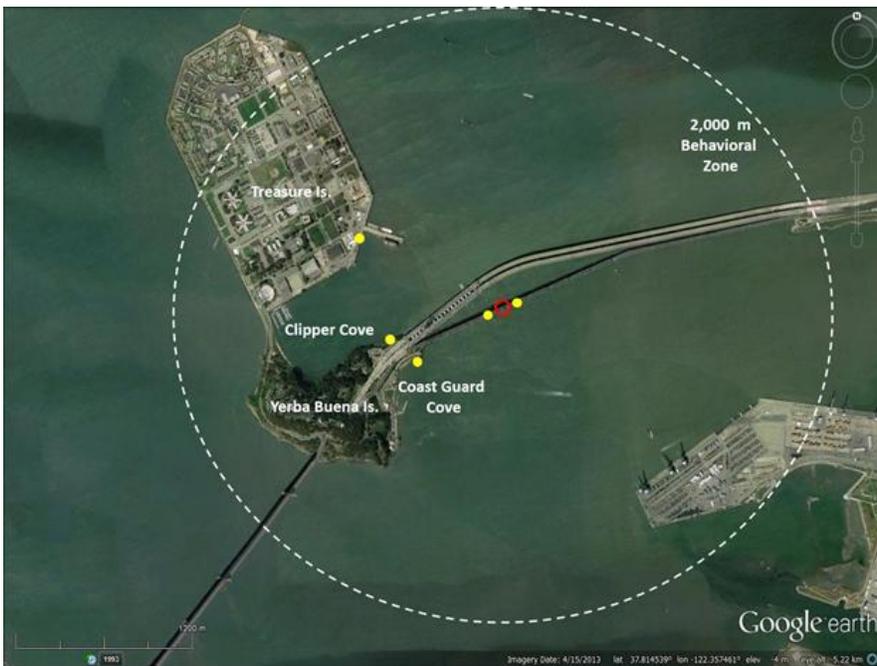
Figure 6. Aerial Photo of the YBITS2 Cantilever Falsework Foundation Project Area.

All pile driving was vibratory (with the exception of proofing which did not require marine mammal monitoring), therefore, there was no MMEZ and a ~~BHZ~~ ZOI of 2,000 meters (6,562 feet) was implemented for monitoring. Past monitoring for the east span has shown that the vast majority of marine mammals are found west of Pier E3, particularly near YBI and Treasure Island (Department 2004 and 2014), therefore, most of the monitors were situated west of the Piers E3/E4 pile driving area. The positions of the MMOs were based on the higher density of seals foraging in the Coast Guard and Clipper Coves around YBI and the area between Piers E2 and E3 of the original bridge and T1 of the new bridge where most harbor seals and sea lions transited north and south. MMO #1 and MMO #2 were located on the pile driving barge, MMO #3 was on the southeast side of YBI, MMO #4 was located on the hill above the northeast side of YBI, and MMO #5 was located on the southeast shore of Treasure Island as shown on Figure 6.
