Punta Gorda Lighthouse Stabilization Project (Phase 2) Incidental Harassment Authorization Permit Application

October 2022

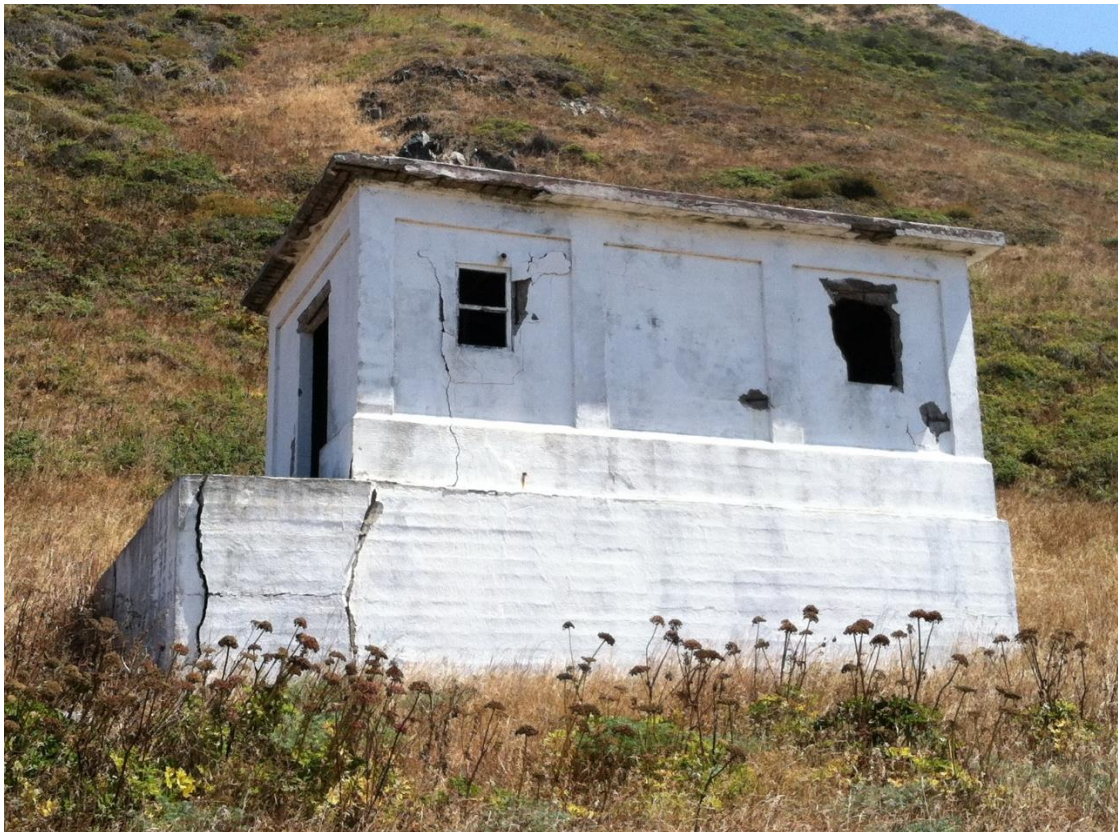
Figure 4. The condition of the oil house at Punta Gorda during a site visit in August 2016.

During the summer of 2022 the BLM restored the PGL during phase one. The oil house repair was the final phase of this project and is slated for summer of 2023. The foundation and walls of the oil house are cracked and separated with lead-based paint deteriorating. A portion of the marine terrace east of the Lost

Correcting the deficiencies in the building will require several separate operations. The first stage will consist of lead paint remediation and demolition of the failing concrete and re-bar followed by treating the remaining structure to prevent further corrosion. The roof of the oil house will be completely demolished along with the northwestern corner of the oil house foundation. Numerous other small concrete repairs will also occur simultaneously. The demolition will use gas powered construction saws, various jack hammers, heavy equipment (likely a backhoe or small excavator), saws, and hand tools. Materials created during the demolition have been proposed for disposal by on site burial, however that detail is not finalized. The alternatives to burial include transport to waste facilities by ground vehicles and/or helicopter lifts.

Once the concrete demolition is complete, concrete forms will be erected and new concrete poured in place. The new concrete will include corrosion inhibitors and will be formed to mimic the visual characteristics of the existing structures. To further protect against corrosion, a sealing elastomeric (or similar product) paint will be applied once the new concrete has thoroughly dried.
