# **Renewal Request for Marine Mammal Protection Act Incidental Harassment Authorization**

## **Falls Bridge Replacement Project**

MaineDOT – Environmental Office  
Natural Resources Division  
16 State House Station  
Augusta, ME 04330

**March 28, 2023**

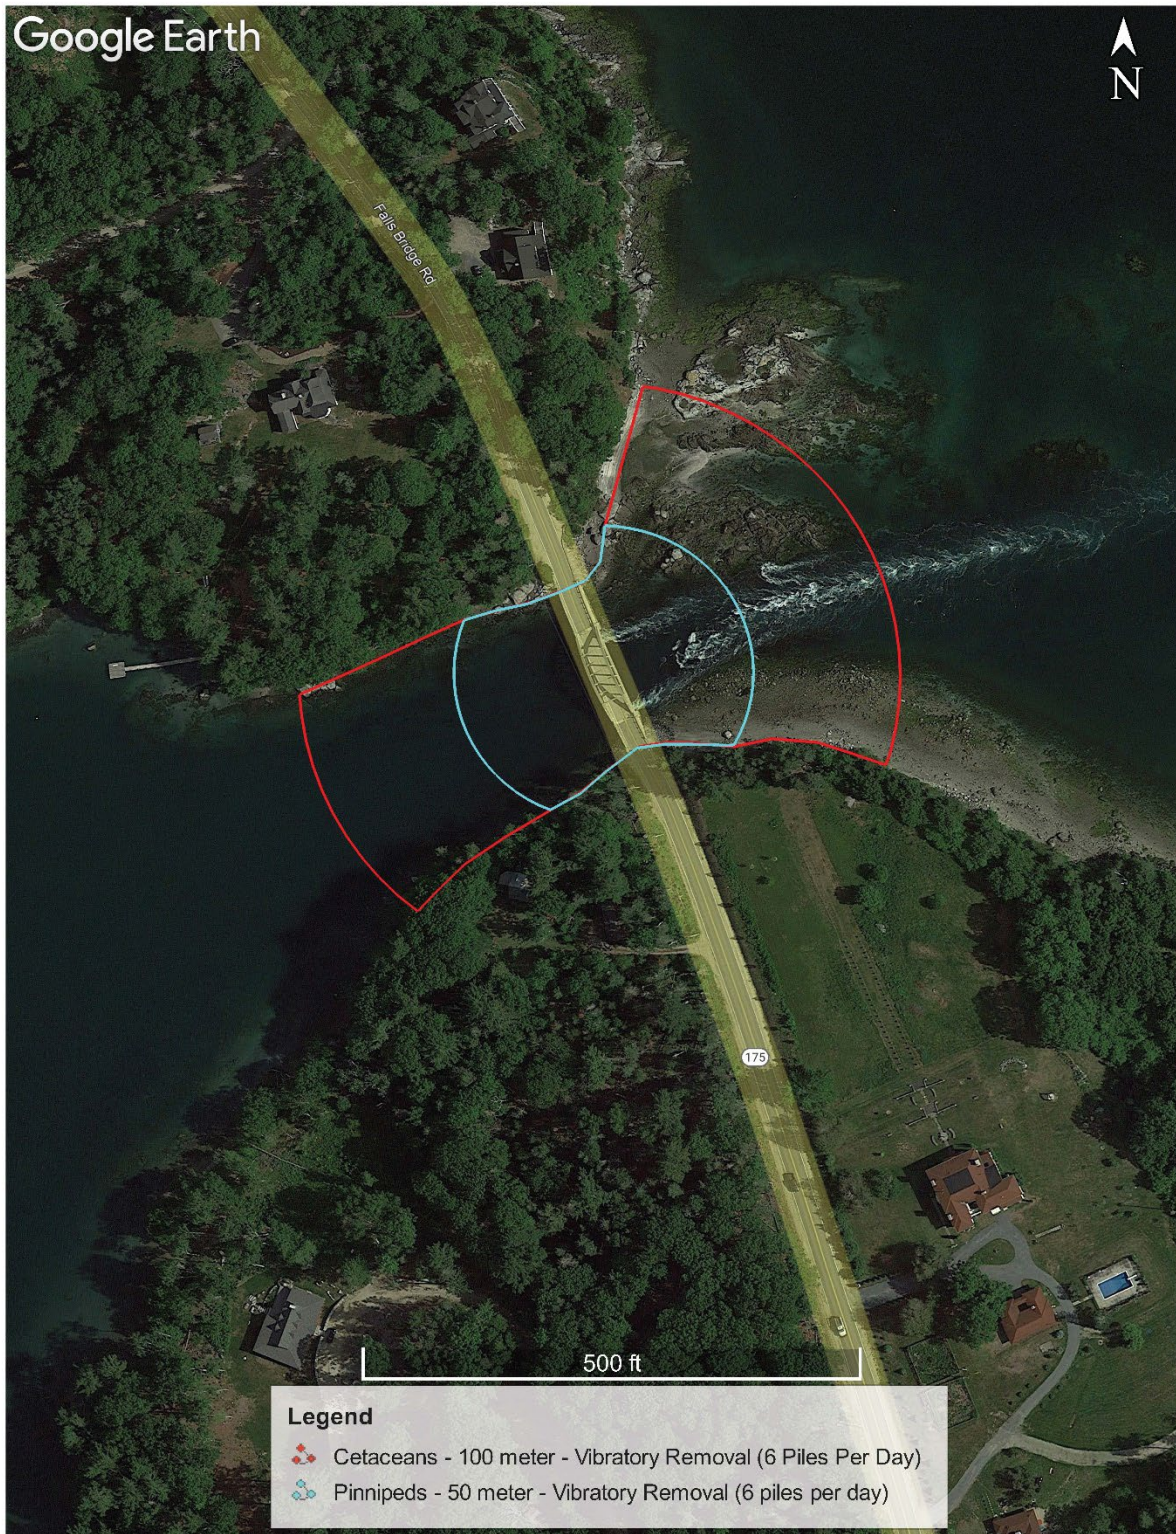
**Figure 1-1. Shutdown Zones for Cetaceans and Pinnipeds during Vibratory Pile Removal for Falls Bridge Replacement Project**

A change that will be realized, and accounted for in monitoring, is the difference in distance to Level A Harassment Isopleths. Distance to Level A Harassment Isopleth for Phocid Pinnipeds will increase from 11 meters to 26 meters (Table 1-2). Because the shutdown distance for Pinnipeds was conservatively set at 50 meters in the IHA, this minor increase in distance will result in no change to the potential for take and the corresponding shutdown zone will not be altered. However, when considering high frequency Cetaceans, the level A Harassment Isopleth will increase from 25 meters to 62 meters, requiring a change in shutdown distance. The shutdown distance for Cetaceans in the IHA was set at 50 meters. MaineDOT proposes increasing that distance to 100 meters (Figure 1-1) to allow for the additional piles to be removed per day.

MaineDOT expects monitoring to remain as described in the IHA except for the cetacean shutdown distance being extend from 50 to 100 meters.

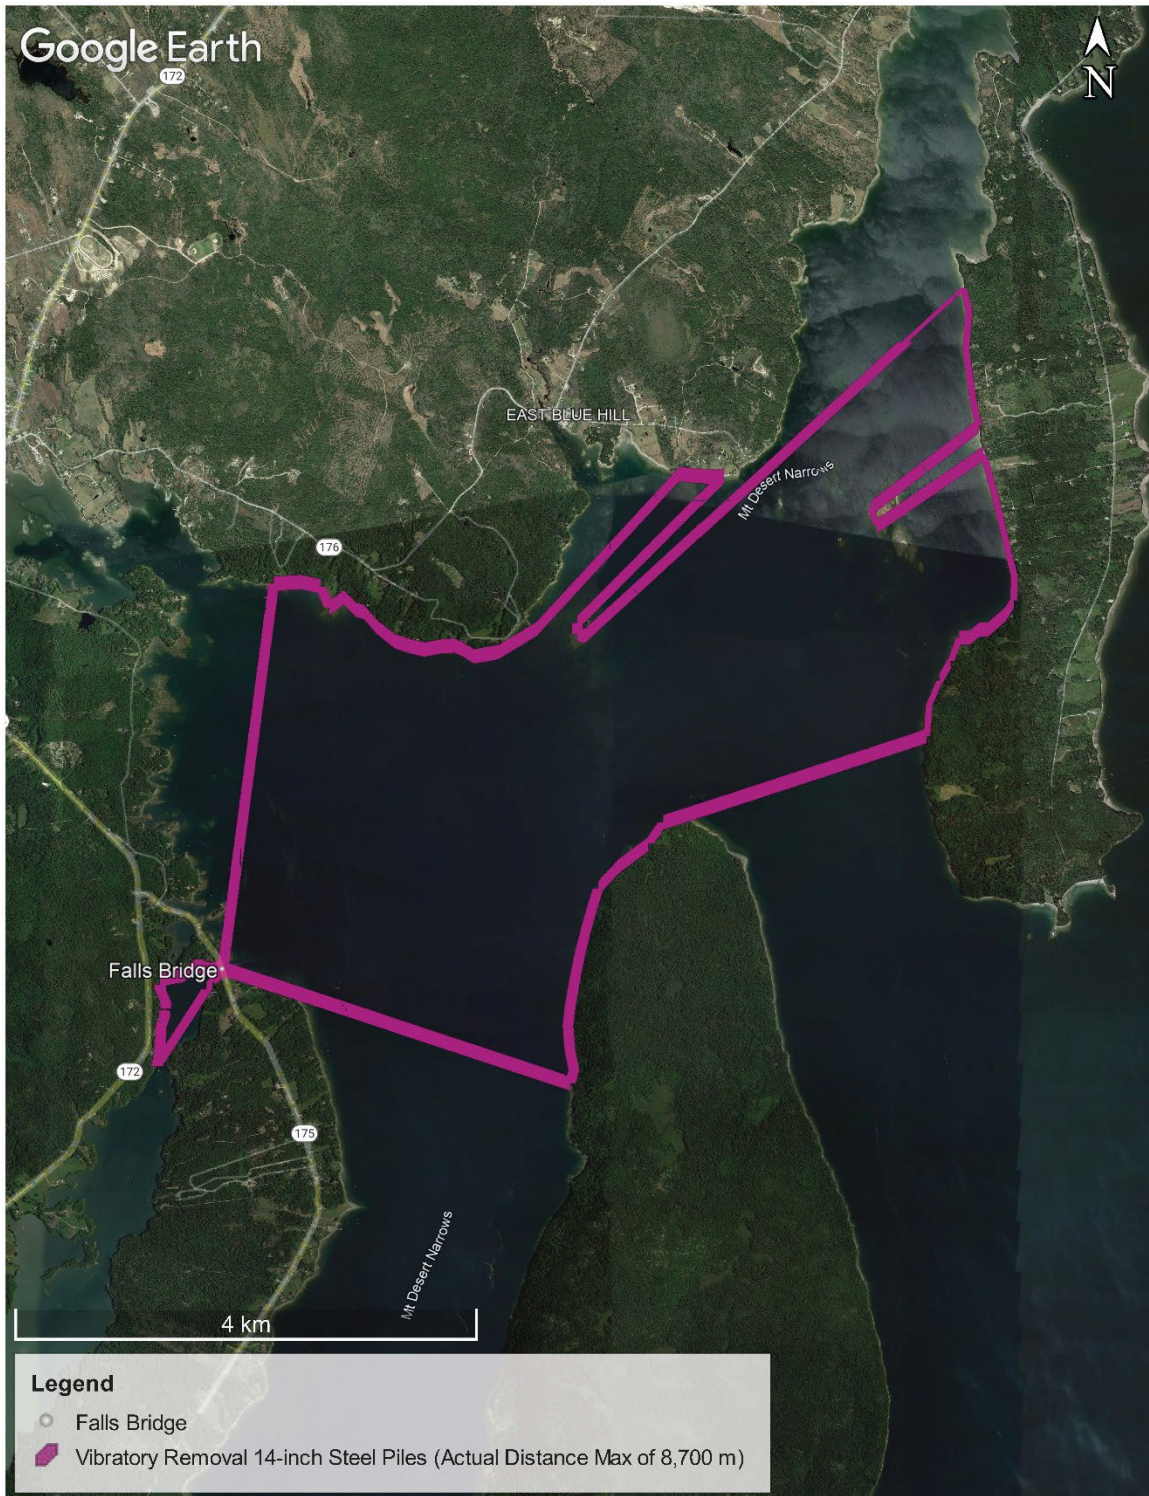
**Figure 1–2. Level B Harassment Zones (and shutdown zones for species not covered by the IHA) during Pile Removal at High Tide for Falls Bridge Replacement Project**

The previous analysis was completed assuming vibratory removal would require 30 minutes per pile, with a total of 95 piles. The resulting time of Level B harassment was estimated to be 2,850 minutes. The current plan for removing the 12 14-inch steel pipe piles will result in 360 minutes (30 minutes per pile) of Level B harassment, an 87 percent reduction in exposure time, and presumably a large reduction in the amount of incidental take. However, with the reduction in pile size and increase from 3 to 6 piles removed per day, the distance to Level B Isopleth will increase from 10,000 meters to 15,849 meters (see Table 1-1). Due to the presence of land masses (see Figure 1-2) on all sides of the Project area, the maximum distance noise can travel through water at high tide before encountering land is approximately 8,700 meters. At low tide, the maximum distance noise can travel through water is approximately 7,000 meters. Therefore, the increase in distance to Level B Isopleth will be theoretical only.

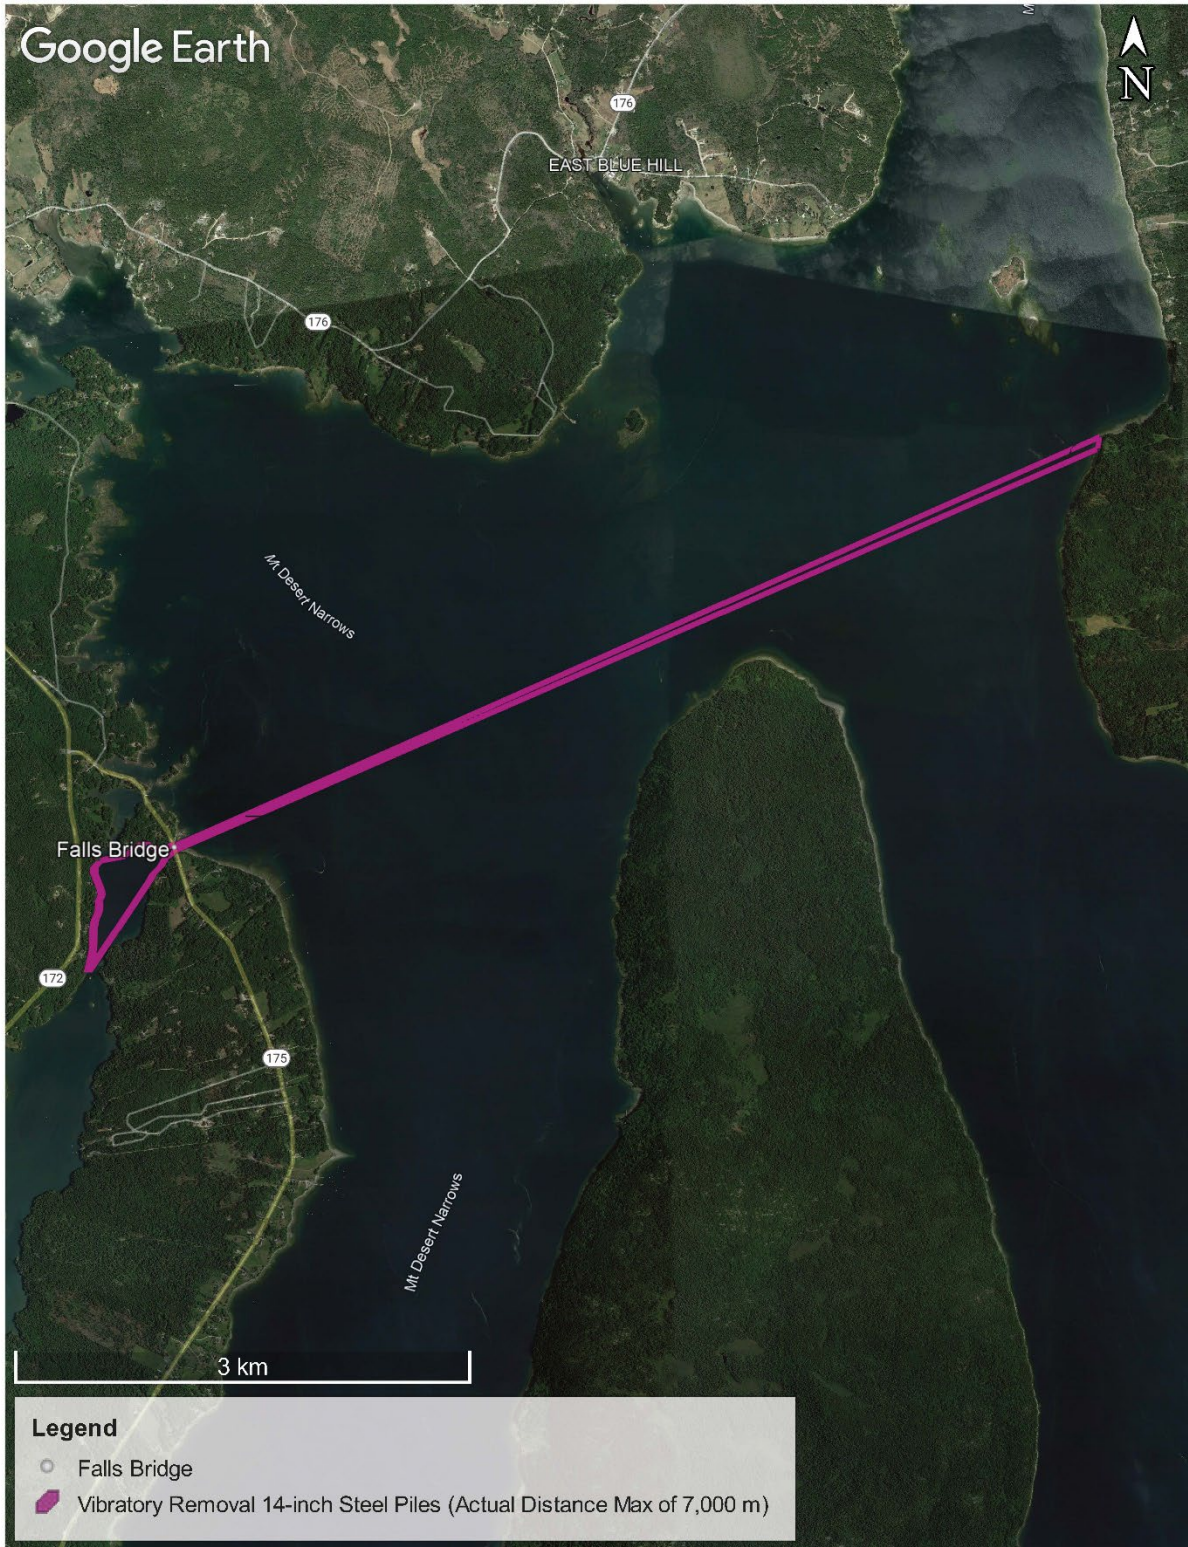
**Figure 1–3. Level B Harassment Zones (and shutdown zones for species not covered by the IHA) during Pile Removal at Low Tide for Falls Bridge Replacement Project**

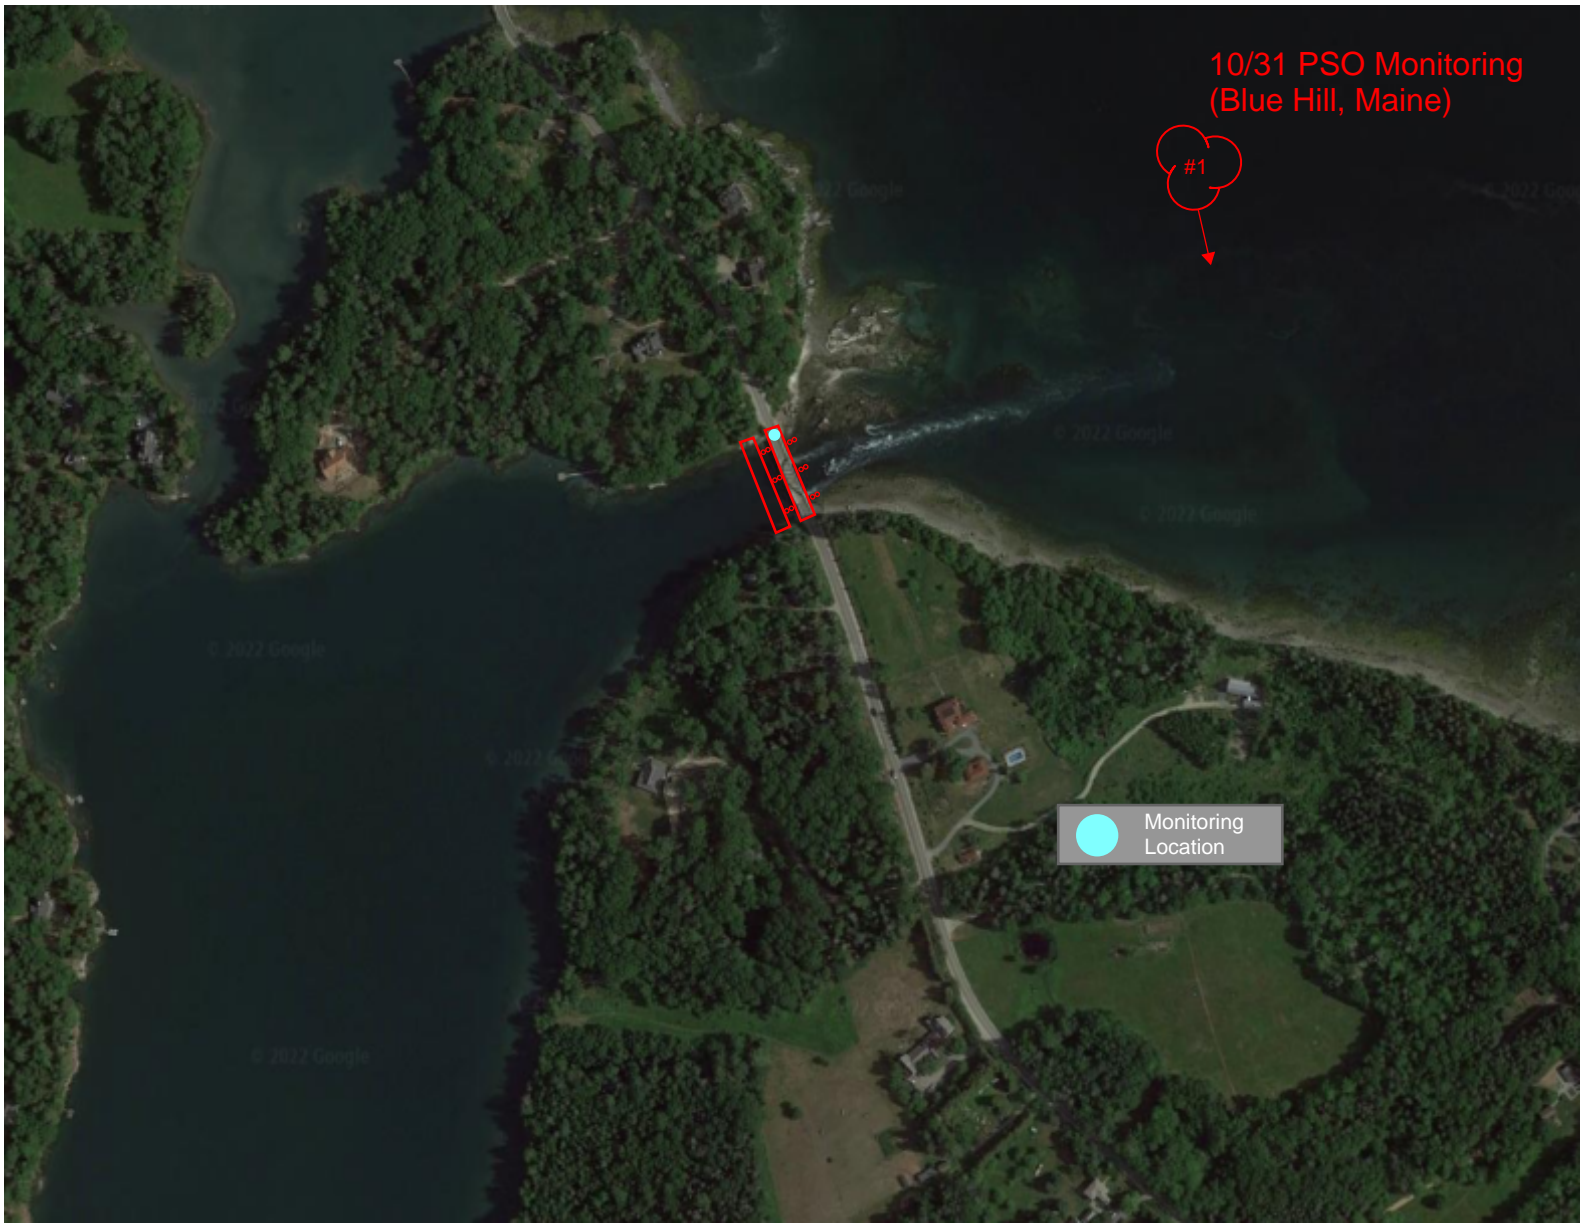
10/31 PSO Monitoring  
(Blue Hill, Maine)

Sighting #	Time (military)	Species	# of Individuals	Entered Harassment Zone A (Yes or No)	Entered Harassment Zone B (Yes or No)	Location <sup>1</sup>	Behavior <sup>2</sup> /Construction Activity
1	14:44	Harbor Seal	1	No	No	200-250m, 90°	<u>POST WATCH. Swimming away, parallel to work. Milling. Adult.</u>

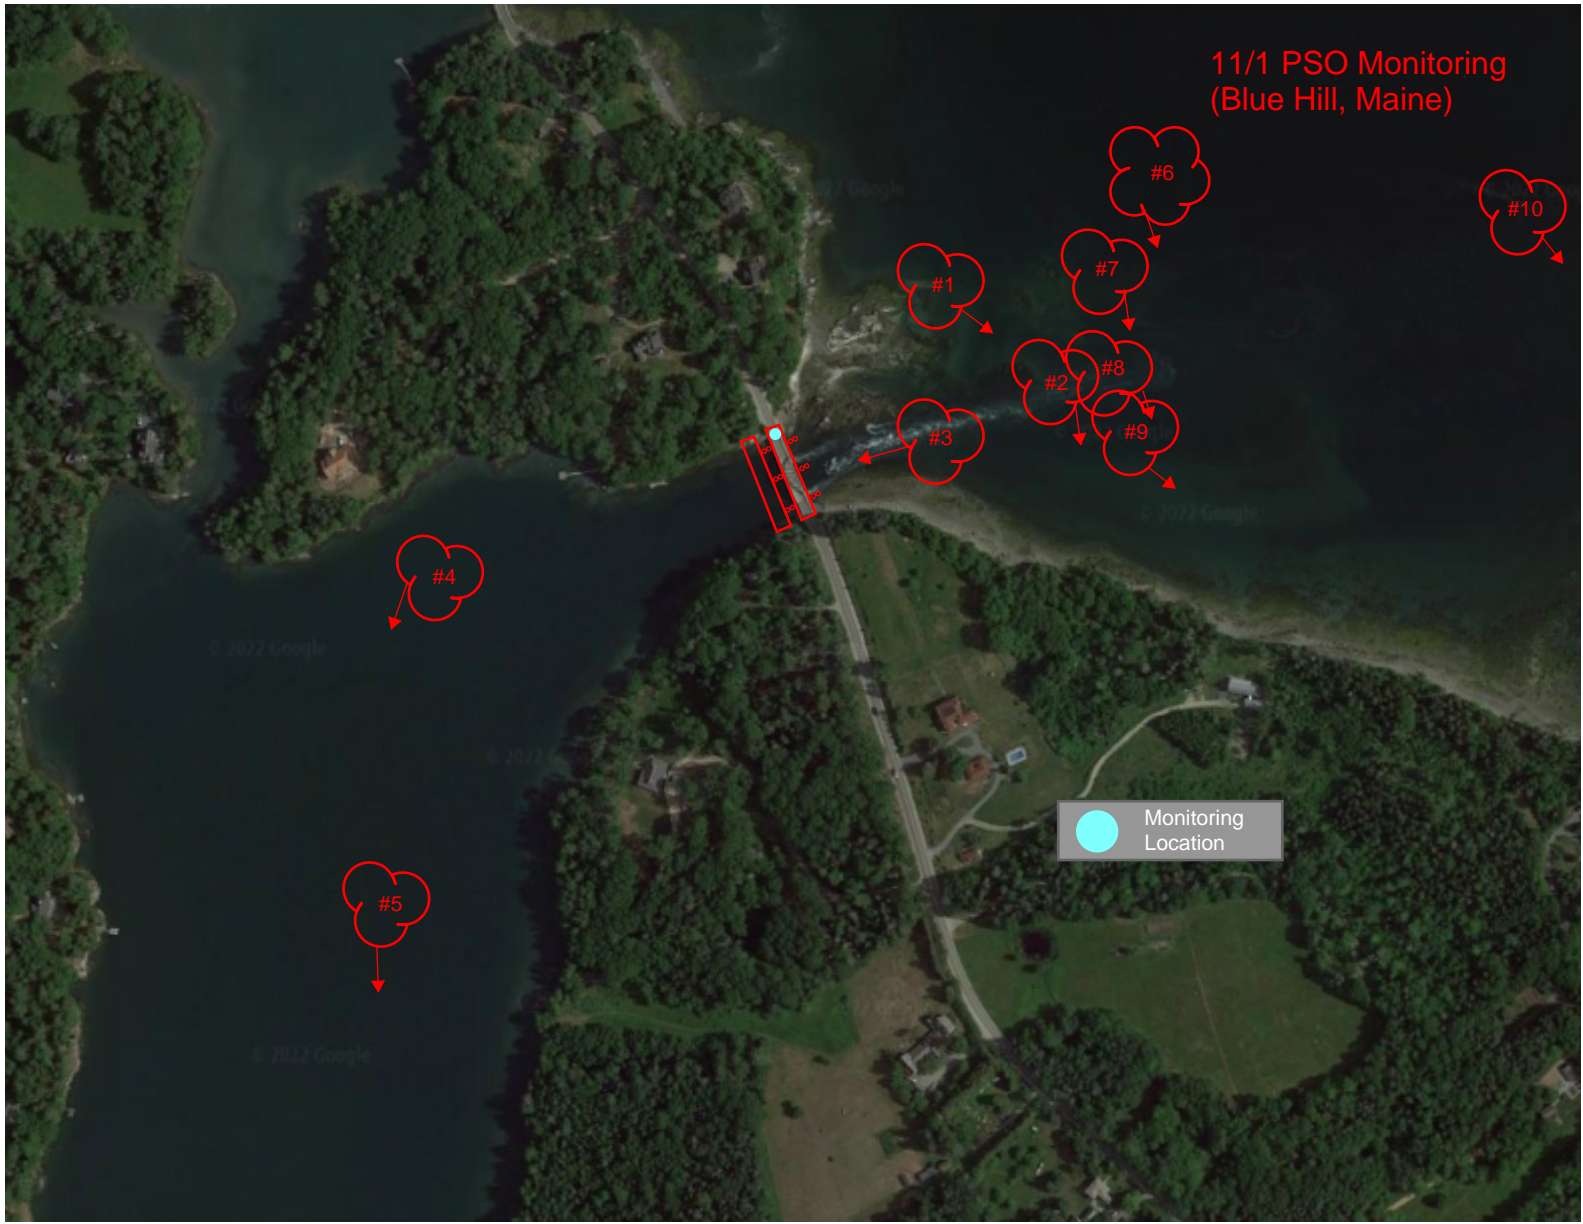
11/1 PSO Monitoring  
(Blue Hill, Maine)

Sighting #	Time (military)	Species	# of Individuals	Entered Harassment Zone A (Yes or No)	Entered Harassment Zone B (Yes or No)	Location <sup>1</sup>	Behavior <sup>2</sup> /Construction Activity
1	0909	Harbor Seal	1	No	Yes	90° (175m) by rocks	Swimming North then changed direction, headed towards construction activity
2	0911	HS	Same seal	No	Yes	110° (75m) narrows	Breaching/surfing incident headed towards work. Work Paused.
3	0914	HS		No	Yes	250° (100m) west side of bridge	Swimming away from work headed west then west. Outside zone
4	0916	HS		No	No	200° (250m) west side	Swimming away from work
5	0920	HS	1	No	No	200° (400m)	Still swimming away
6	0925	HS	1	No	No	90° (225m)	swimming by rocks. Headed away from work
7	1348	Grey seal	1	No	Yes	90° (175m)	Milling towards work area
8	1352	Grey Seal	1	No	Yes	90° (150m)	Moving SE moving parallel to work area
9	1420	Grey seal	1	No	Yes	90° (150m)	Headed south. Parallel to work

10	1430	Grey seal	1	No	Yes	90° (350m)	Milling East of bridge

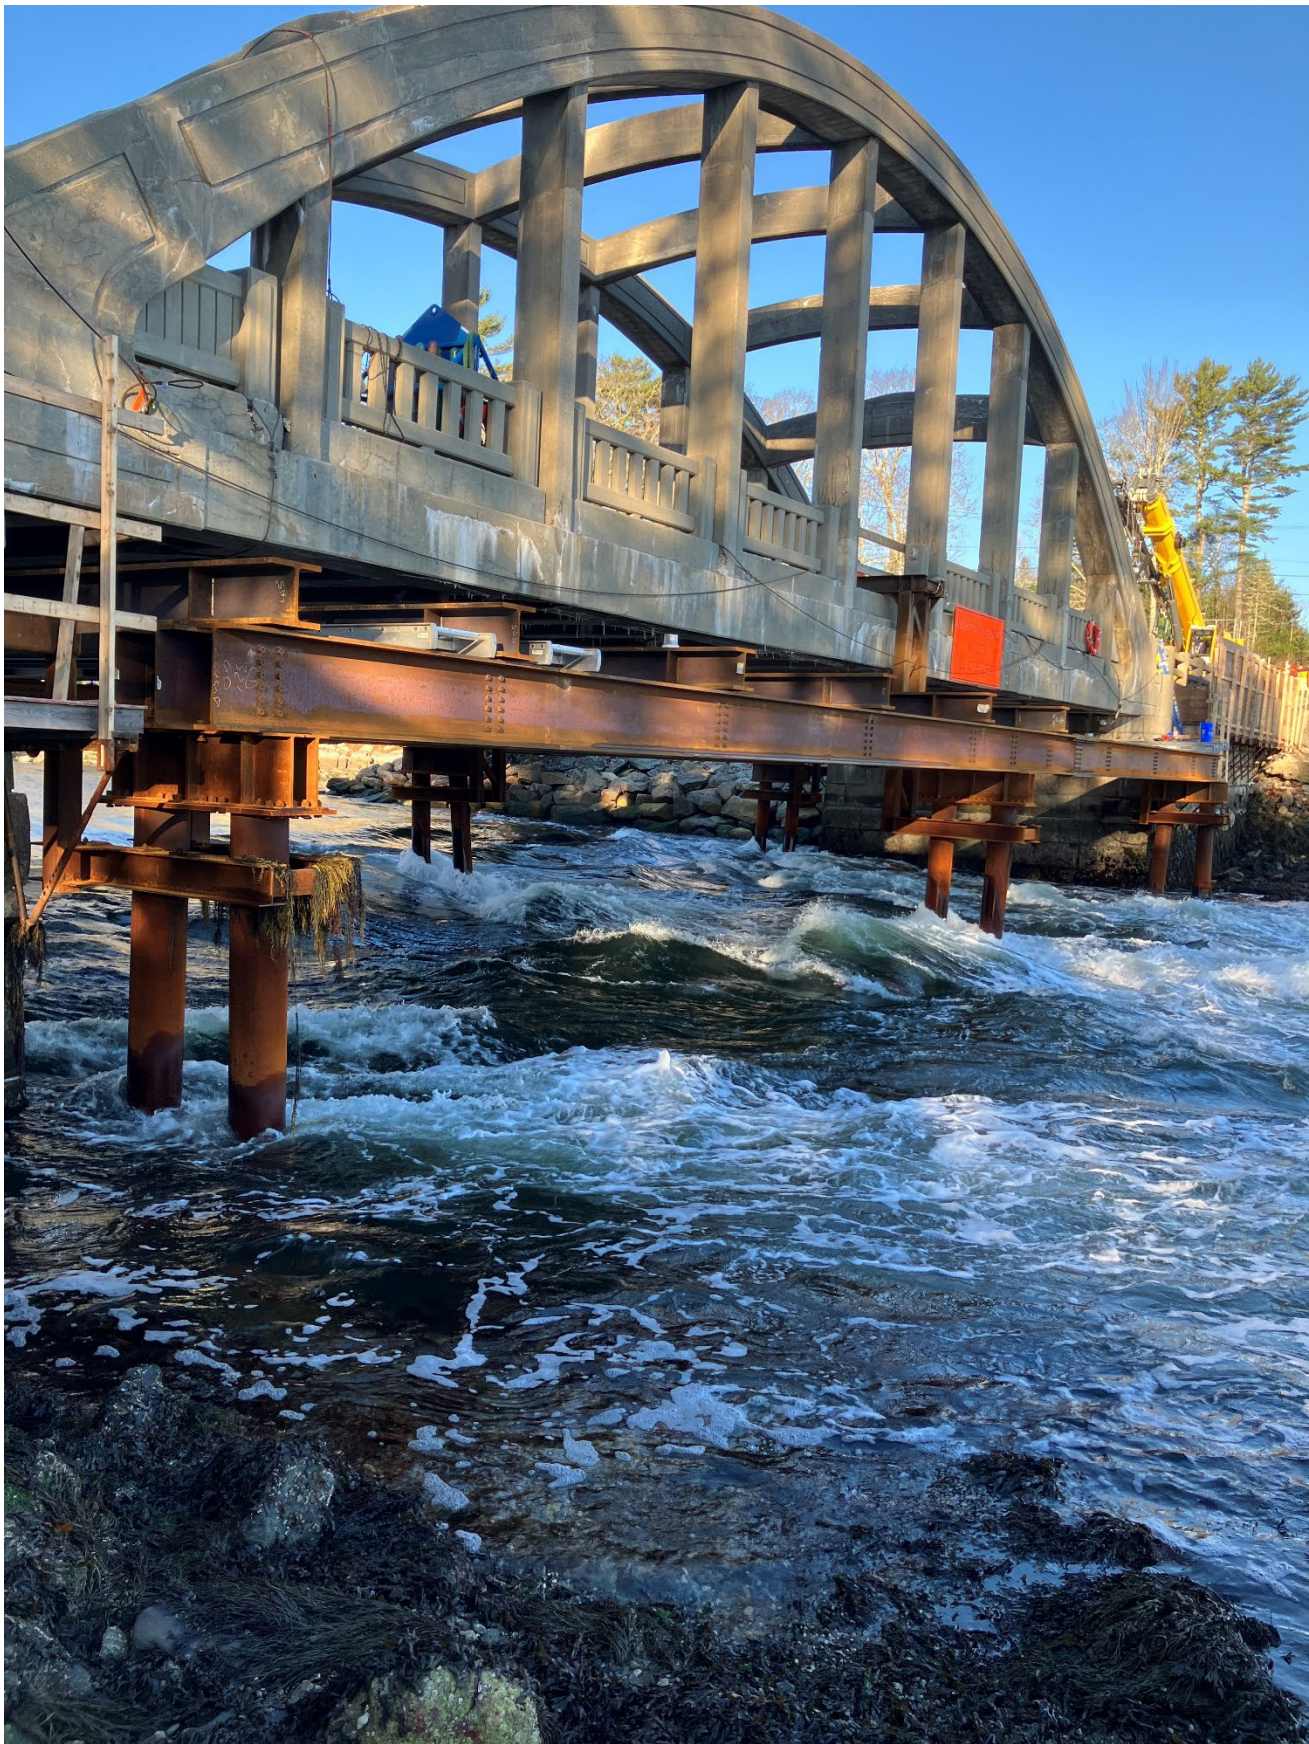
Six pairs (12 total) of 14" steel pipe piles installed and demolition platform being attached.

The following is the annual report for marine mammal monitoring at the Blue Hill Falls Bridge Project. All project related pile installation was completed in 2022. In total, MaineDOT's contractor installed twelve 14" steel pipe piles to support the temporary work trestle (bridge demolition platform). All piles were installed between 10/31/2022 and 11/1/2022. Pile driving was completed with an impact hammer between the hours of 1240 and 1438 on 10/31, and again from 0908 to 1414 on 11/1. These times include the time needed for soft start procedures. There were two PSOs present during all pile driving activities (and for at least 30 min before/after pile driving activities). Both PSOs completed the monitoring from Location 1 (north side of bridge) in the monitoring plan. Completed activity logs and observation sheets are provided in Appendix A and B, respectively.
