# PROTECTED SPECIES MONITORING REPORT

## YEAR 2: MARCH 1, 2021 – FEBRUARY 28, 2022

### DEMOLITION AND REPLACEMENT OF PIER 32

Naval Submarine Base New London  
Groton, Connecticut

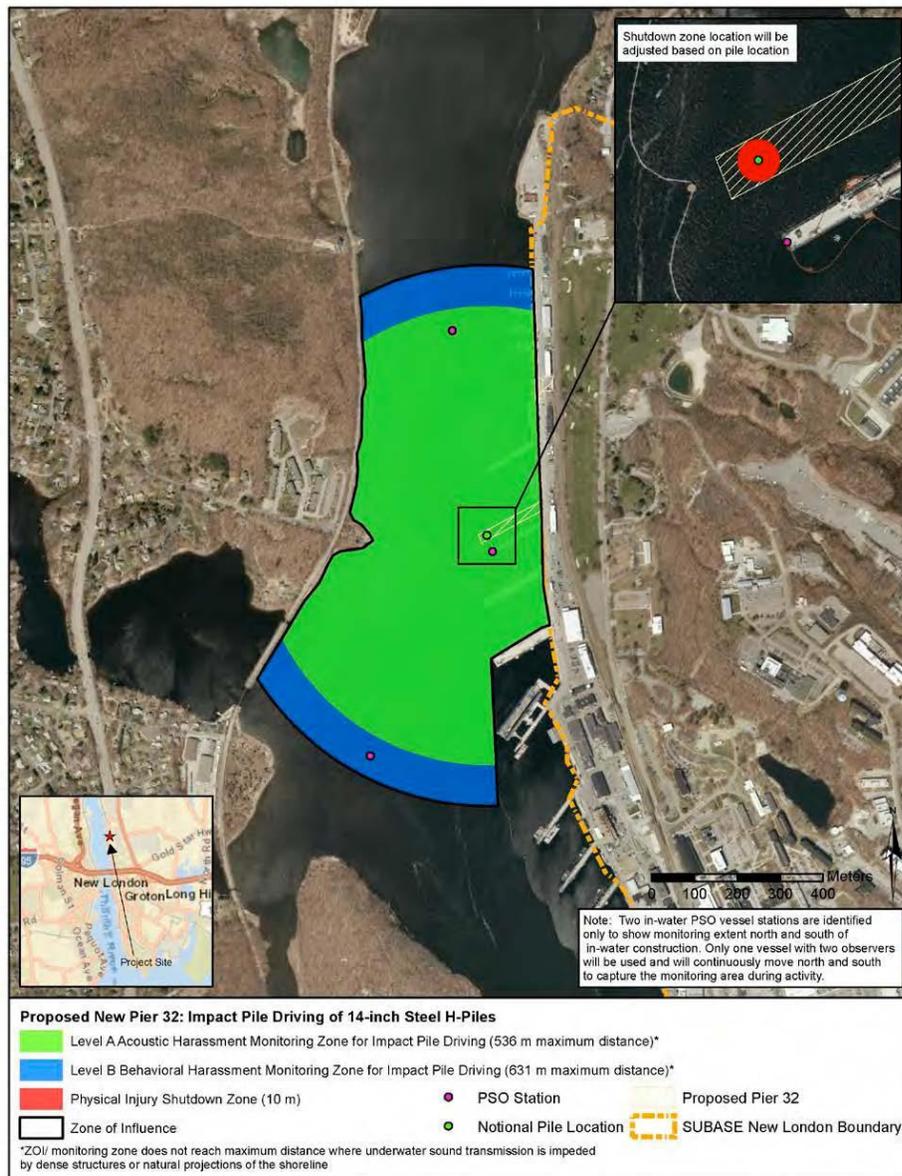
Figure 2 Level A Acoustic Harassment and the Level B Behavioral Harassment Monitoring Zones for Impact Pile Driving of 14-Inch Steel H-Piles

respective Level A and Level B monitoring zones. An example of the Level A and Level B monitoring zones is depicted in the map shown in Figure 2. The complete set of Level A & B Zones can be found in Appendix A.

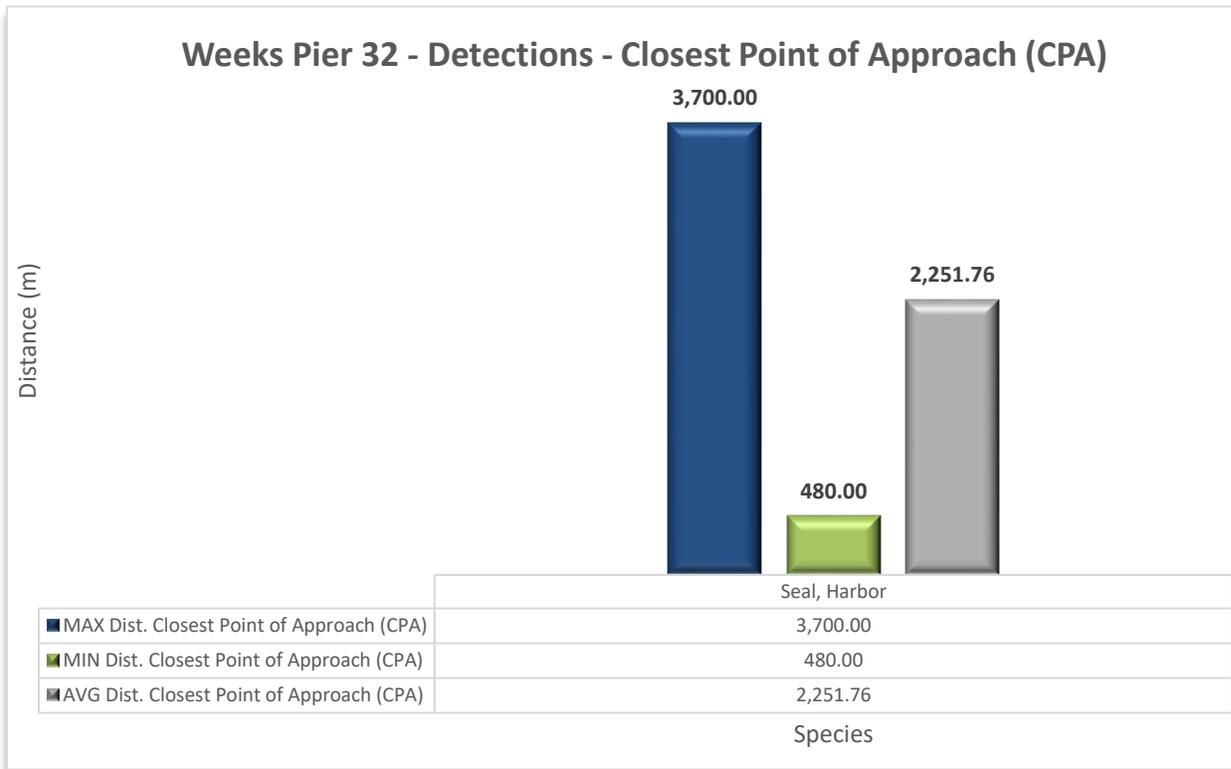
Figure 9 Protected Species Detections Closest Point of Approach in meters, to Sound Source

Figure 9 depicts the distance ranges of the 17 detections from the sound source. The closest distance a detection occurred from the sound source was 480 m while the furthest detection occurred when the animal was approximately 3700 m from the sound source.

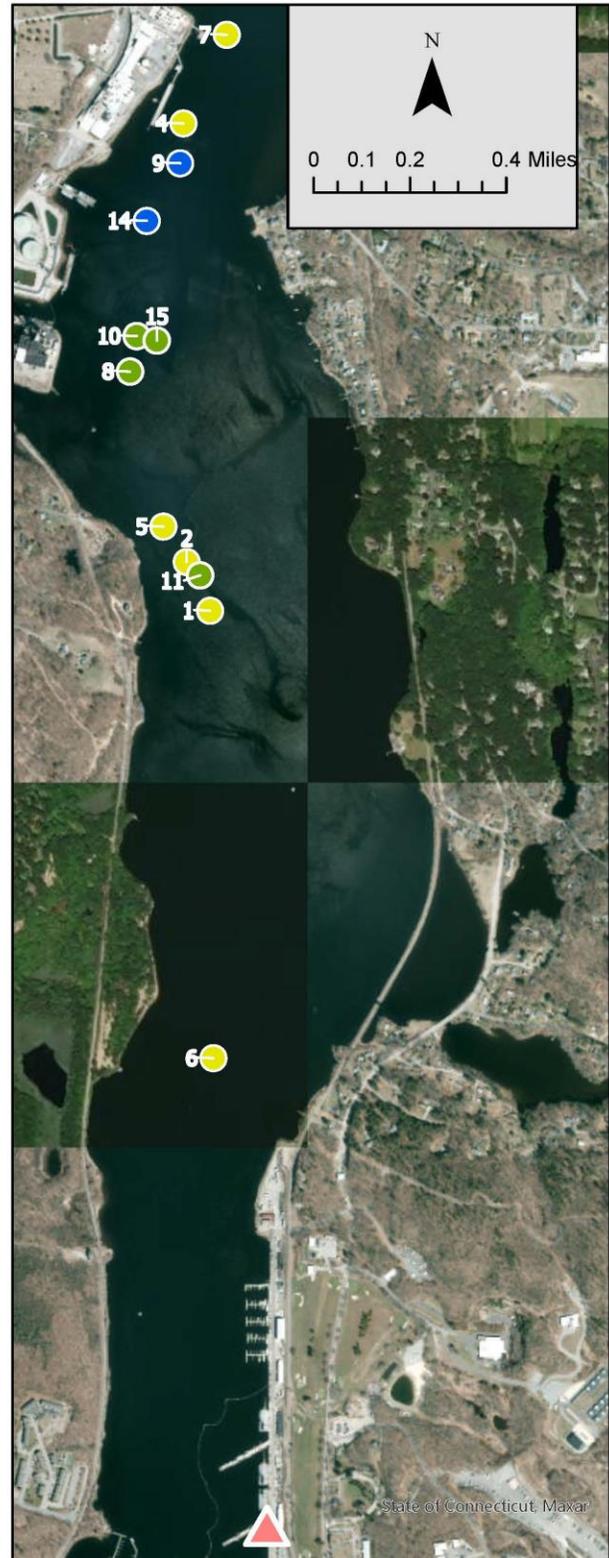
## Summary Map of all Sightings South of Operations

This map shows all sightings that occurred south of construction and demolition operations. Detections are labeled in order of observation. All sightings were of harbor seals, *phoca vitulina*, and occurred when the sound source was inactive. 5 of the 17 total sightings occurred south of the sound source.

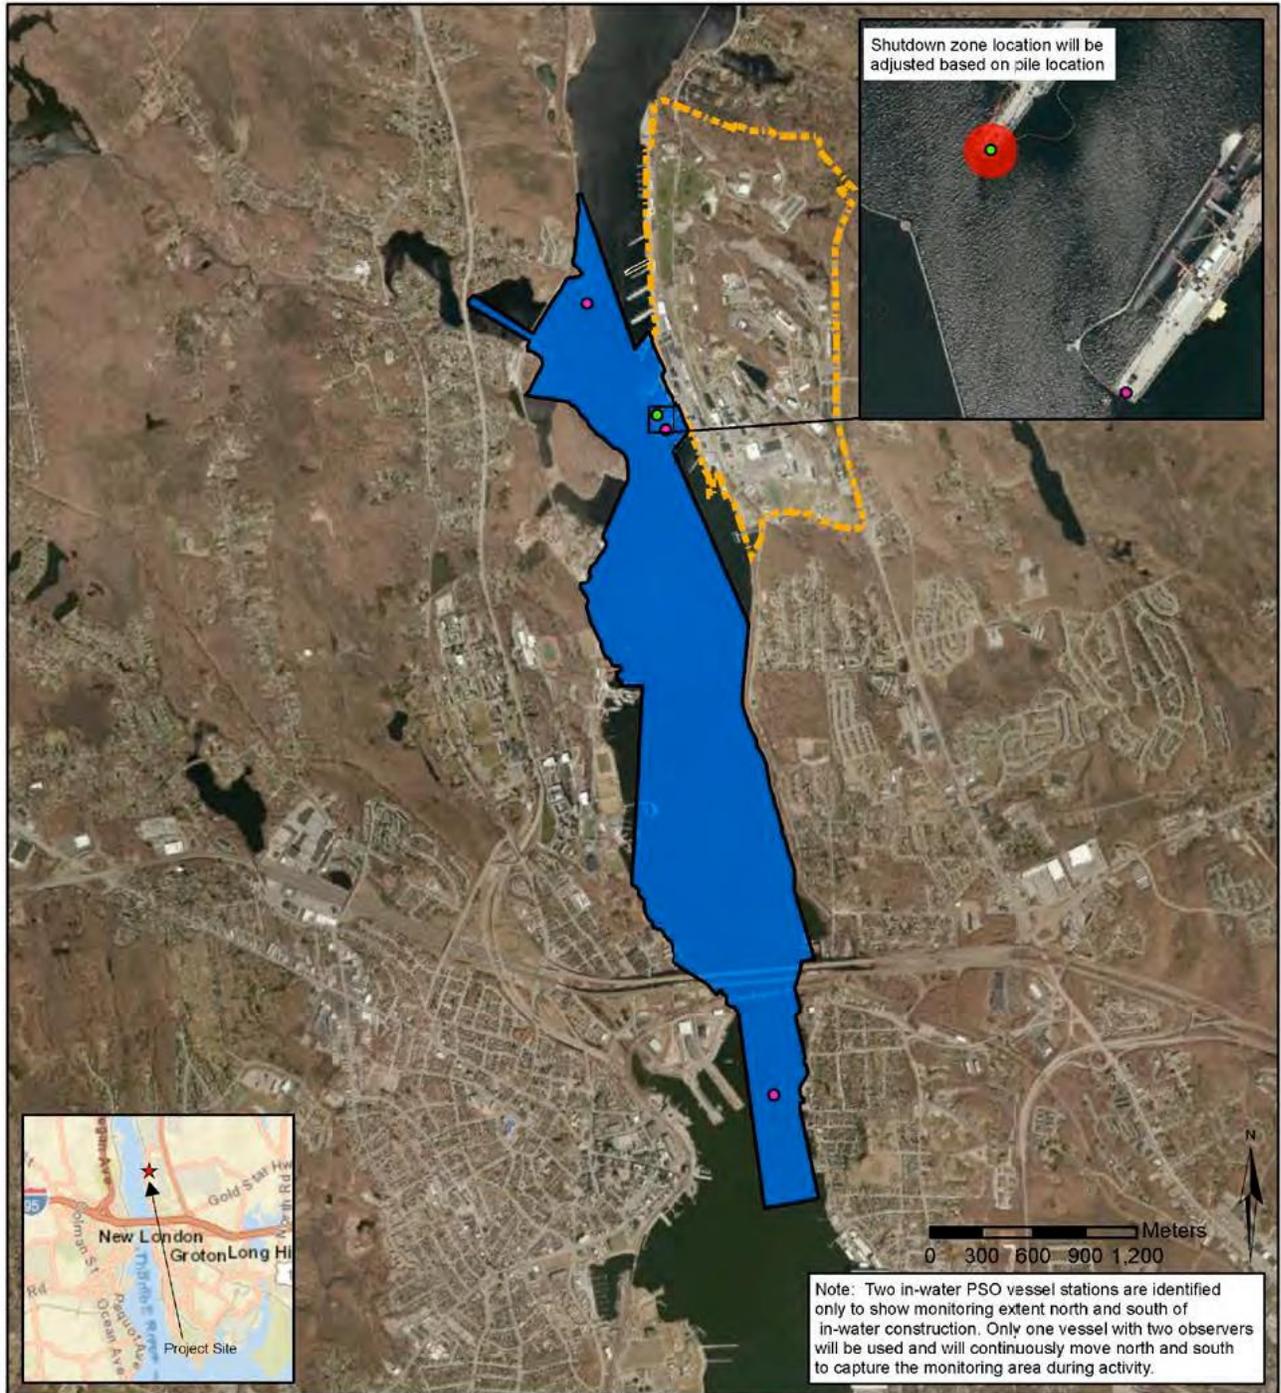
**Pier 10 Demolition: Vibratory Extraction of 33-inch Concrete Piles**

- Level B Behavioral Harassment Monitoring Zone (4,642 m maximum distance)\*
- Level A/Physical Injury Shutdown Zone (10 m)
- PSO Station
- Notional Pile Location
- SUBASE New London Boundary
