Bangor Service Pier B710 Pile Replacement Project

Marine Mammal Monitoring Report

Naval Base Kitsap – Bangor
Silverdale, Washington

11 March 2022

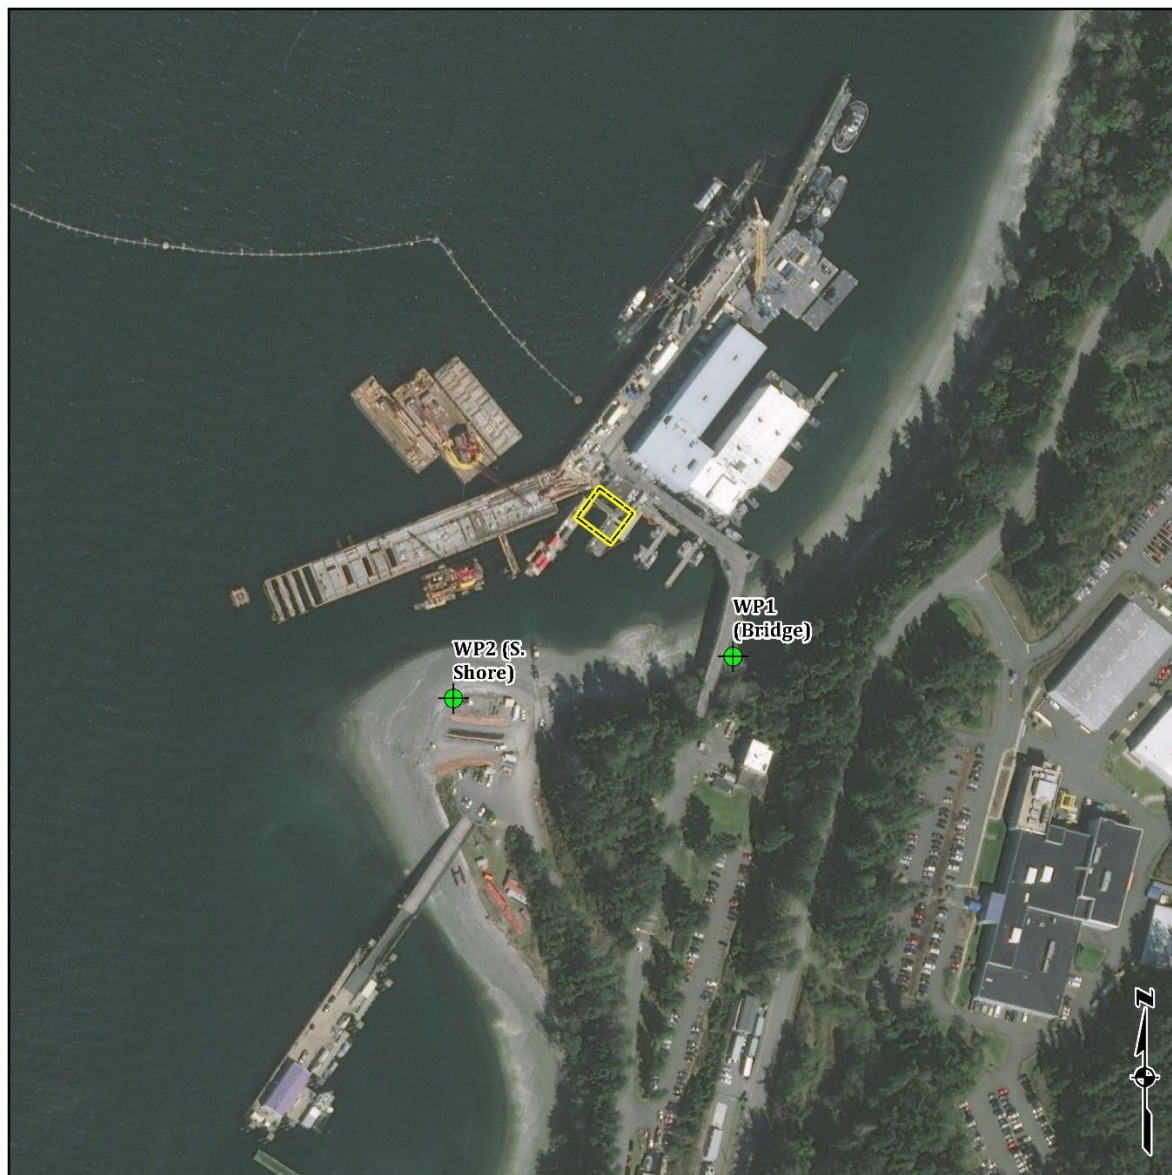
Figure 2. Monitor positions and construction area at Service Pier B710 Pile Replacement Project, Naval Base Kitsap - Bangor, Silverdale, Washington.

Location Name	Position Code	Latitude	Longitude	Northing (Y)	Easting (X)
Bridge	(WP #1)	47.730409	-122.741599	5286369	519375
South Shore	(WP #2)	47.729545	-122.743577	5286272	519227

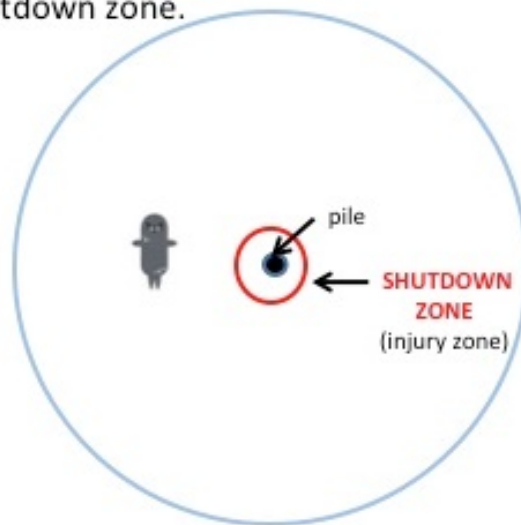
The **shutdown** zone for pinnipeds is the **Injury Zone** for pile driving. Shutdown will also occur within the behavioral zone if the pinniped is swimming toward the pile driving equipment that is turned on/in use, to avoid potential injury to a pinniped swimming toward the Injury Zone. If the pinniped is within the Behavioral Disturbance Zone, construction will be allowed to continue, and marine mammal monitors will **document behavior and location and will track** animal to ensure that it does not enter the shutdown zone.

Figure 2. Monitoring and Shutdown for Pinnipeds

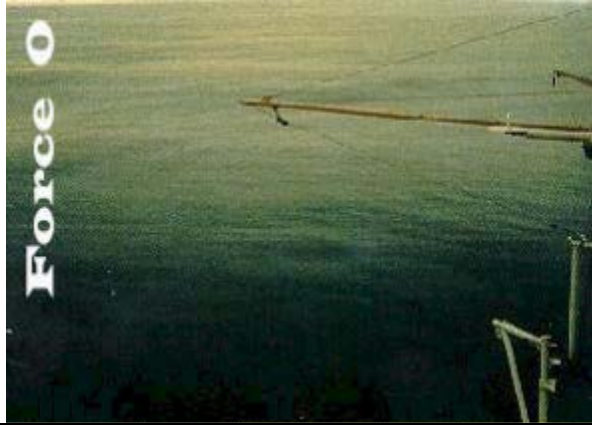
Beaufort Sea State	Wind Speed (knots)	Wind Description	Wave Height (ft) Beaufort	Sea State – Beaufort	Notes Specific to On-water Seabird Observations	Photos Indicating Beaufort Sea State
0	<1	Calm	0	Calm; like a mirror	Excellent conditions, no wind, small or very smooth swell. You have the impression you could see anything.

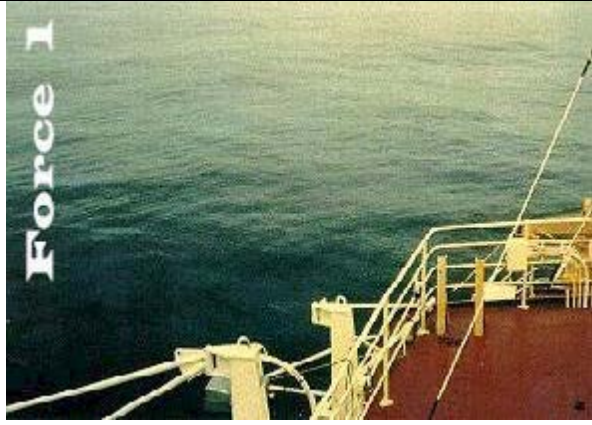
1	1-3	Light air	$\frac{1}{4} < \frac{1}{2}$	Ripples with appearance of scales; no foam crests	Very good conditions, surface could be glassy (Beaufort 0), but with some lumpy swell or reflection from forests, glare, etc.

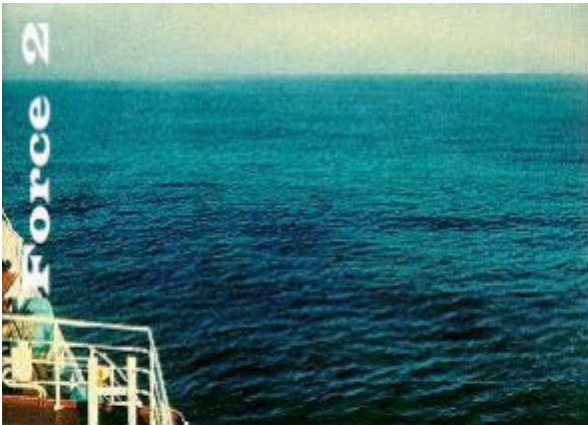
Beaufort Sea State	Wind Speed (knots)	Wind Description	Wave Height (ft) Beaufort	Sea State – Beaufort	Notes Specific to On-water Seabird Observations	Photos Indicating Beaufort Sea State
2	4-6	Light breeze	½ – 1 (max 1)	Small wavelets; crests with glassy appearance, not breaking	Good conditions, no whitecaps; texture/lighting contrast of water make murrelets hard to see. Surface could also be glassy or have small ripples, but with a short, lumpy swell, thick fog, etc.

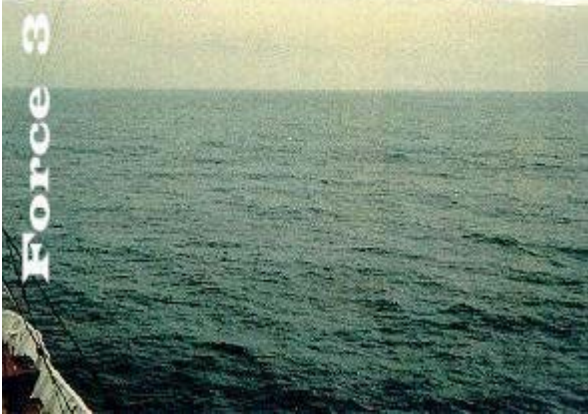
3	7-10	Gentle breeze	2 – 3 (max 3)	Large wavelets; crests begin to break; scattered whitecaps	Fair conditions, scattered whitecaps, detection of murrelets definitely compromised; a hit-or-miss chance of seeing them owing to water choppiness and high contrast. This could also occur at lesser wind with a very short wavelength, choppy swell.

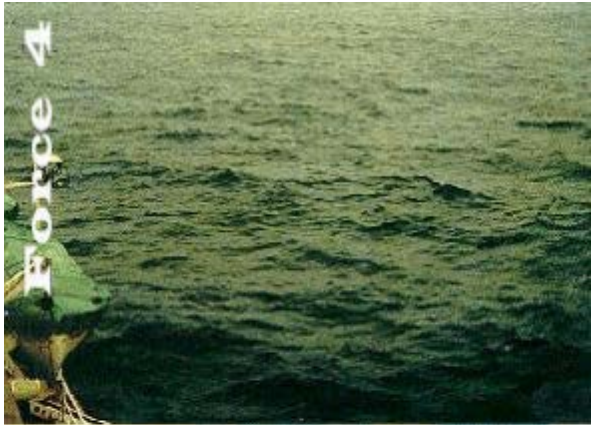
Beaufort Sea State	Wind Speed (knots)	Wind Description	Wave Height (ft) Beaufort	Sea State – Beaufort	Notes Specific to On-water Seabird Observations	Photos Indicating Beaufort Sea State
4	11-16	Moderate breeze	3 ½ – 5 (max 5)	Small waves becoming longer, numerous whitecaps	Whitecaps abundant, sea chop bouncing the boat around, etc.

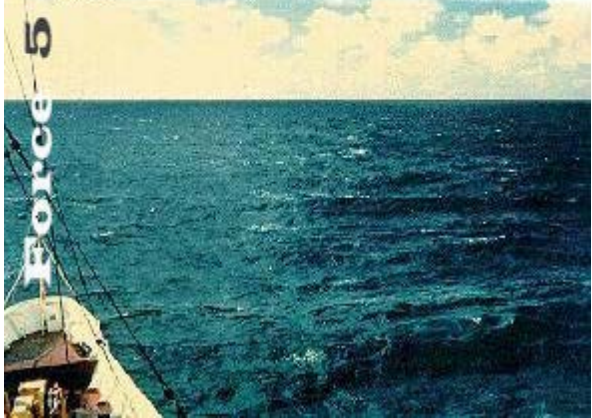
5	17-20	Fresh breeze	6 – 8 (max 8)	Moderate waves, taking longer form; many whitecaps; some spray
