Memorandum

To: Benjamin Laws, National Oceanic and Atmospheric Administration
From: Merri Martz, Hannah Fotherby, Michelle Havey, and Josh Jensen, Anchor QEA, LLC
cc: Katherine Chesick, Jill Macik, and Ticson Mach, City of Seattle Department of Transportation
**Re: Incidental Harassment Authorization Renewal Request, Waterfront Park (Pier 58),
City of Seattle**

**WATERFRONT PARK RECONSTRUCTION PROJECT
ACOUSTIC MONITORING REPORT**

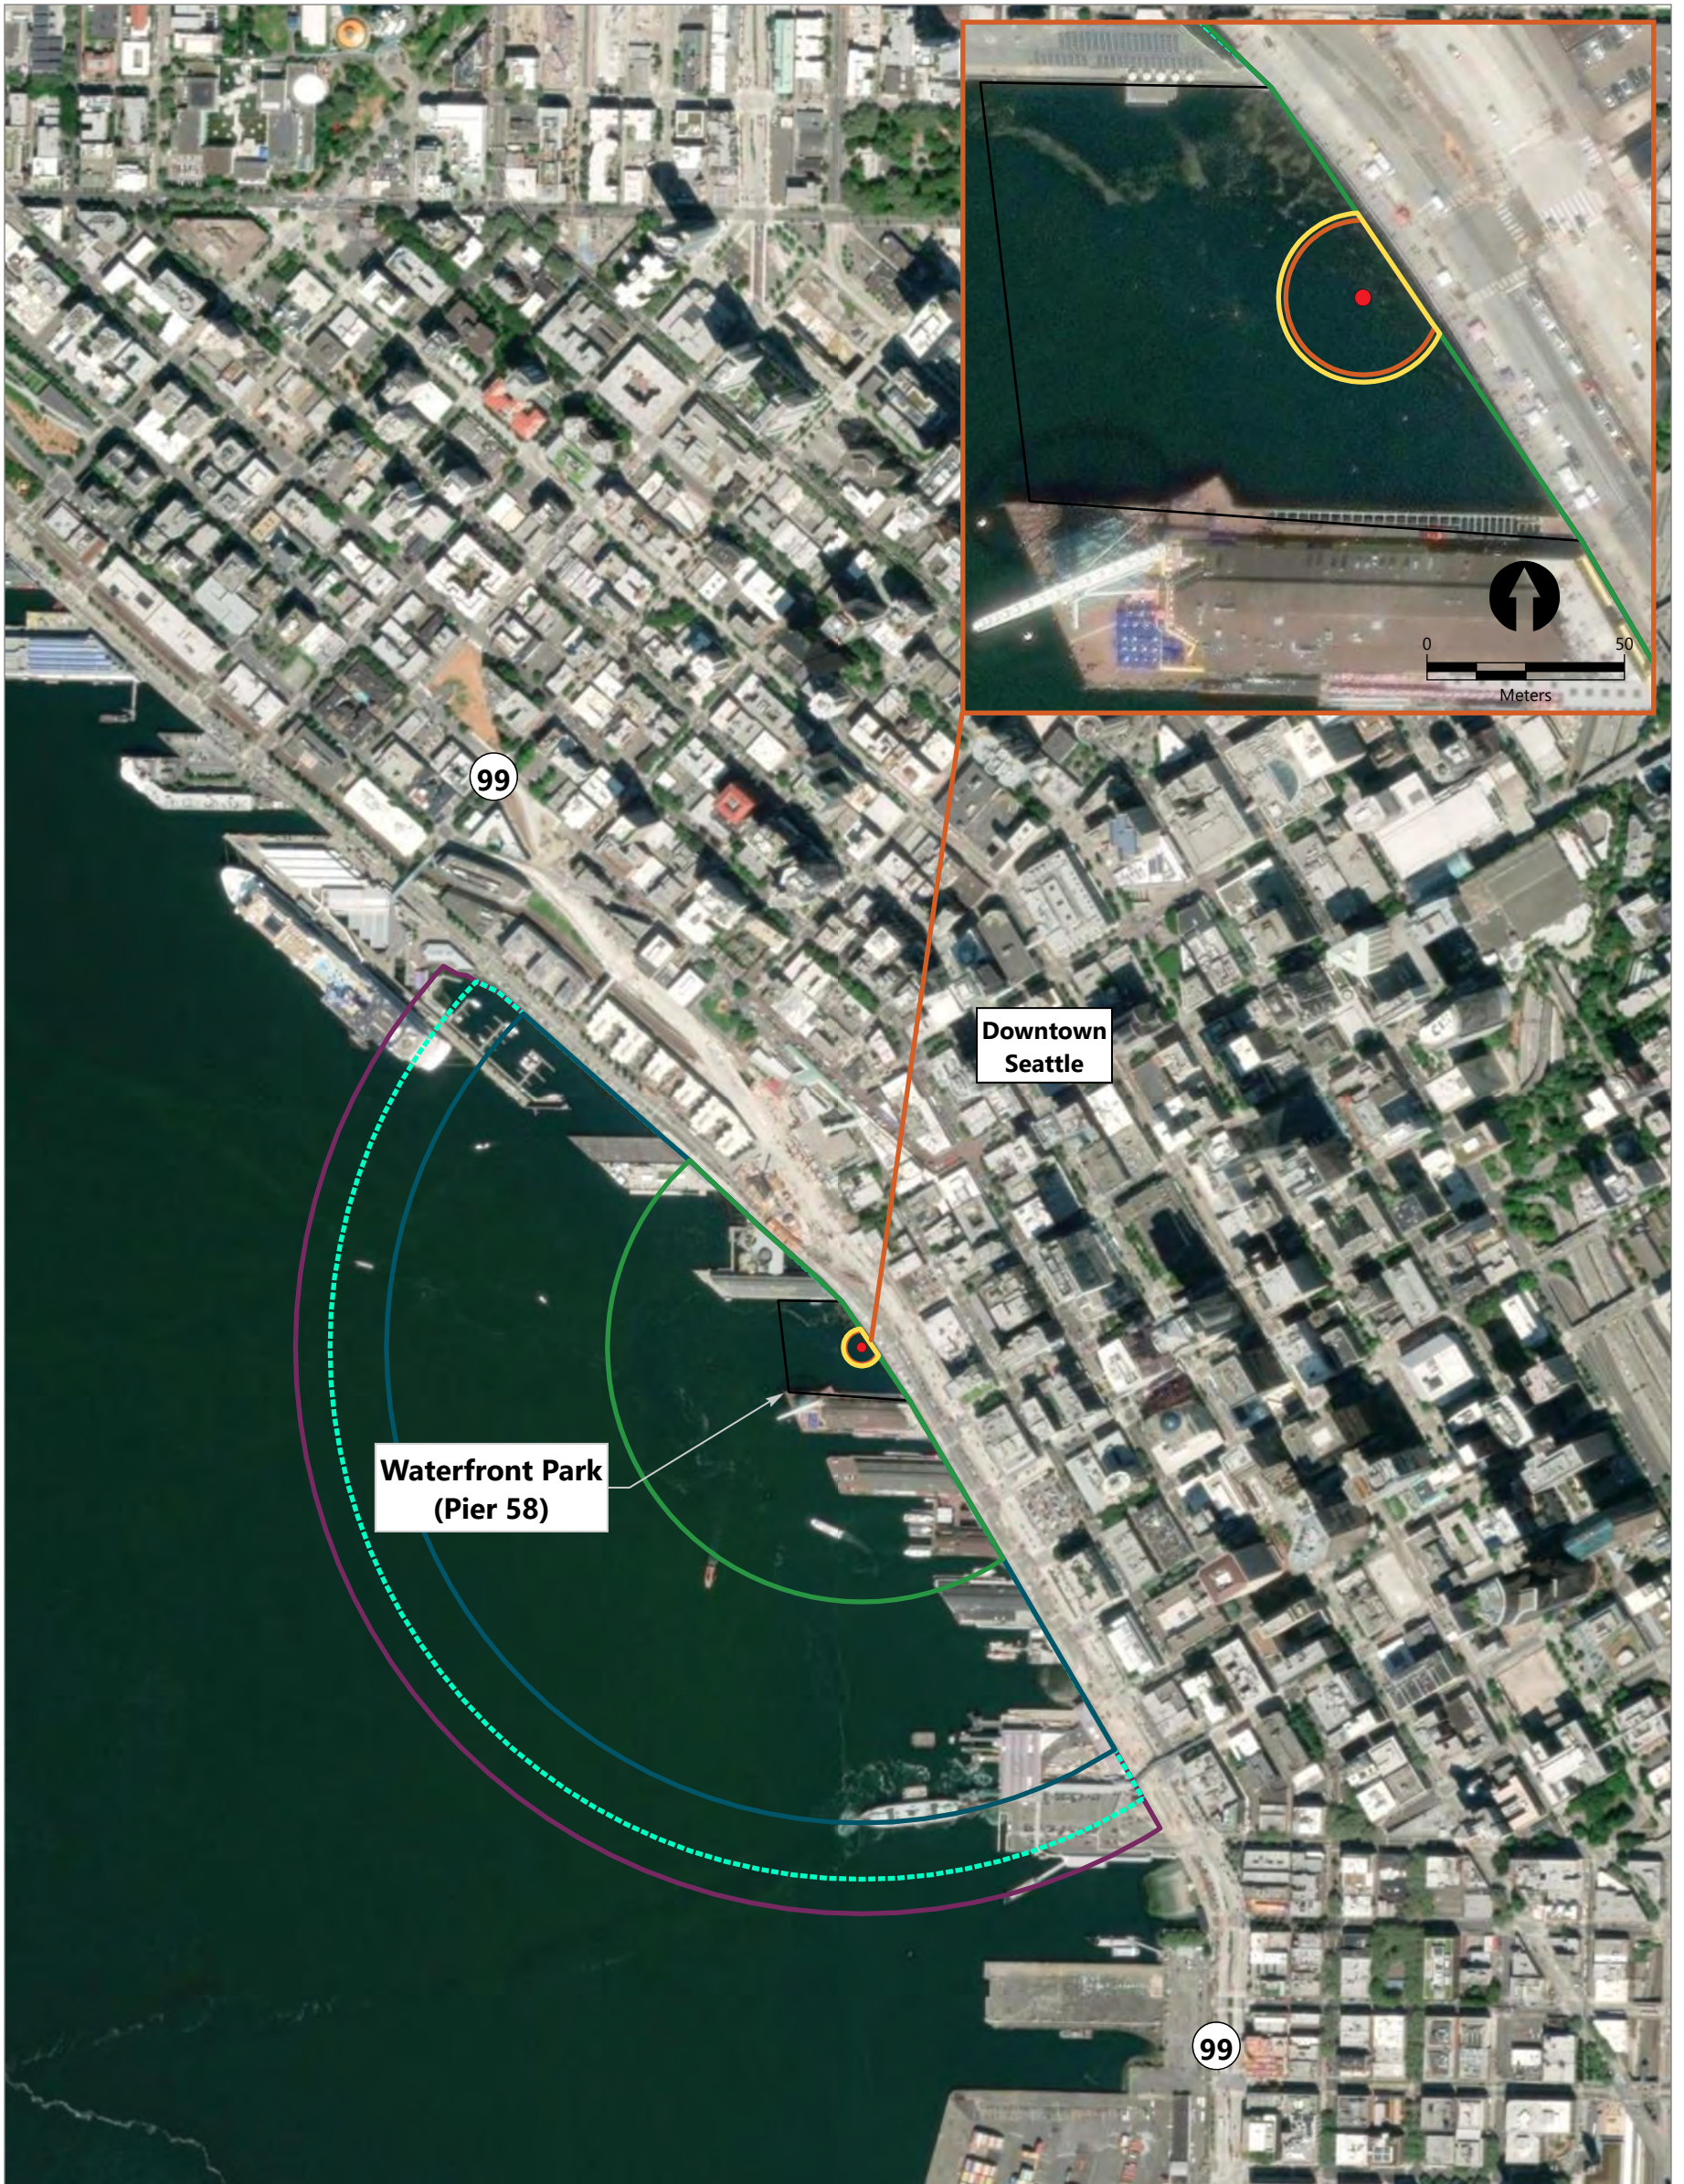
- Hammer Location
- Waterfront Park
- Level B Harassment Zone - All Hearing Groups**
- ▬ Impact Installation (Steel Pile): 616 meters
- Exclusion Zones**
- ▬ Mid-Frequency Cetaceans (20 meters)
- ▬ Otariid Pinnipeds (21 meters)
- ▬ Phocid Pinnipeds (295 meters)
- ▬ Low-Frequency Cetaceans (551 meters)
- ▬ High-Frequency Cetaceans (656 meters)

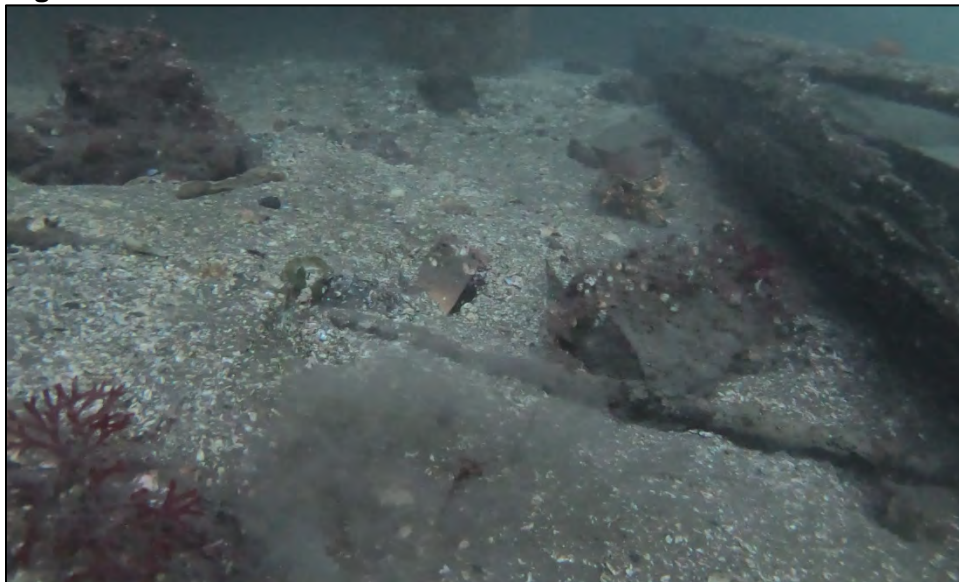
Figure 5.2 Seafloor Near Pier 58

Piles installed during the monitoring period were driven to refusal with a vibratory pile driver, then with an impact hammer for the remainder of the pile drive. The steel pipe piles were 30-inches in diameter and between 92 and 121 feet in length. The substrate the piles were driven into was generally hard, rocky, and covered with silt and marine debris. A photo of the typical seafloor is provided in Figure 5.2.

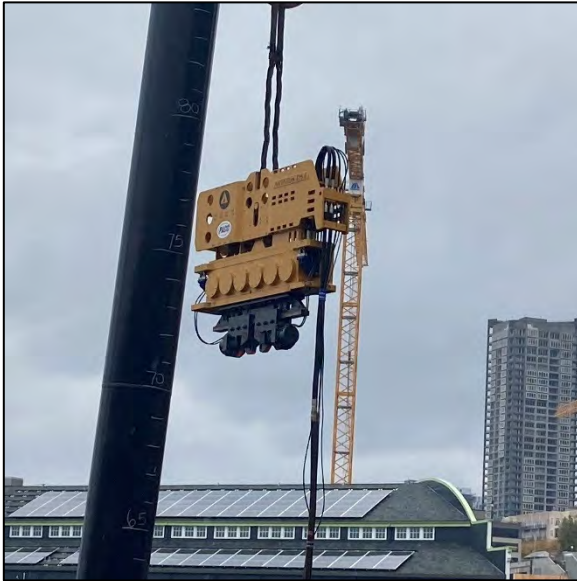
Figure 5.3 Antaeus 325-6

During the acoustic monitoring, vibratory pile driving was completed using an Antaeus 325-6 Vibratory Pile Driver and Extractor. The Antaeus 325-6 operates at a maximum frequency of 1,650 VPM with a maximum driving force of 270 tons and has a suspended weight of 19,450 pounds. A cut sheet of the Antaeus 325-6 can be found in the Appendix of this Report.

Photos of the Antaeus 325-6 Vibratory Pile Driver and Extractor and APE Model D62-22 are shown in Figure 5.3 and Figure 5.4.

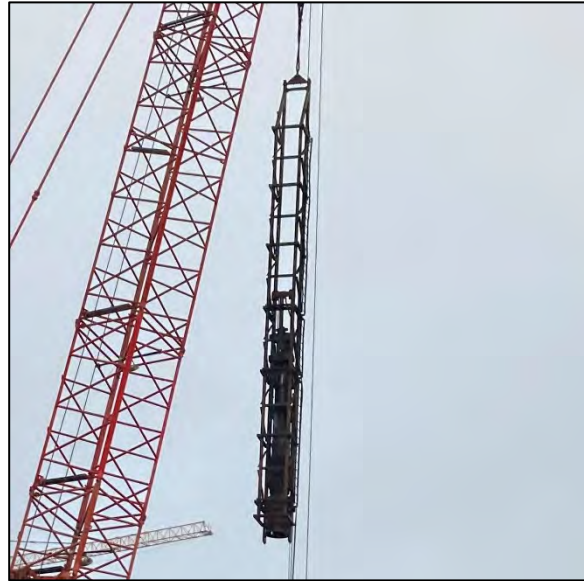
Figure 5.4 APE D62-22

After the piles were driven to refusal with the vibratory hammer, an APE Model D62-22 single acting diesel impact hammer was used to drive the piles to embedment. The APE Model D62-22 has an energy rating of 78,956 to 153,770 foot-pounds, a piston weight of 13,669 pounds, and a stroke length of 11.24 feet. A cut sheet of the APE Model D62-22 diesel impact hammer can be found in the Appendix.

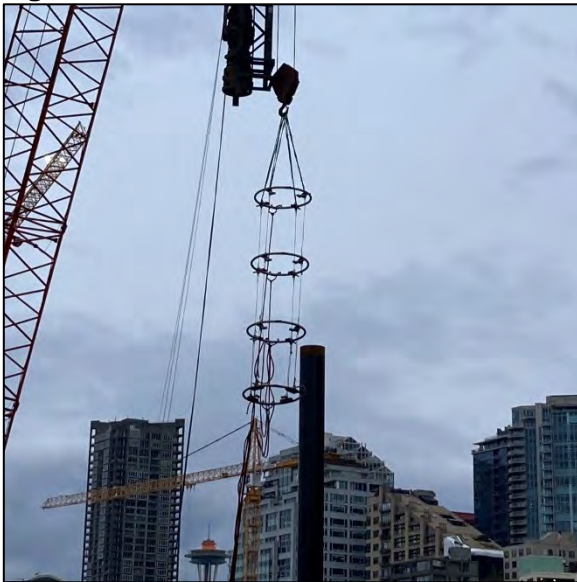
Figure 5.5 Bubble Curtain

An unconfined bubble curtain was used during all impact pile driving. Design drawings of the bubble curtain are provided in the Appendix and photos of the bubble curtain are shown in Figure 5.5 and Figure 5.6.

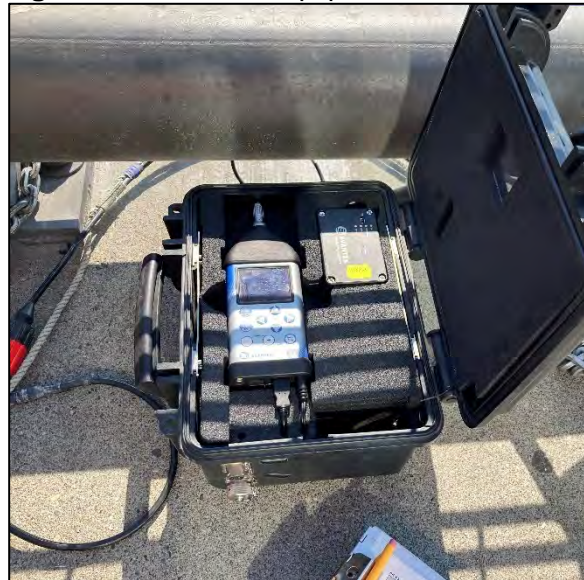
Figure 6.2 Airborne Equipment

Photographs of the monitoring equipment are provided in Figure 6.1 and Figure 6.2.

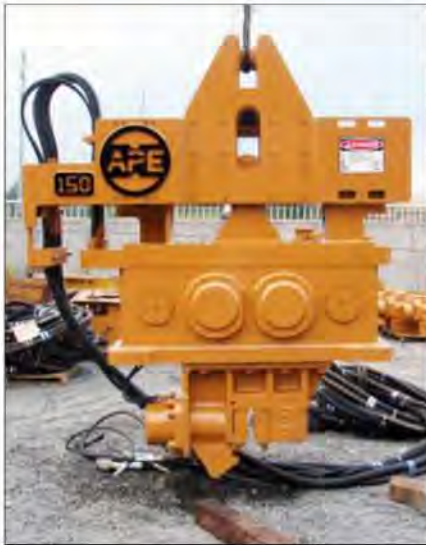
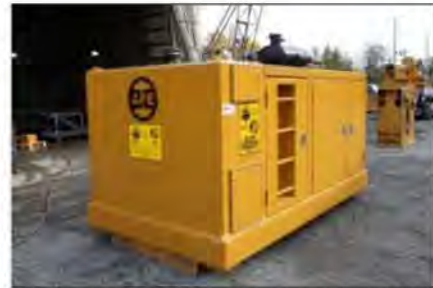
APE Model 150 Vibratory Driver Extractor
The Worlds Largest Provider of
Foundation Construction Equipment

SPECIFICATIONS	DATA
Eccentric Moment	2,200 in-lbs (25.35 kgm)
Drive Force	85 tons (757 kN)
Frequency Maximum (VPM)	0 - 1,650 vpm
Max Line Pull	108 tons (961 kN)
Bare Hammer Weight w/o Clamp	8,330 lbs (3,778 kg)
Throat Width	14.25 in (36 cm)
Length	88.75 in (225 cm)
Height w/o Clamp	72.38 in (184 cm)

SPECIFICATIONS	DATA
Engine Type	Caterpillar C9 Tier III
Horse Power	375 HP (276 kW)
Drive Pressure	0 - 4,500 psi (310 bar)
Drive Flow	120 gpm (454 lpm)
Clamp Pressure	4,800 psi (69,618 bar)
Clamp Flow	10 gpm (3 lpm)
Engine Speed	2,100 rpm
Weight	12,600 lbs (5,715 kg)
Length	137 in (347 cm)
Width	77 in (195 cm)
Height	82 in (208 cm)
Hydraulic Reservoir	300 gal (1,136 L)
Fuel Capacity	140 gal (530 L)

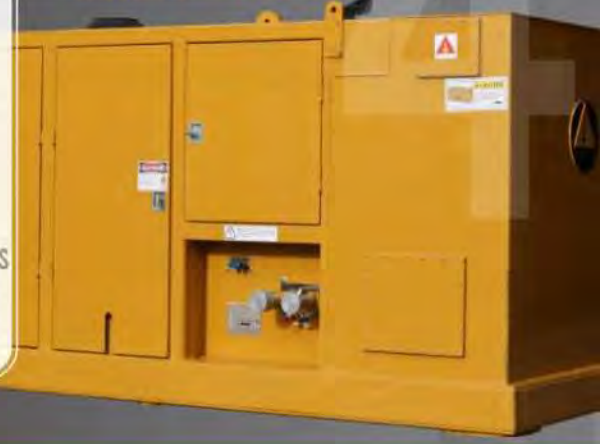
800HP POWER UNIT

- OPERATES VIBROS, DRILLS & IMPACTS
- SPARE HYDRAULIC TANK
- FULL FORWARD AND REVERSE
- MEETS EUROPEAN REGULATIONS

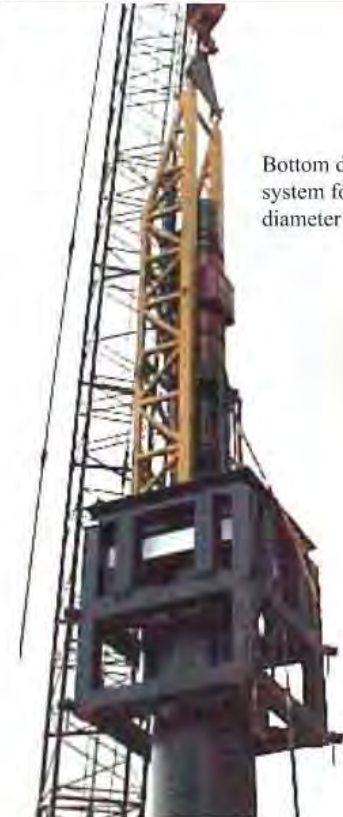
APE MODEL D62-22 SINGLE ACTING IMPACT HAMMER

APE Model D62-22 Single Acting Impact Hammer
operates on diesel or bio-diesel for all types of impact pile driving

MODEL D62-22 (6.2 metric ton ram)
SPECIFICATIONS

Maximum Rated Energy	153,770 ft/lbs (208,484 Nm)
Minimum Rated Energy	78,956 ft/lbs (107,050 Nm)
Stroke at Rated Energy	11.24 ft (3.42 m)
Maximum Obtainable Stroke	12.5 ft (3.81 m)
Speed (blows per minute)	36-50

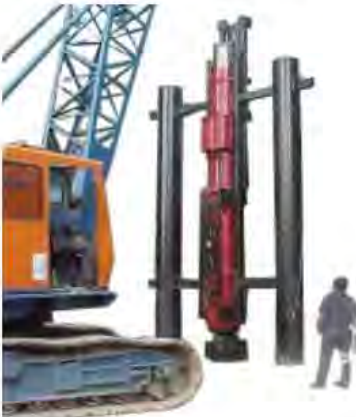
Bottom drive system for large diameter piles
