**Final Observer Report**  
**For the**  
**Alaska Department of Transportation & Public Facilities**  
**Sand Point City Dock Replacement Project**  
**Sand Point, Alaska**  
**Nov 29, 2019**

**Prepared by:**  
**High Tide Environmental, LLC**  
**180 E Hygrade Lane**  
**Wasilla, AK 99654**

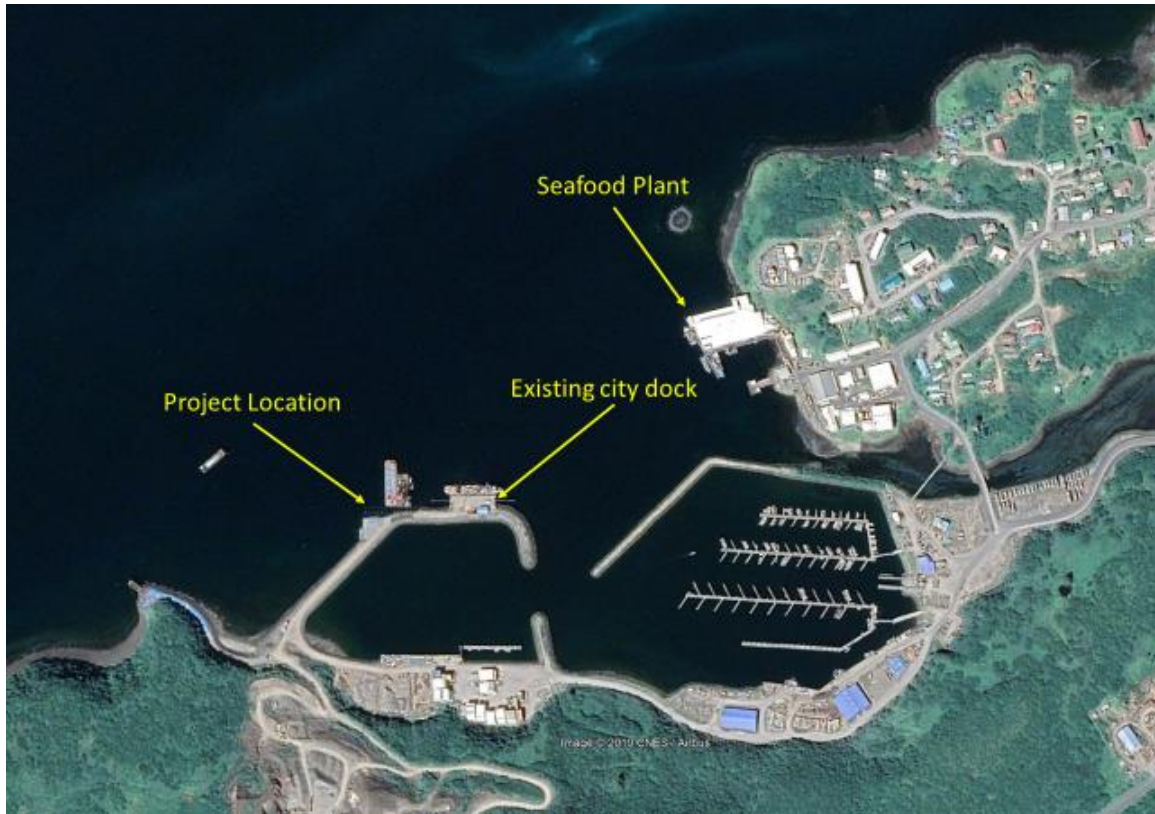
Figure 1. Project location within Sand Point, AK. This image shows the project under construction.

The Sand Point City Dock is in the City of Sand Point, Alaska, at 55°20'06.6" N, 160°30'05.9" W, on the northwest side of Popof Island, in the Gulf of Alaska. The Sand Point City Dock is a multi-function dock and active ferry terminal located in Humboldt Harbor, on the southwest side of the City of Sand Point. The existing City Dock is located on the causeway of Sand Point's "New Harbor" at the end of Boat Harbor Road. The replacement dock (i.e. this project) is located immediately adjacent (southwest) to the existing City Dock along the causeway, which also serves as the breakwater for the New Harbor (figure 1). A small boat harbor is located immediately northeast of the City Dock. There is a seafood processing facility located approximately 410 meters (0.25 mile) north of the proposed dock.

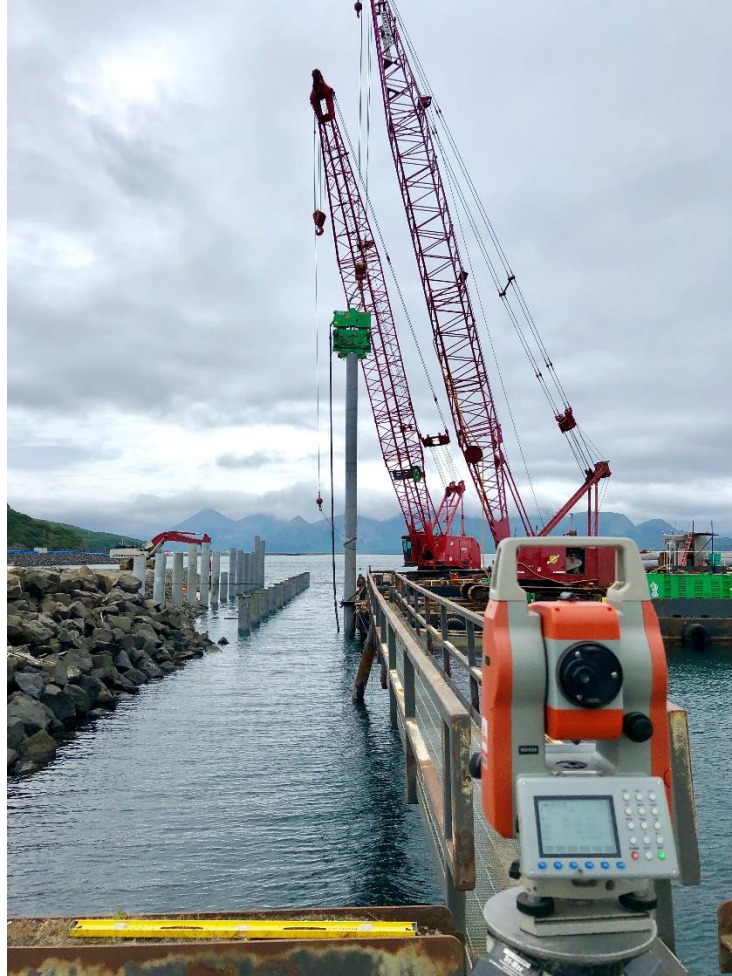
**Figure 2 – Vibratory pile installation**

The proposed action required placing fill material adjacent to the existing causeway to create support for the new dock. Dock construction included the installation of structural support piles (figure 2), a concrete dock platform, four fenders, a catwalk with dolphin, a generator building, and electrical infrastructure. No dredging was undertaken as part of this Project, and the existing dock was not removed. Minor modifications to the existing dock's dolphin occurred as part of the proposed action.

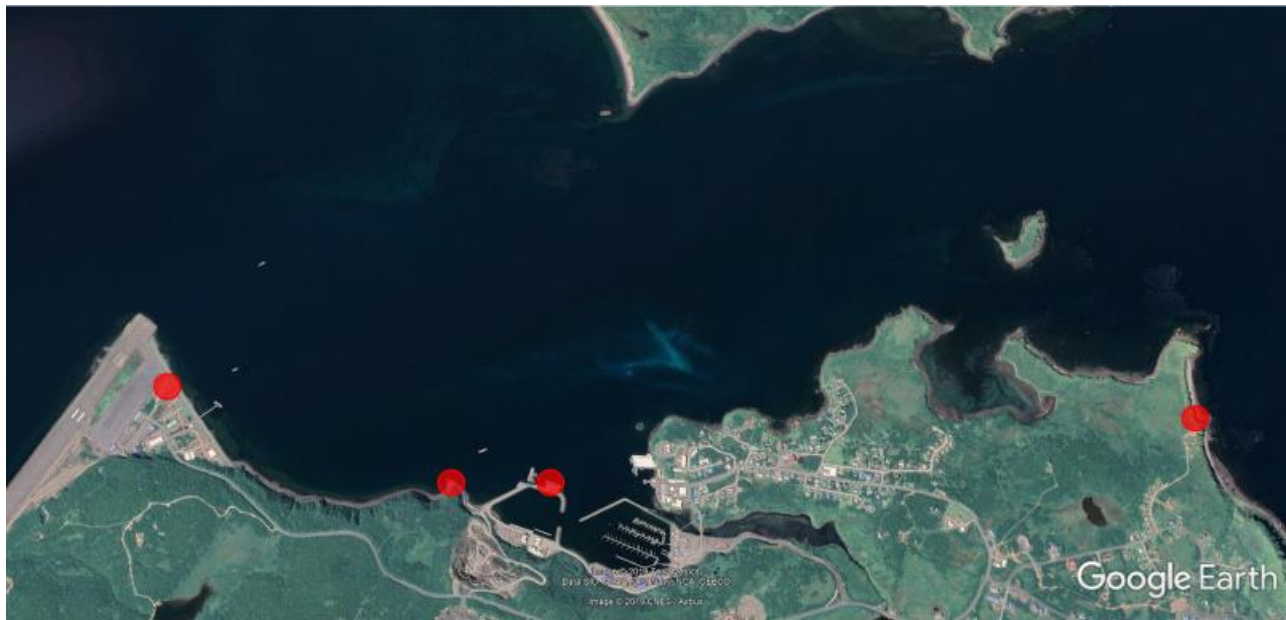
**Figure 3. Observer monitoring locations in red.**

The primary observation stations were on the city dock and the site shown at the far right of figure 3. Pre and post-construction monitoring typically involved driving along the road system along the coastal portions of the road system in town to ensure animals were not present in any blind spots caused by vessels, infrastructure, or protrusions of land. Daily usage of the observation stations was based on construction activities, weather conditions, and optimization of view angles.

MMOs recorded mammal sightings, construction activities, environmental conditions, and made general notes on vessel traffic. The MMOs utilized stations that provided sufficient view of the project activities, varying their location based on weather, visibility, and project needs (figure 3). Various combinations of

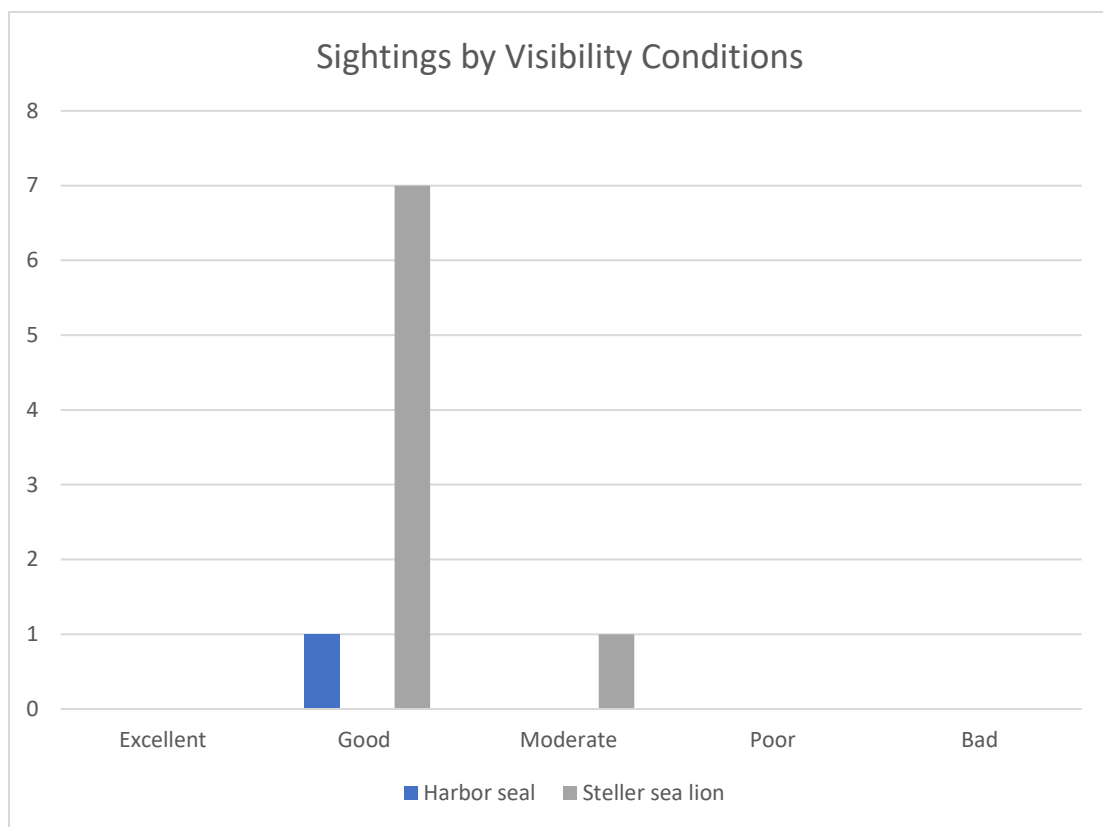
**Figure 4 – Graph of protected species sightings by specified visibility condition**

Visibility condition is an estimate of visible distance made by the observers based on the following intervals: Excellent (>10 km), Good (3 – 10 km), Moderate (0.9 – 3 km), Poor (0.5 – 0.9 km), Bad (<0.5 km).

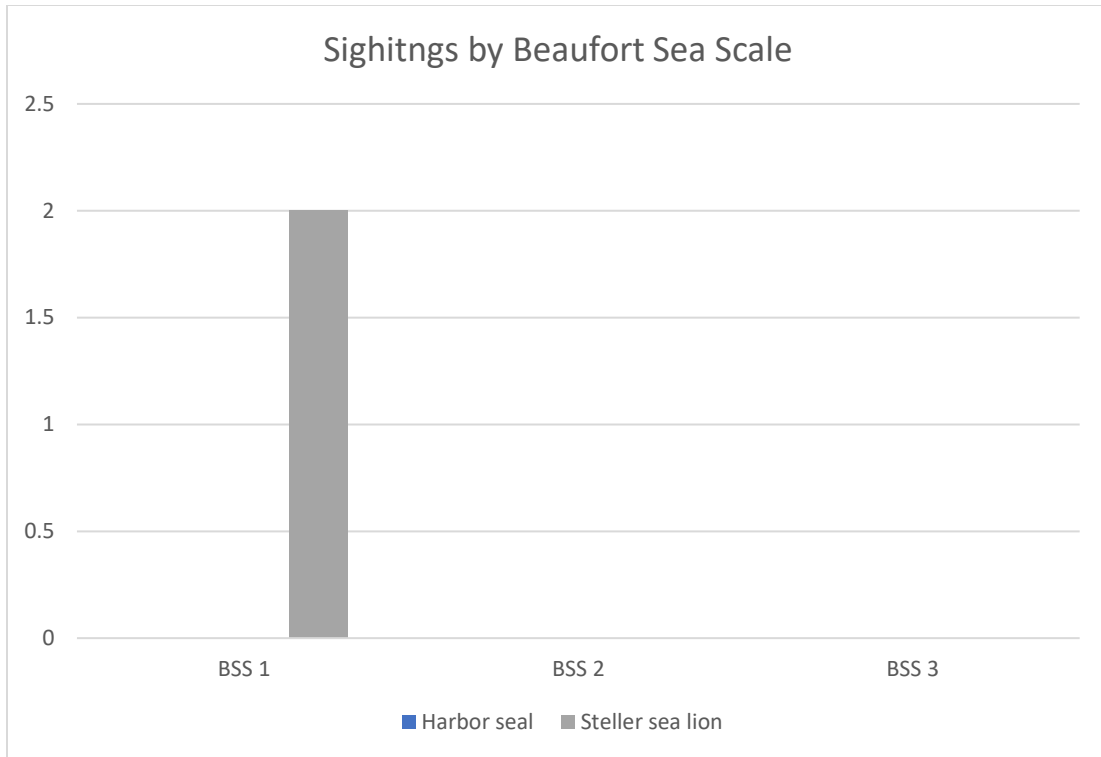
**Figure 5 – Graph of protected species sightings by specified Beaufort sea state (BSS)**

Beaufort sea state (BSS) is an established scale designed to describe wind and wave conditions at sea, described further in the 4MP. Sightings relative to BSS are shown in figure 5.

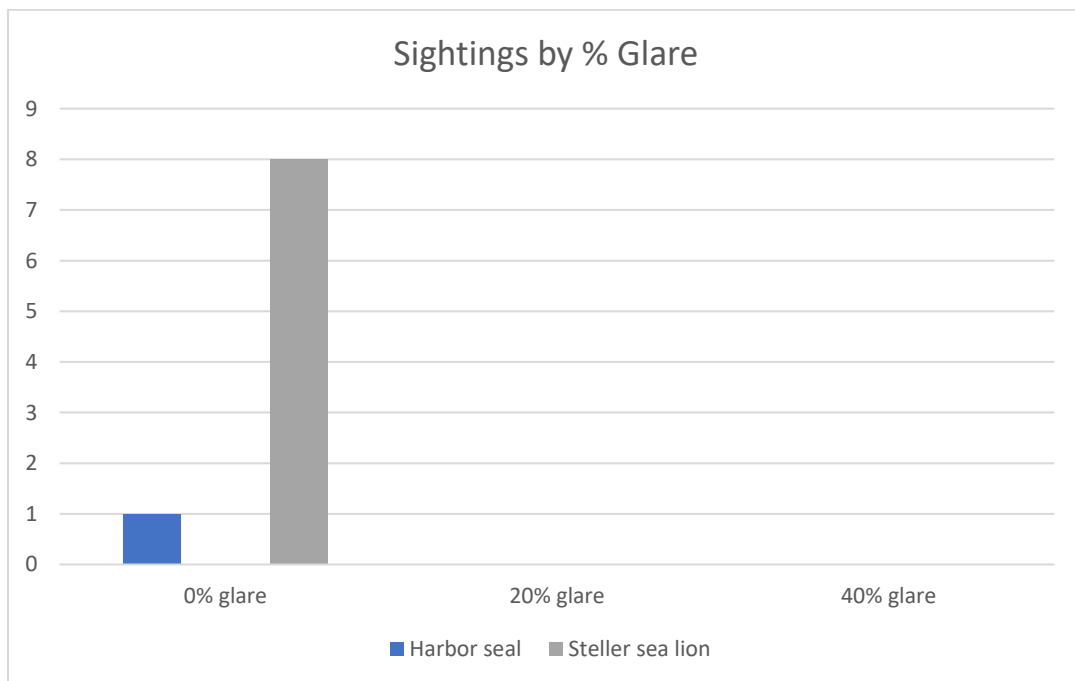
**Figure 6 – Graph of protected species sightings by hour of specified % glare**

Glare can impact the ability of an observer to view portions of the project area. Glare was not a factor during observations for this project (figure 6).

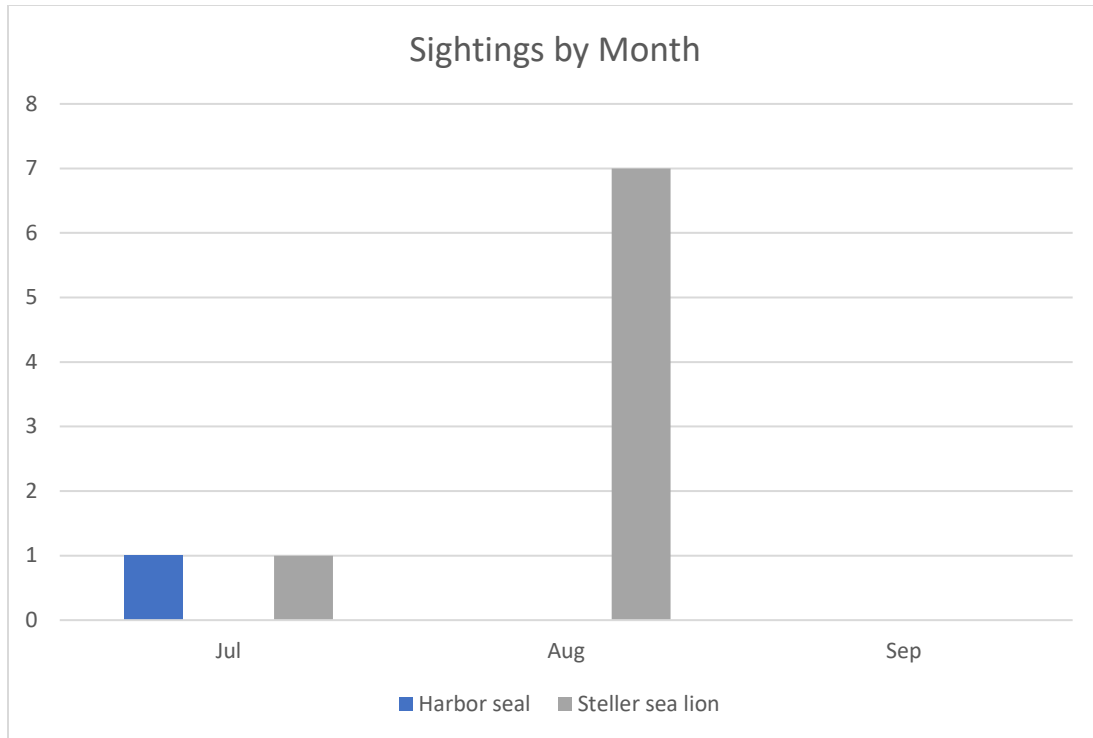
Figure 7 – Graph of sightings by month

Steller sea lion sighting rates are likely explained by a combination of their reproductive history and local conditions. Many Steller sea lions are likely at rookeries in July, possibly accounting for the low numbers observed by MMOs. It does not appear that marine construction on the project attracted or deterred Steller sea lions or altered their behavior in any noticeable manner. Harbor seals were present in low number during July. MMOs did not note any visible reaction by harbor seals.

A total of 9 marine mammal sightings were recorded between 28 July 2019 and 9 September. This count includes 8 Steller sea lion sightings (9 individuals), and 1 harbor seal sighting. There were no re-sightings recorded. Figure 12 shows sighting rates for each species by month.
