2023 Final Biological Monitoring and Mitigation Compliance Report

Chevron Long Wharf Maintenance and Efficiency Project

Chevron Products Company

Revised March 2024

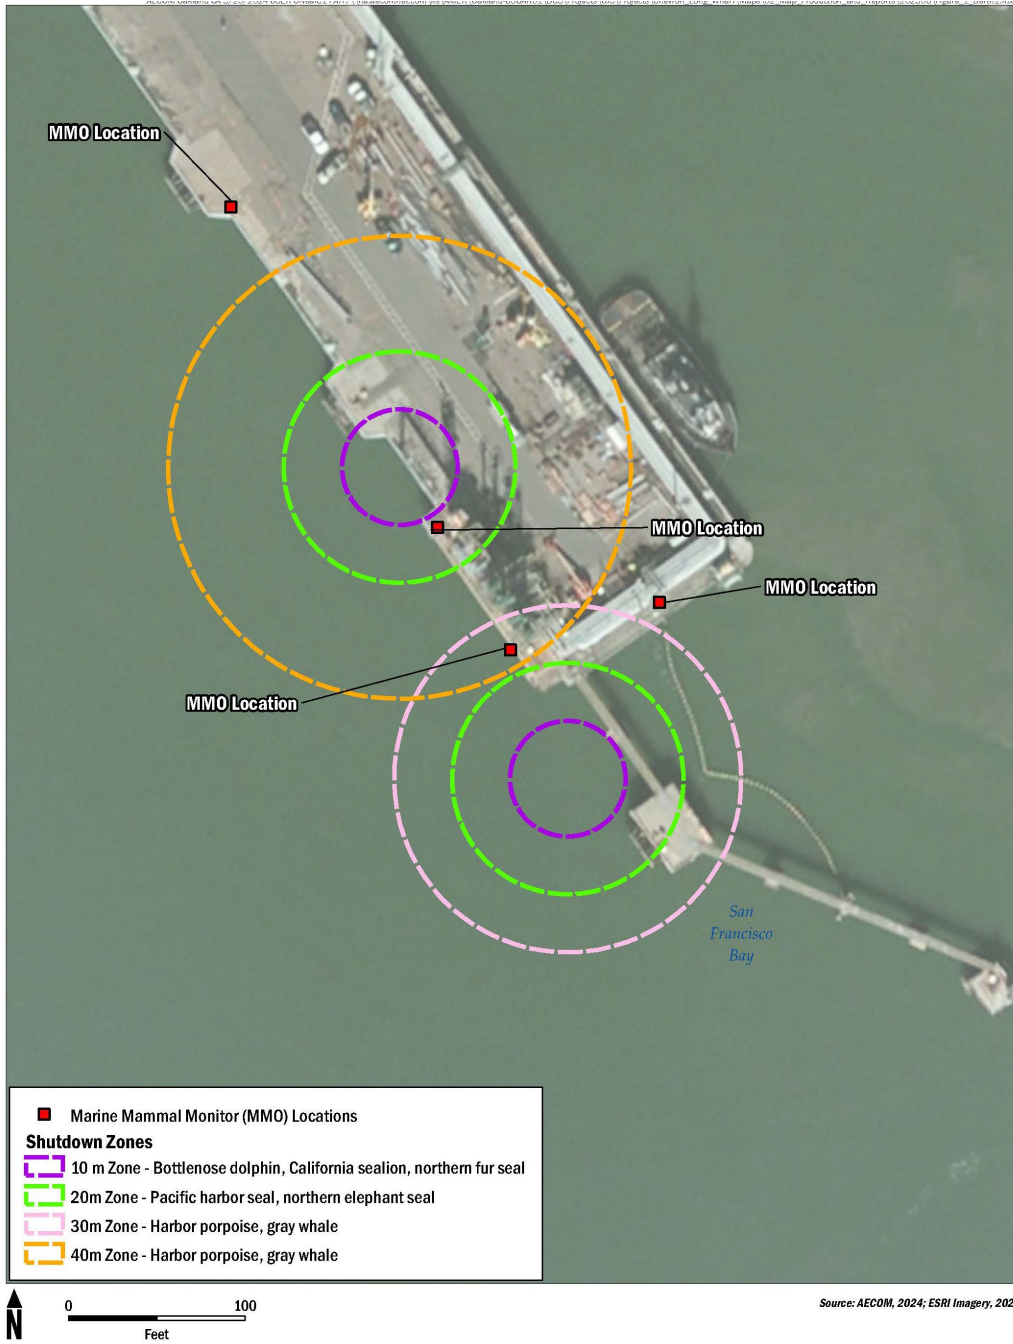
Figure 2 Berth 1 Shutdown Zones for 24-inch Concrete Pile Installation (top) and 36-inch Steel Pile Installation and Extraction (bottom)

Work at Berth 1 included impact driving a total of 22 square (24-inch) concrete piles with associated shutdown zones of 10 meters for bottlenose dolphin, California sea lion and northern fur seal; 20 meters for Pacific harbor seal and northern elephant seal; and 40 meters for harbor porpoise and gray whale (Figure 2). Additionally, 10 steel piles (36-inch) were installed via vibratory driving with a 10 meter shutdown zone for all species (Figure 2).
