2021 Final Biological Monitoring and Mitigation Compliance Report

Chevron Long Wharf Maintenance and Efficiency Project

Chevron Products Company

January, 2022

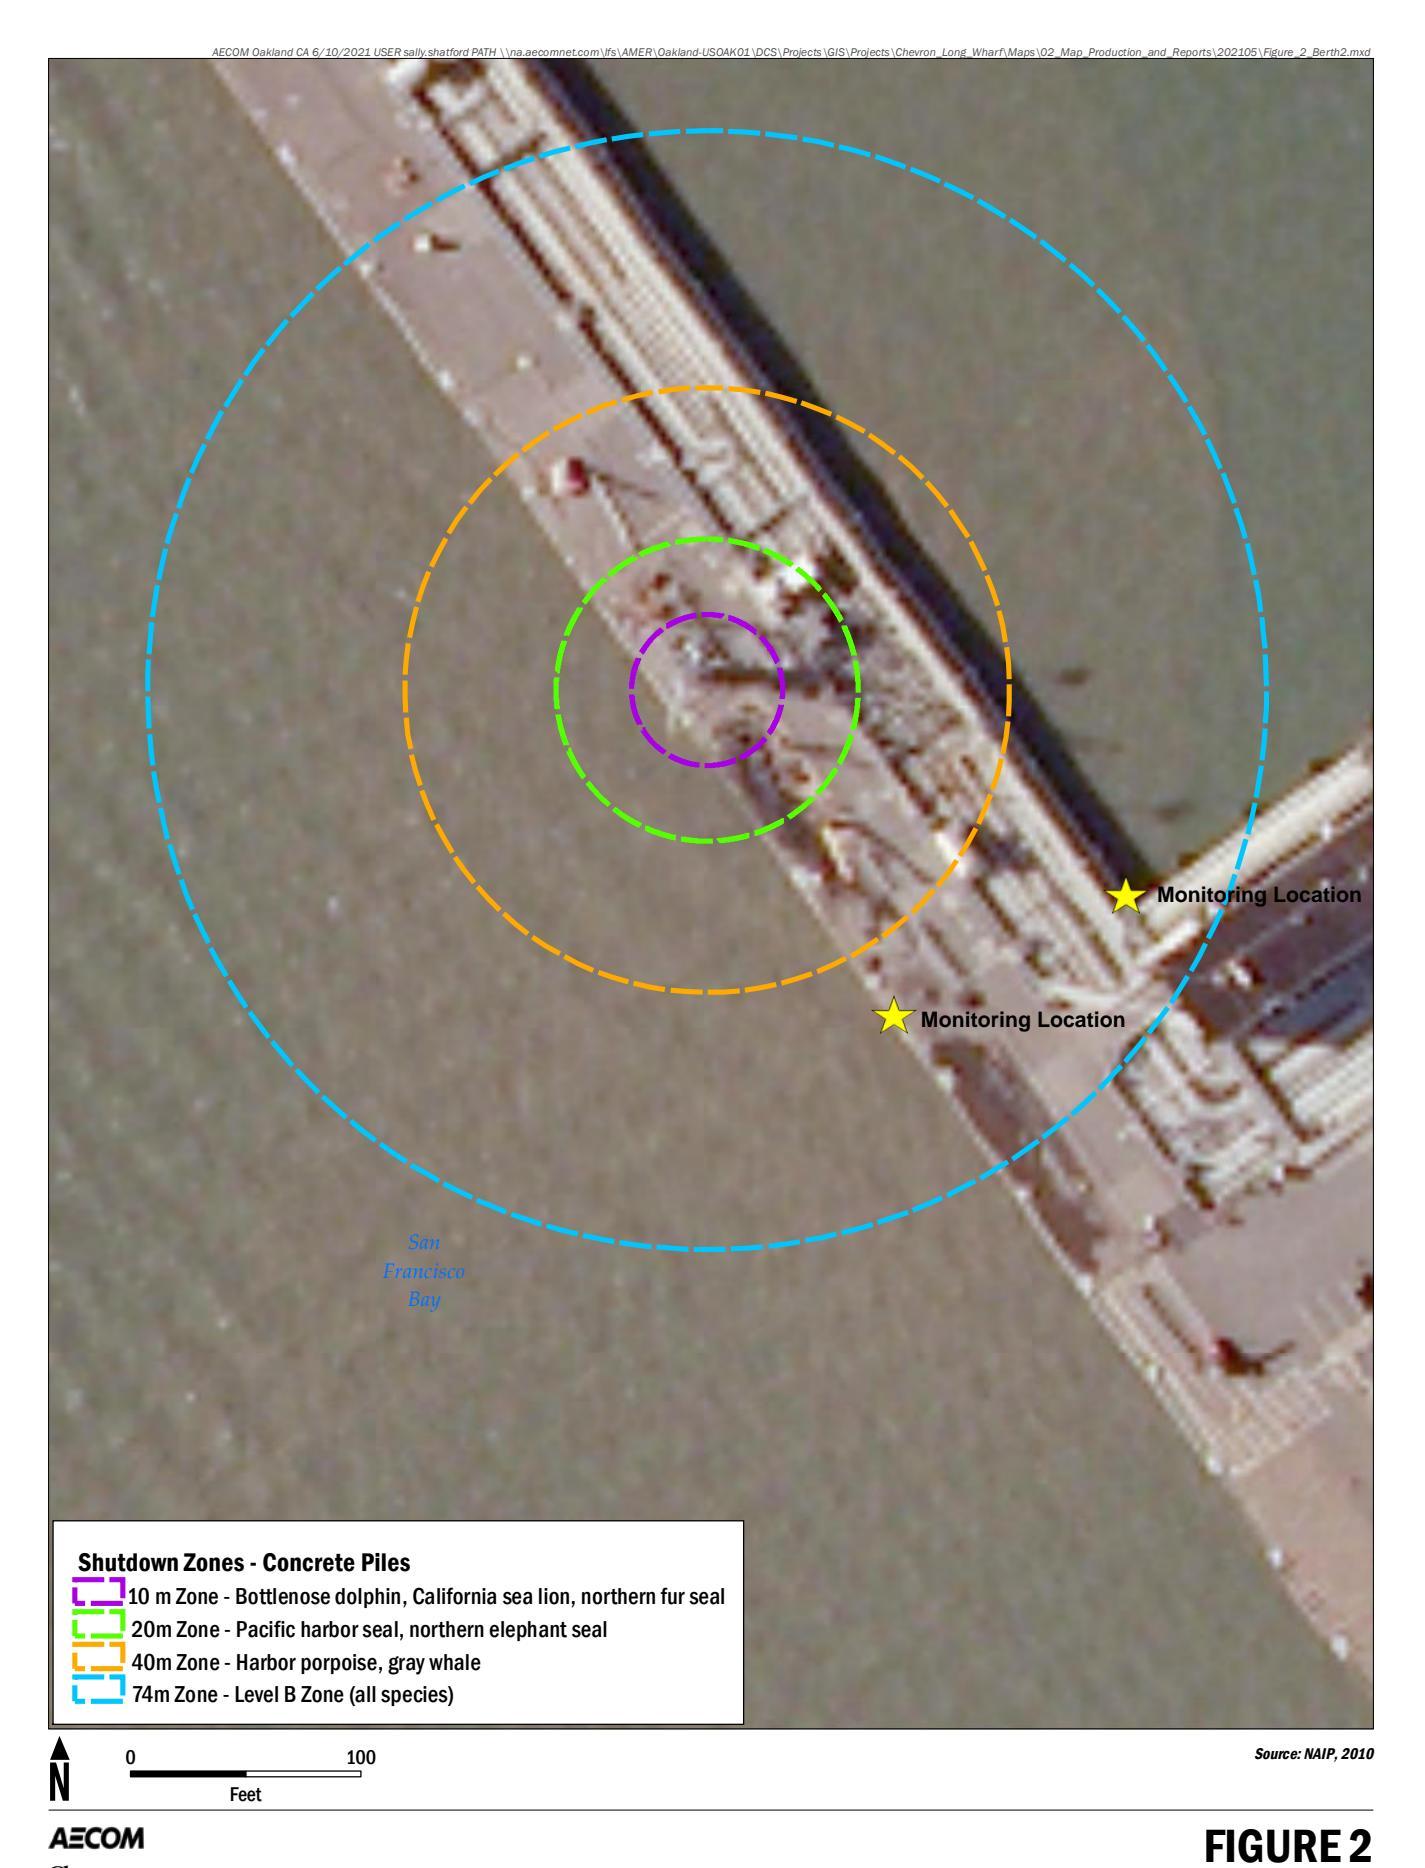
Berth 2 Shutdown Zones for Concrete Pile Driving

Initial work at Berth 2 included impact driving a total of nine 24-inch-square concrete piles with associated shutdown zones of 10 meters for bottlenose dolphin, California sea lion and northern fur seal; 20 meters for Pacific harbor seal and northern elephant seal; 40 meters for harbor porpoise and gray whale; and 74 meters for all species in the Level B zone (Figure 2). Additionally, Steel H-piles were removed via vibratory extraction with a 10 meter shutdown zone for all species (Figure 3).

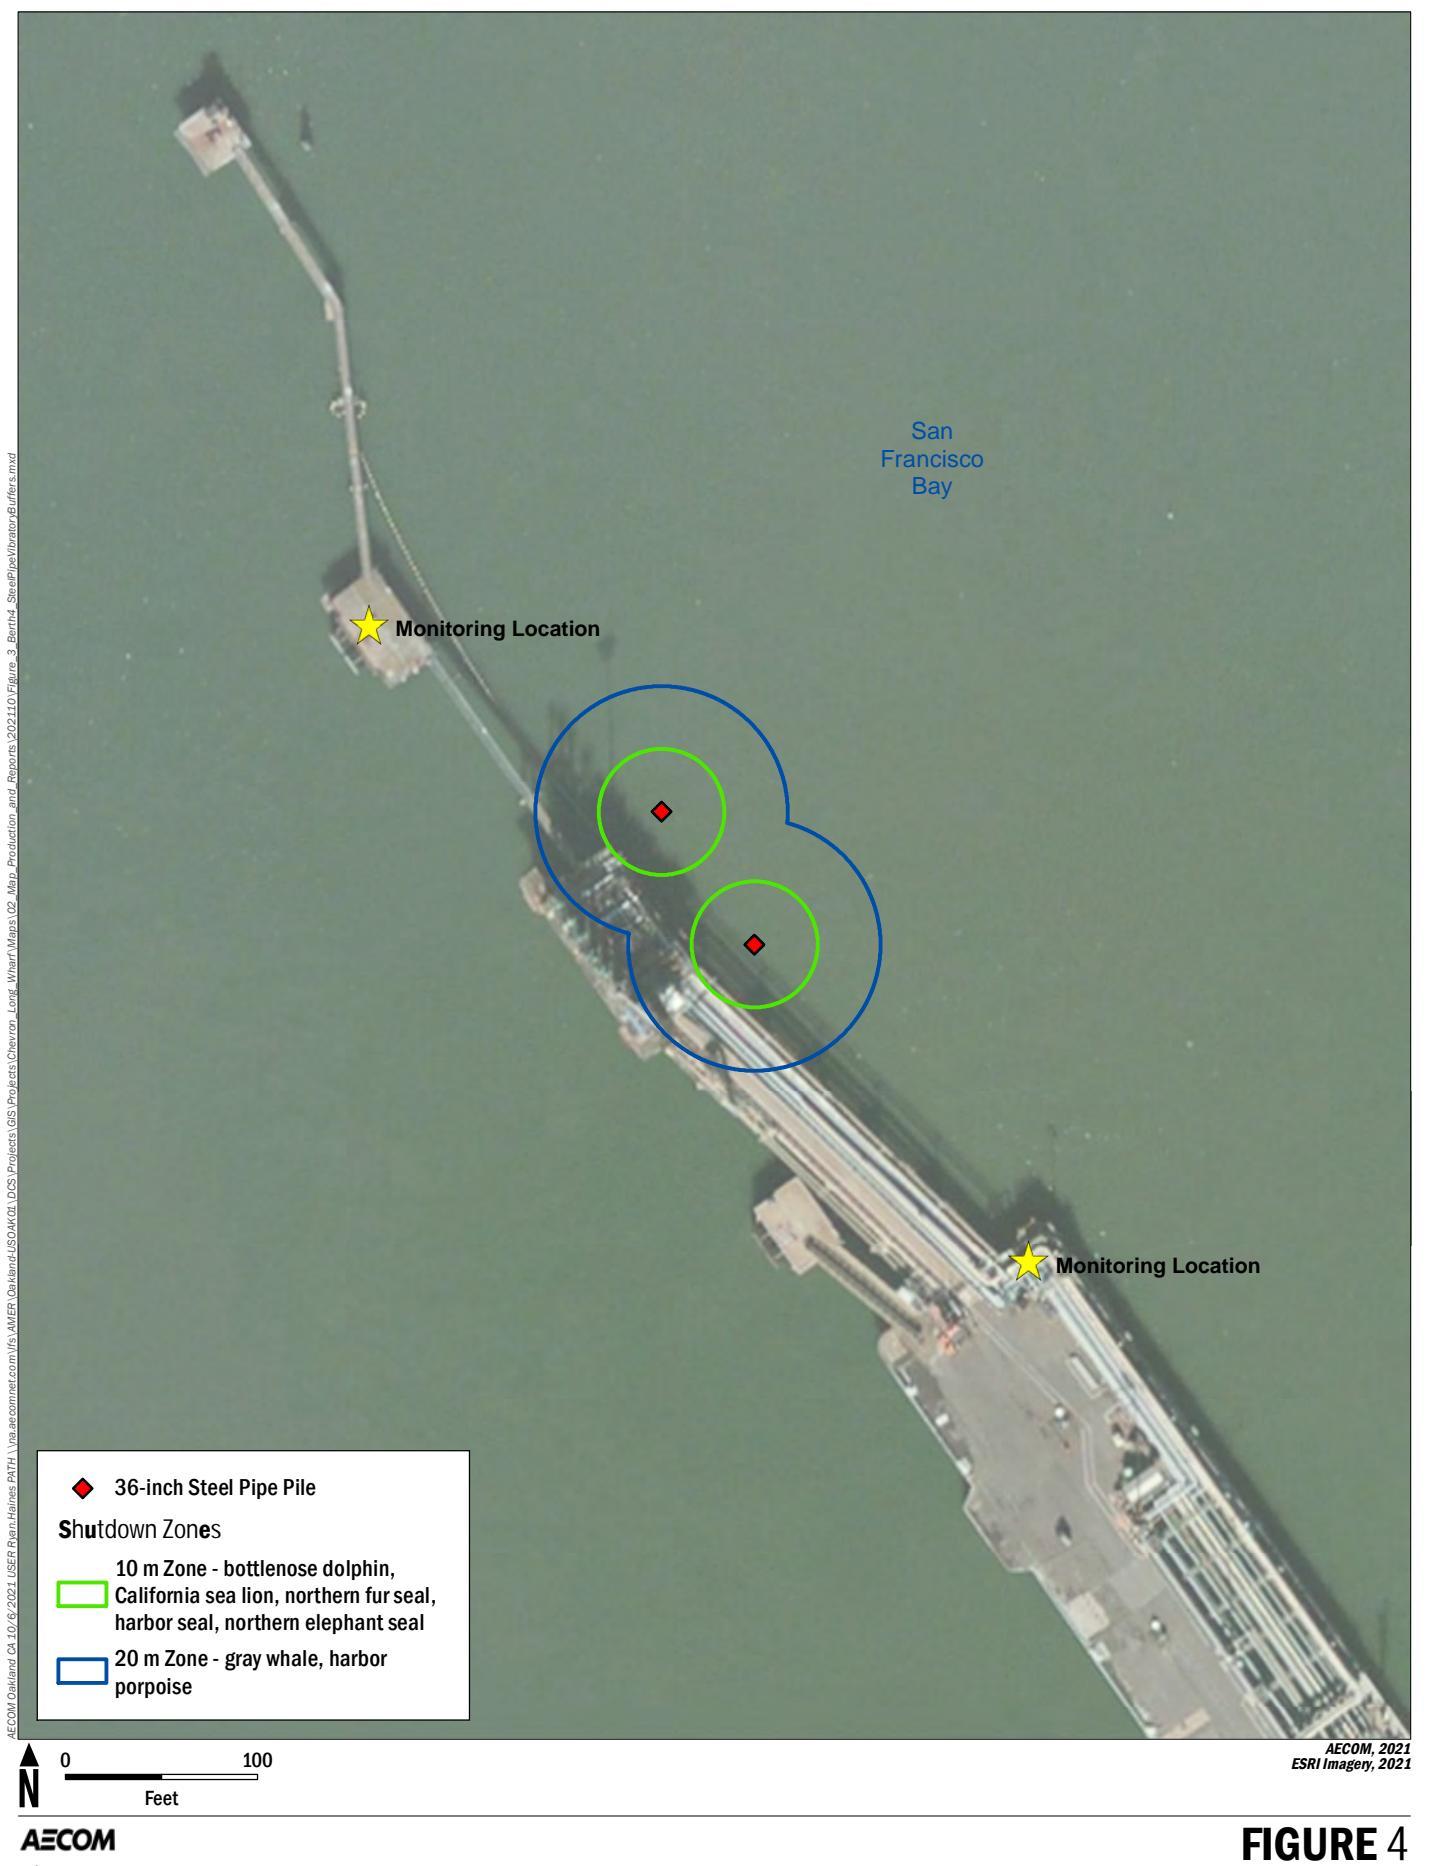
Berth 4 Shutdown Zones for Vibratory Extraction of 36-Inch Steel Piles

Work at Berth 4 began with an attempt to remove 36-inch steel pipe piles via vibratory extraction. However, the vibratory hammer was ineffective in loosening the piles and piles were cut at the mudline by divers instead. The shutdown zones for this work included 10 meters for bottlenose dolphin, California sea lion, northern fur seal, harbor seal, and northern elephant seal, and 20 meters for gray whale and harbor porpoise (Figure 4).

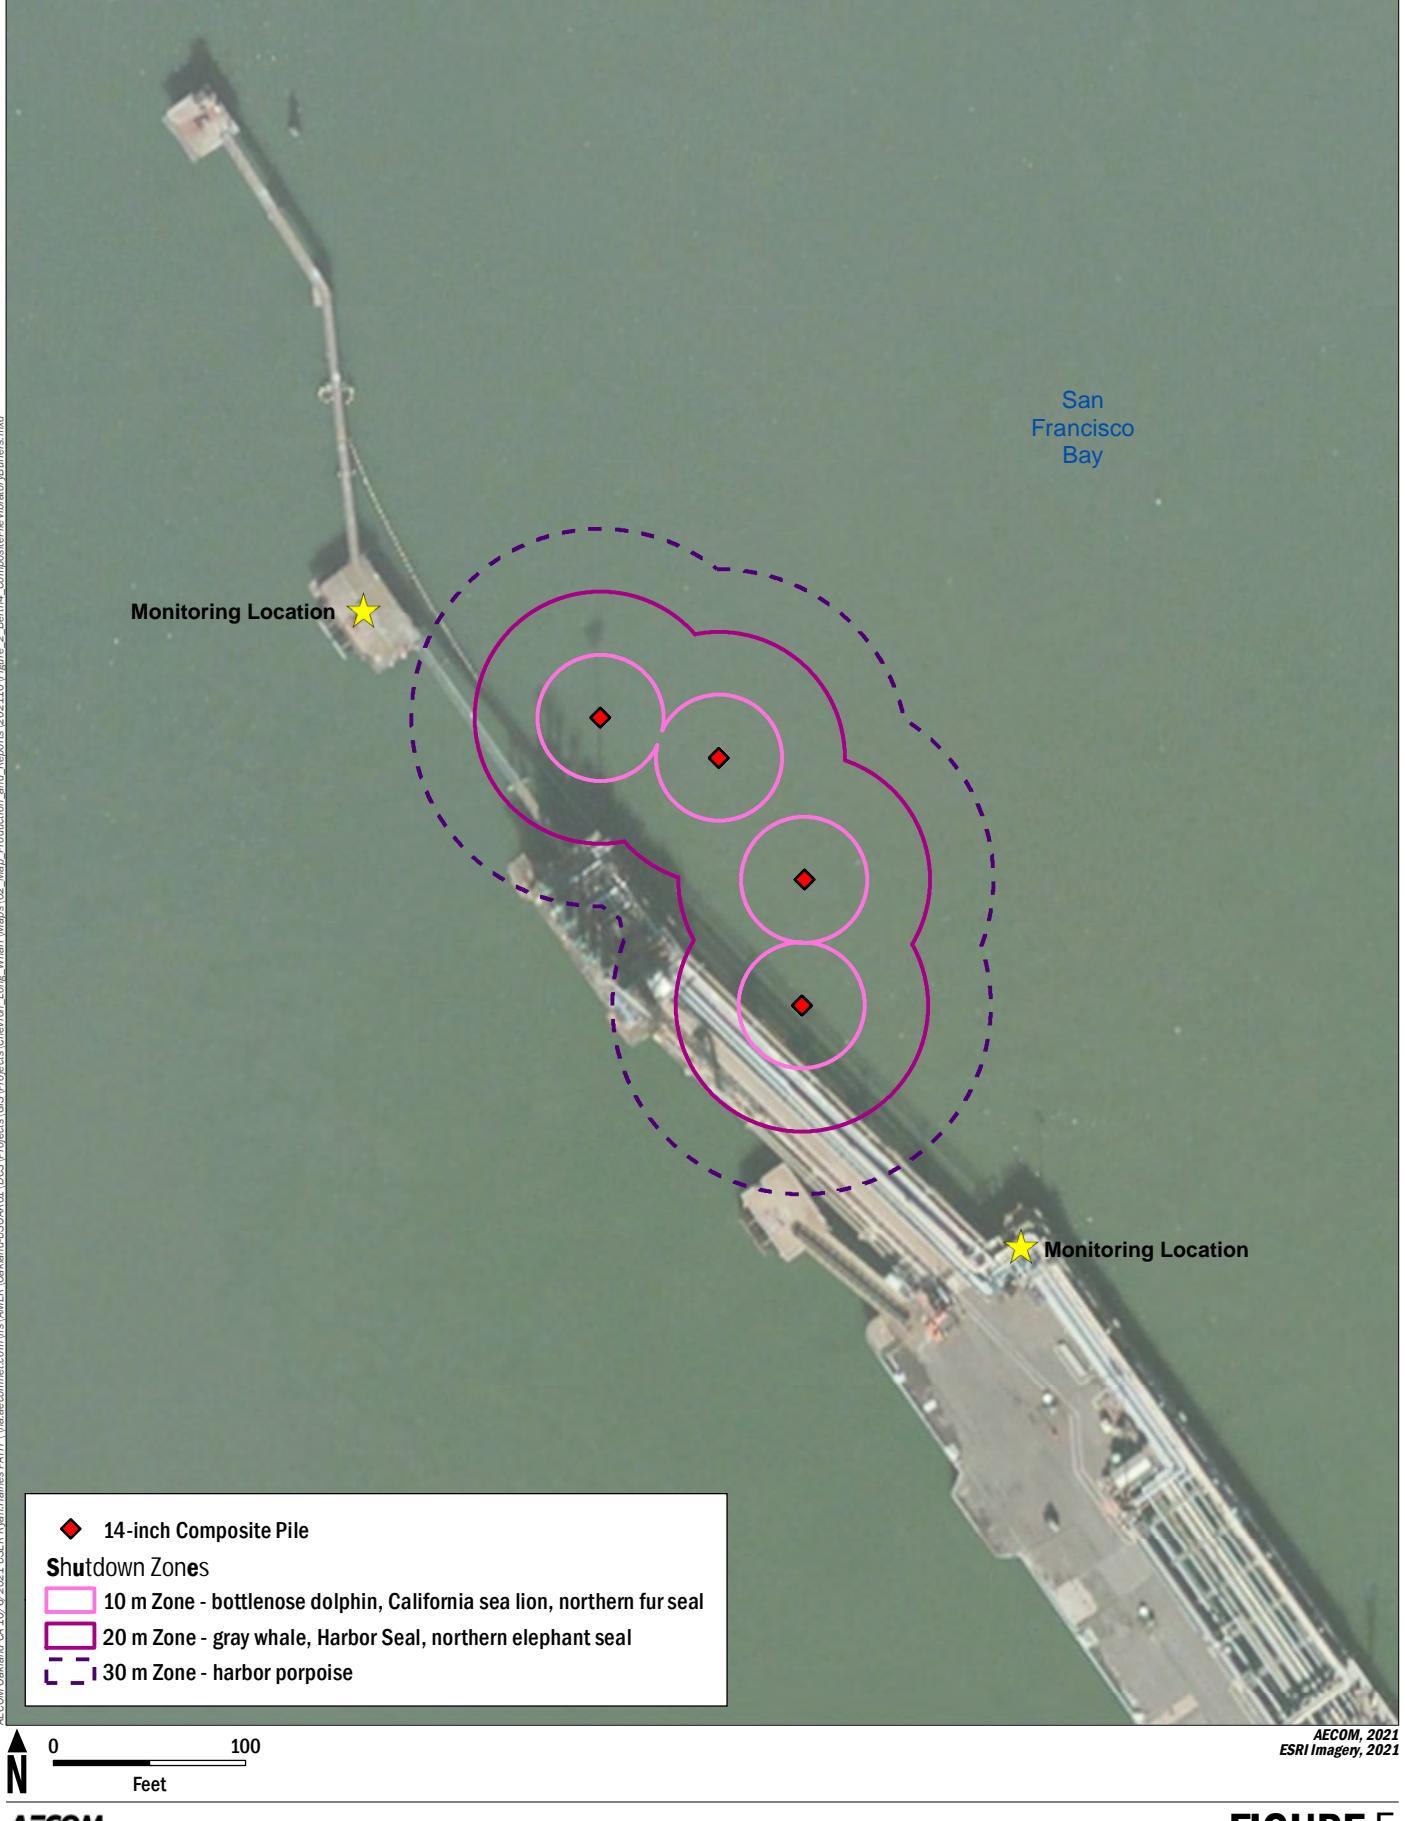
AECOM Chevron Chevron Long Wharf **FIGURE** 5 Berth 4 Shutdown Zones for Installation of 14-inch Composite Piles (note: vibratory hammer was ultimately not needed for these piles)

Lastly, although MMOs were present in November during installation of the 14-inch composite piles, these piles did not require vibratory driving. MMOs were on-site in case the work crew needed to use the vibratory hammer at any point (Figure 5). Because the vibratory hammer was never used, no monitoring
