TECHNICAL MEMORANDUM

SUBJECT: Marine Mammal Monitoring Plan

PROJECT: U.S. Coast Guard Fast Rescue Cutter Homeport, Astoria, Oregon

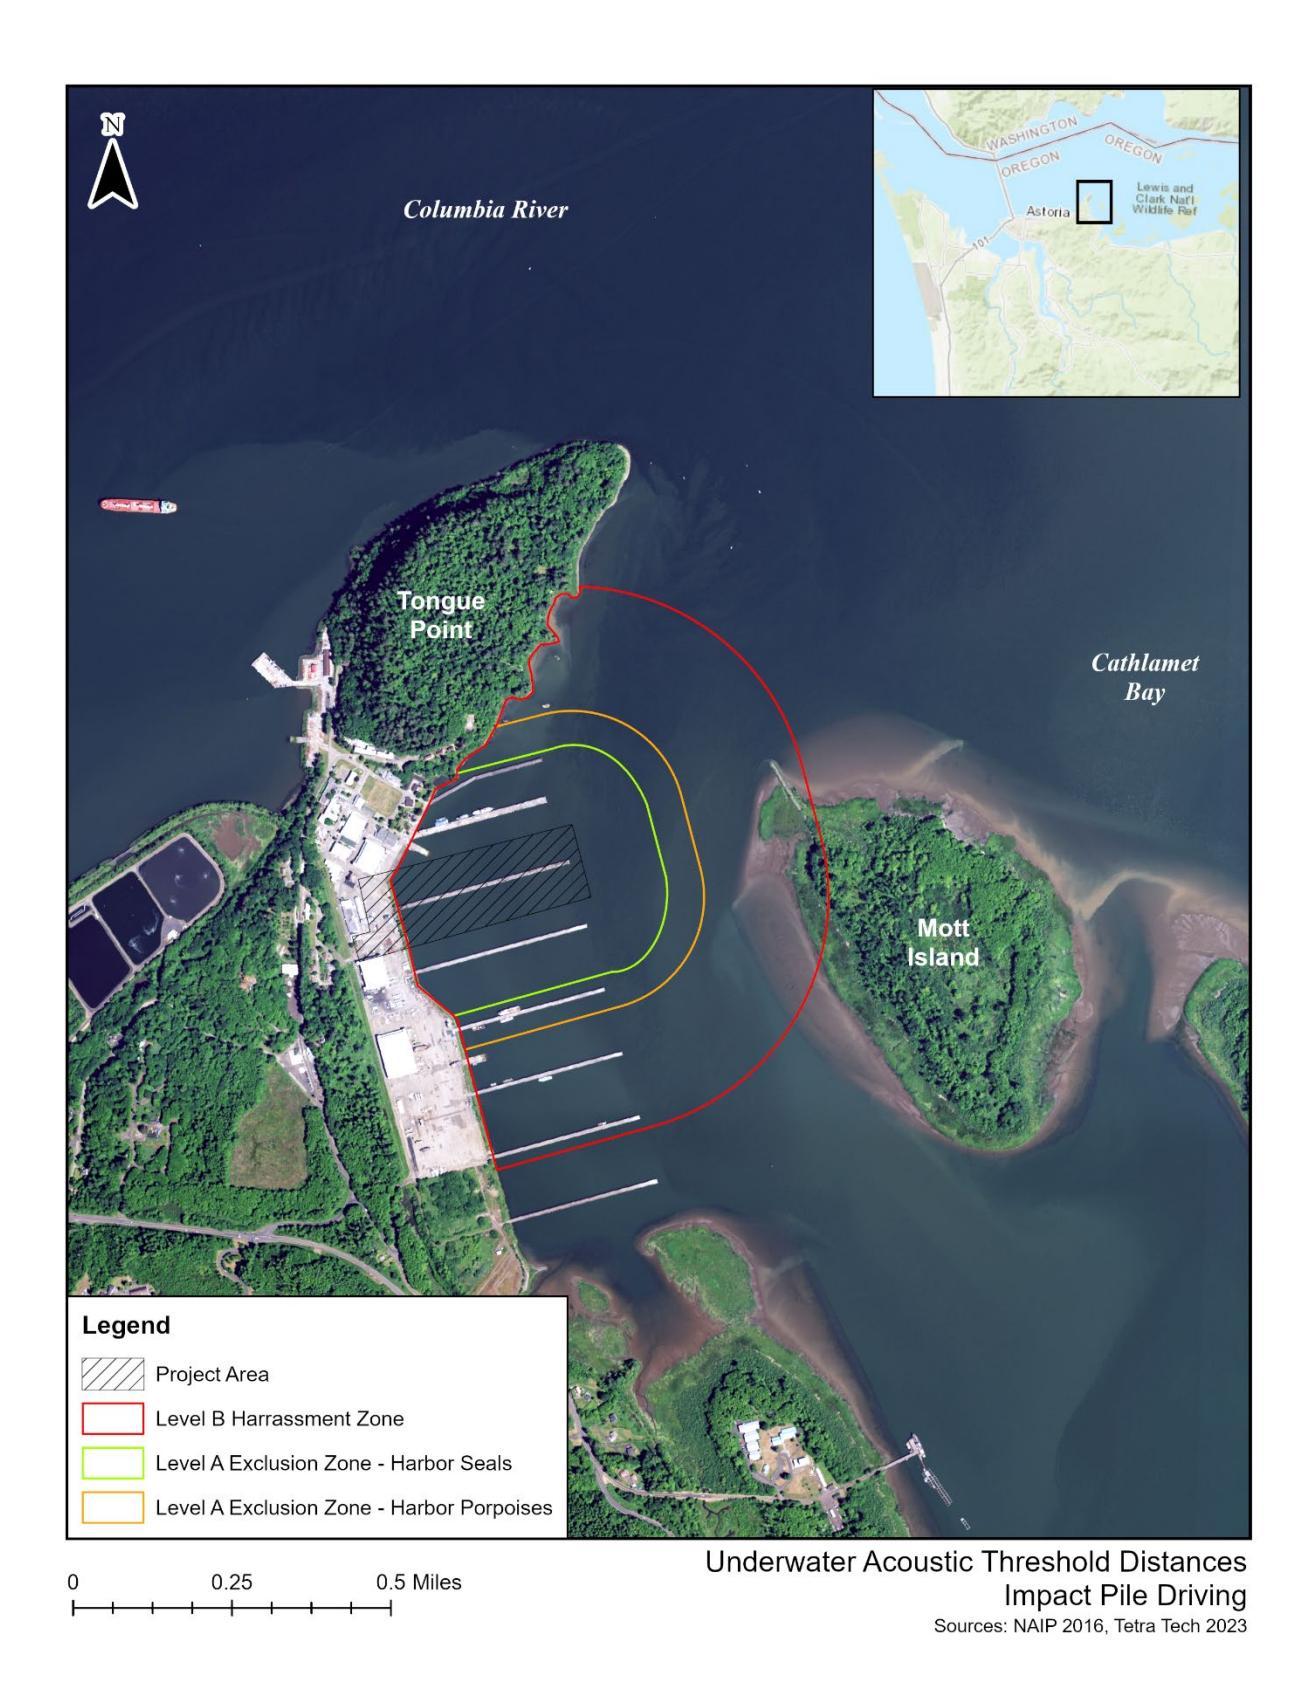
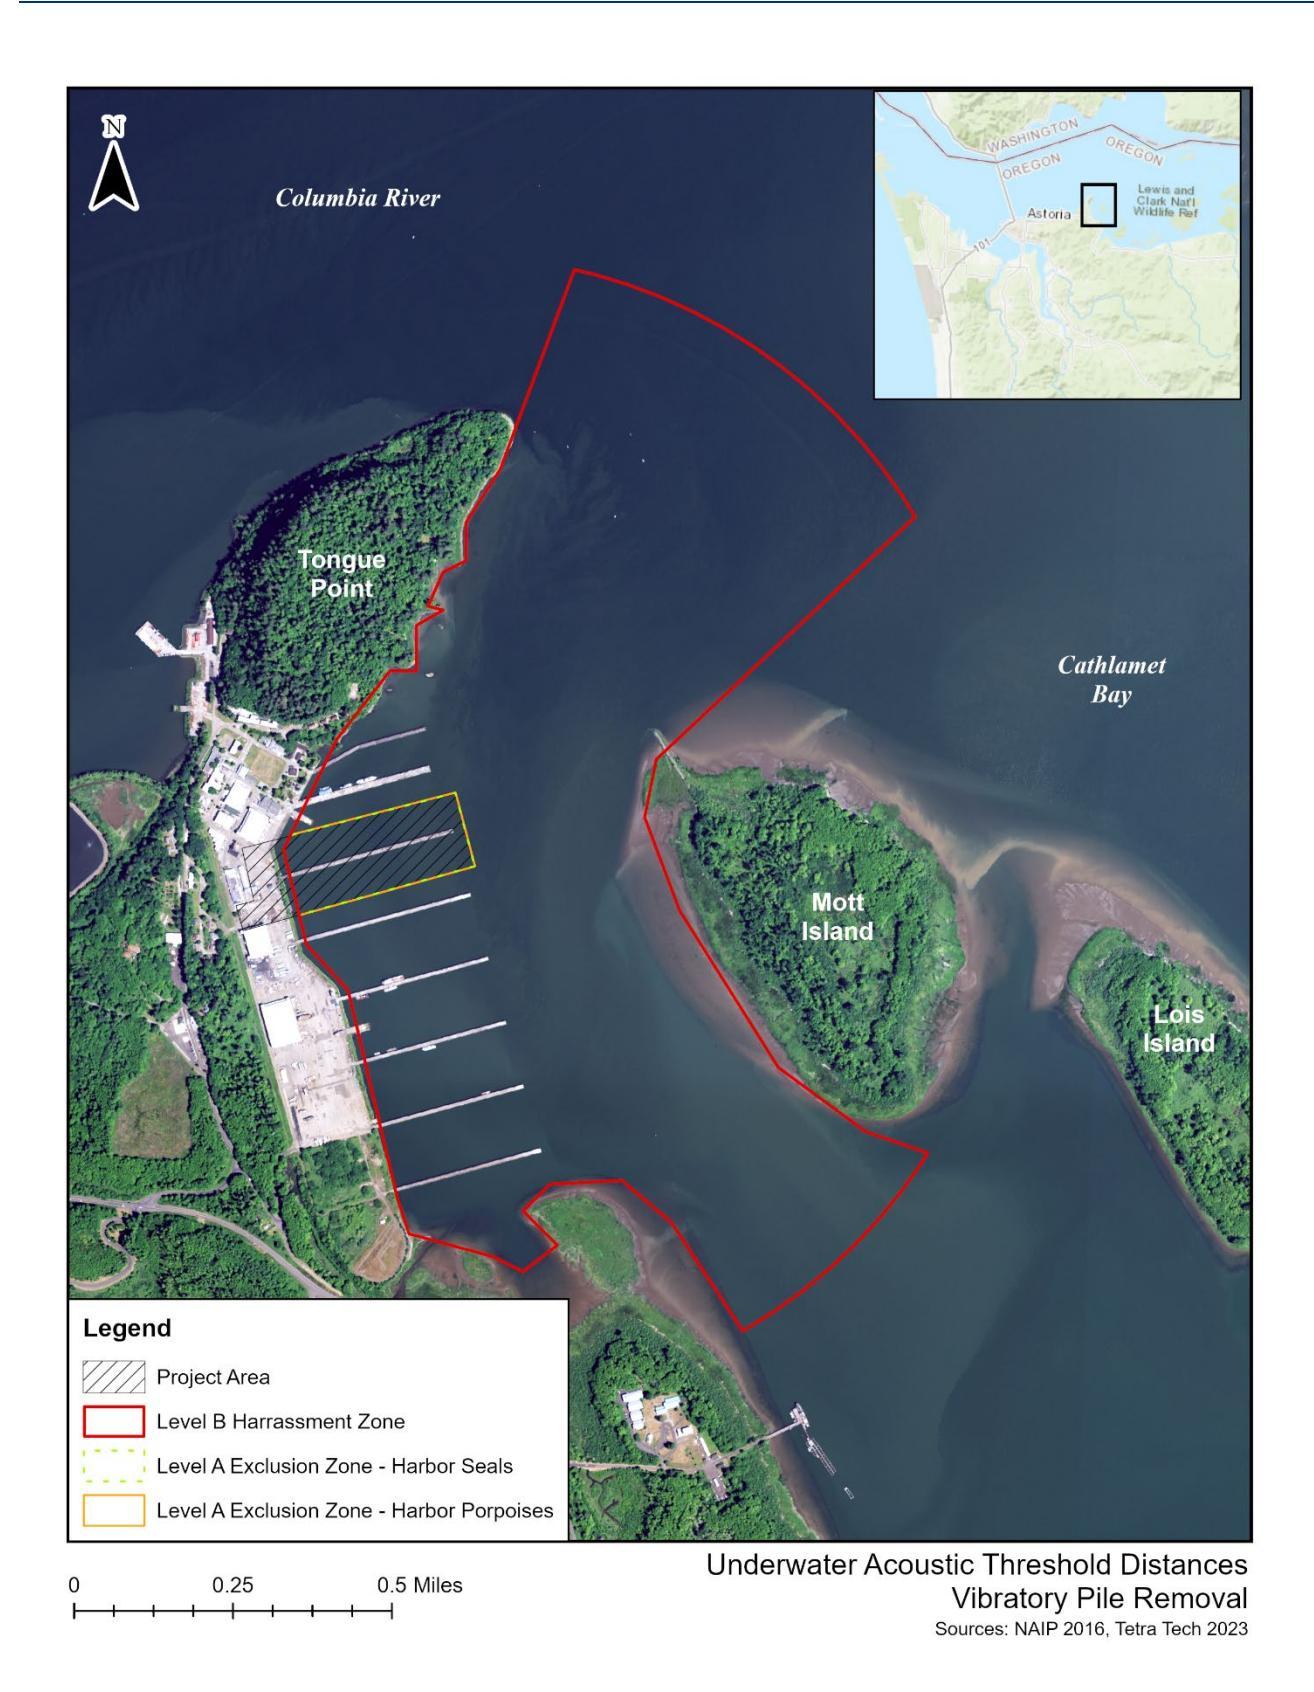
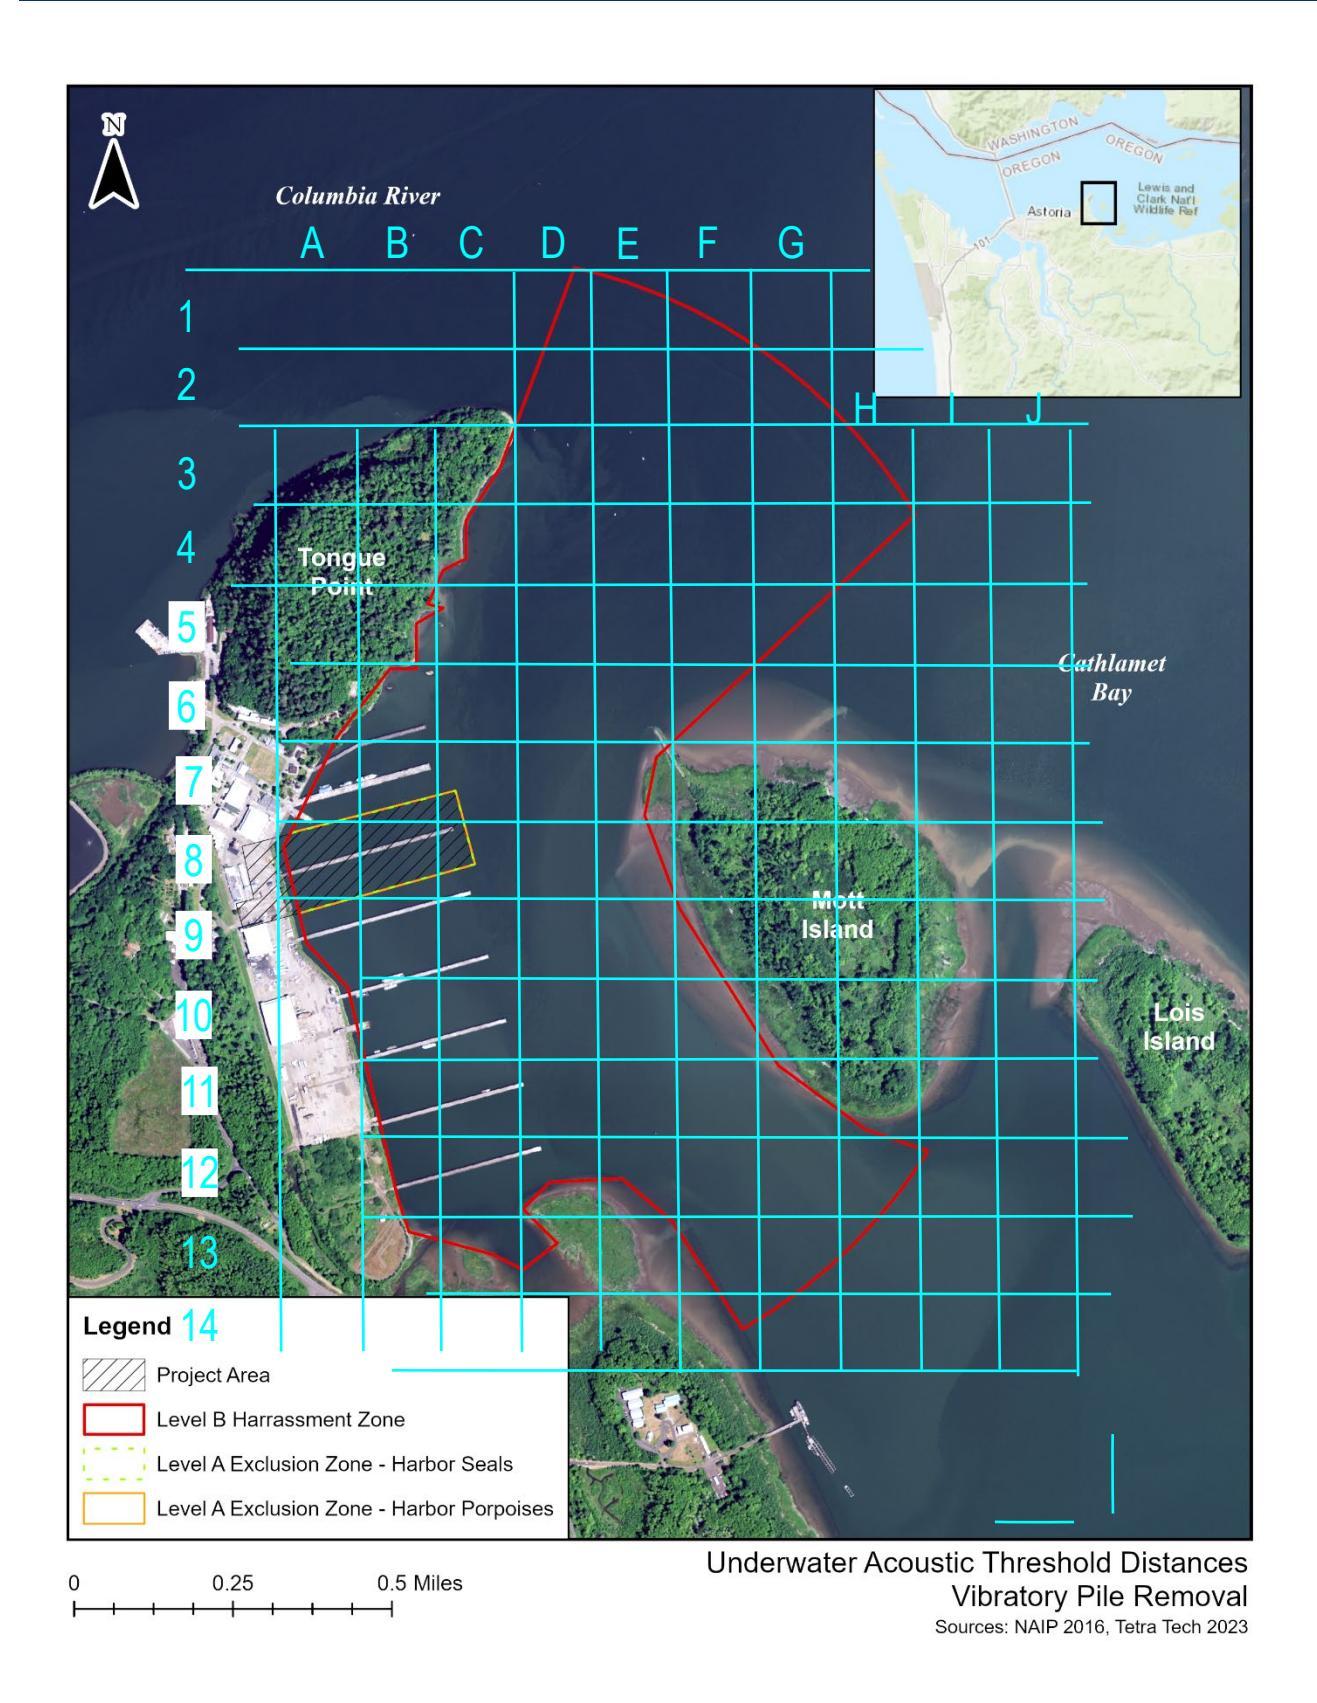
Attachment A: Monitoring Zones

The IHA request identified zones for inwater noise monitoring areas. These include two activities, one for impact hammer installation of pilings and the other for vibratory hammer removal of pilings.

IMPACT HAMMER	See Figure 1	VIBRATORY HAMMER	See Figure 2
Hearing Group	Level A Exclusion Zone (meters)	Level B Harrasment Zone (meters)	Level A Exclusion Zone (meters)	Level B Harrasment Zone (meters)
HF Cetaceans	287	602	1.2	1359
Phocid Pinnipeds	197	602	0.5	1359
Otariid Pinnipeds	-	602	-	1359
